## METALLURGICAL ASSESMENT OF MAIN BORE SURFACE DEFECT OF A MACHINED ALUMINUM ALLOY AILERON BLOCK

**D. N. Adnyana**

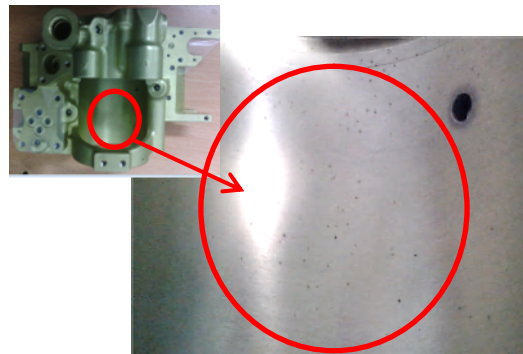
Figure 1. As received machined aileron block that revealed several pits on some of its main bore area

The defective machined aileron block that revealed several pits on its particular main bore area has been presented in Figure 1. These pits were observed after the machined aileron block was subjected to sulfuric anodizing process. Surface topography obtained from some main bore area of the machined aileron block shows machining marks that formed parallel to one another (see Figure 4). As indicated in Figure 4, there is also possibly seen a few number of surface defects or pits.

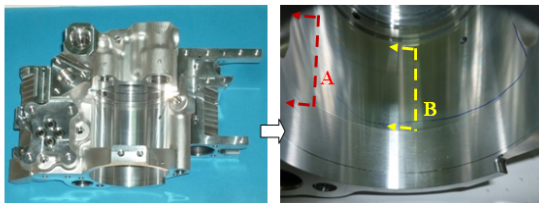
Figure 3. Two transverse sectioned specimens were cut away from locations A and B of the received machined aileron block for metallographic examination

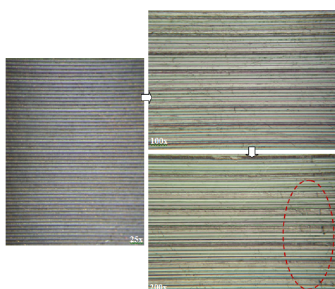
Figure 4. Surface topography obtained from some main bore area of the machined aileron block

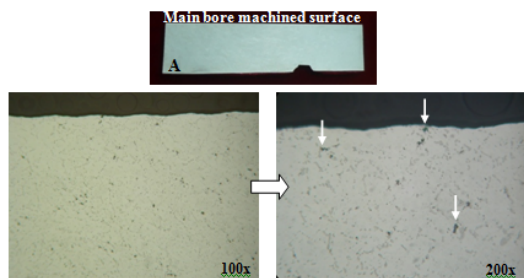
A number of samples were made from the machined aileron block within its main bore area that revealed several pits formation for laboratory examination. For metallographic examination, specimens A and B were also sectioned in transverse direction at locations shown in Figure 3. Photomicrographs obtained from the un-etched specimen A at different magnifications show a few black particles and a quite large number of grey particles that form many islands within the matrix of the

aileron block material (see Figure 5). In addition, the photomicrographs also exhibit some wavy surface topography which corresponds to the machining marks shown in Figure 4. Most likely, the black particles as indicated in Figure 5 and 6 may be associated with some manufacturing inclusions, while the grey particles are associated with the precipitates of intermetallic phase that formed mostly on the grain boundaries of the aileron block material.

Figure 5. Photomicrographs of un-etched specimen A at different magnifications

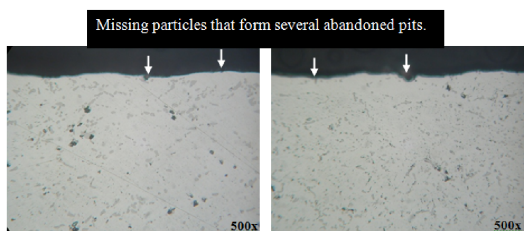
Figure 6. Similar photomicrographs as shown in Figure 5 of specimen A (without being etched) at different locations

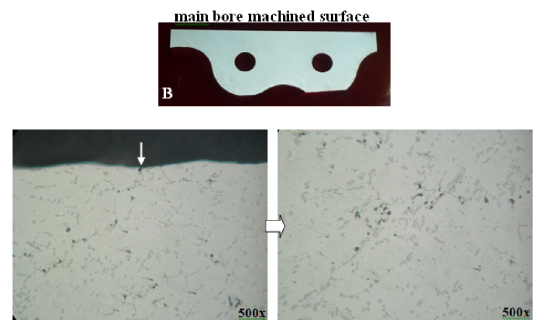
Photomicrographs obtained from the un-etched specimen B of the machined surface of the aileron block within its main bore area (see Figure 7) show similar pattern of photomicrographs with that obtained from specimen A shown in Figures 5 and 6. Many islands of grey particles are also formed along with several black particles. Some particles located at the machined surface in the main bore area appear to have left the material to form several abandoned pits thereon (see Figure 7).

Figure 7. Photomicrographs of un-etched specimen B obtained from the machined surface of the aileron block main bore area showing similar pattern of photomicrographs with that obtained from specimen A shown in Figure 5 and 6

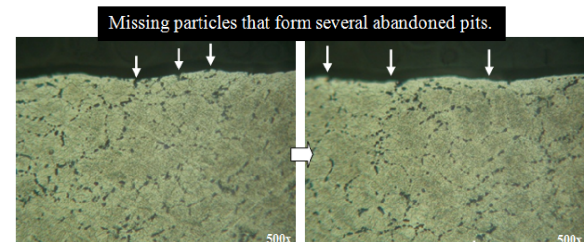
Microstructures obtained from specimen A after being etched at different magnifications show typical microstructures of aluminum alloy 2618 containing with several second phase particles or precipitates that formed along the grain boundaries of the aluminum matrix phase<sup>[4]</sup>. All of these precipitates which were previously appeared in the form of grey color islands in un-etched specimens (see Figure 5 to 7), now they appear black in color after being etched. These precipitates are intermetallic

phases of aluminum with other alloying elements that may have formed during hot forging and/or during heat treating process which includes solution heating and aging treatment<sup>[5]</sup>. It is also seen that some precipitates that formed on the machined surface of the aileron block within the main bore area may have left the machined surface and formed several abandoned pits (see Figure 8).

Figure 8. Microstructures obtained from specimen A after being etched, showing typical microstructures of aluminum alloy 2618 containing with several second phase particles or precipitates that formed along the grain boundaries of the aluminum matrix phase (etched with Keller's reagent)

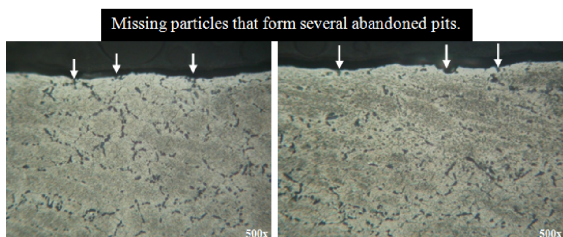
Microstructures obtained from specimen B after being etched, show similar microstructures as that obtained from specimen A shown in Figure 8. All of the grey particles or precipitates that were observed in un-etched specimen have appeared black and formed islands of second phase particles or precipitates along the grain boundaries of the aluminum alloy 2618 matrix phase. Some of these second phase particles or precipitates that may have formed during its thermo-mechanical processing may have left the machined surface of the main bore area to form several abandoned pits thereon (see Figure 9), especially when the particle size of the precipitates increased significantly and lose their coherency with the matrix phase.

Due to inappropriate thermo-mechanical processing that may have occurred during hot forging and/or during heat treating of the aileron block material, the particle size of the precipitates may have increased significantly and lose their coherency with the matrix phase, and this may have caused the large particle easily to detach from the main bore surface during machining and formed several abandoned pits thereon. In addition, formation of pits on the machined surface of the aileron block within the main bore area may have also to some extent been affected by the presence of inclusions in the forging stock material due to inappropriate manufacturing process.

Figure 9. Microstructures obtained from specimen B after being etched, showing similar microstructures as that obtained from specimen A shown in Figure 8 (etched with Keller's reagent)

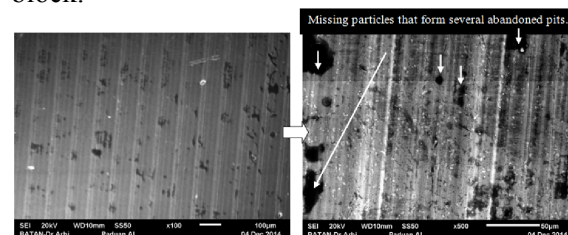
SEM photomicrograph obtained from some machined surface of the aileron block within its main bore area apparently shows several abandoned pits that were previously occupied by some particles or precipitates (see Fig.10). In addition, some of these abandoned pits may have also been related with some manufacturing inclusions. EDS spectrum of elements of some machined surface of the aileron block within its main bore area shows a number of elements from which the aileron block material was made using of aluminum alloy 2618, including Al as a major element and other alloying elements such as Cu, Mg and some small amount of Si. No any corrosive agent is apparently observed in most of the EDS test results obtained (see Figure 11 and 12). From the results of SEM examination and EDS analysis obtained that formation of several pits on the machined surface within the main bore area of the aileron block is most likely caused by the presence of large particles or precipitates and/or inclusions within the aluminum matrix phase. This condition could lower their coherency with the aluminum matrix phase and hence they were easily being detached from the material during machining<sup>[2,7]</sup>. In addition, there is also no any corrosive agent observed that could promote formation of pitting corrosion on the machined surface of the main bore area of the aileron block.

Figure 10. SEM photomicrograph obtained from some machined surface of the aileron block within its main bore area

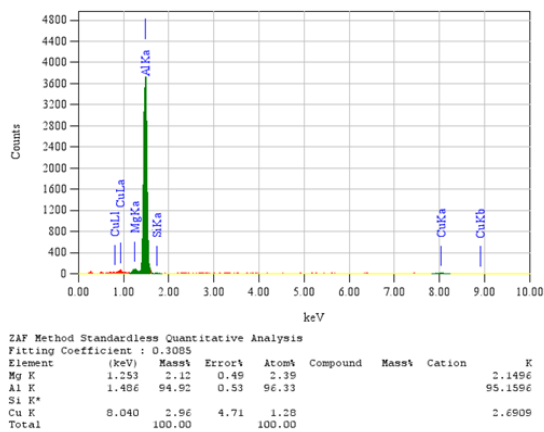
Figure 11. EDS spectrum of elements of some machined surface of the aileron block main bore area

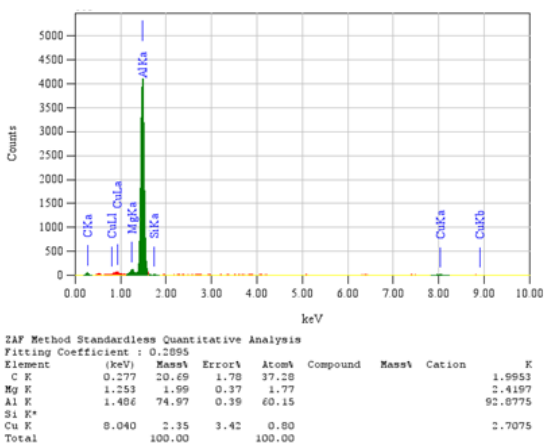
Figure 12. EDS spectrum of elements of some machined surface of the aileron block main bore area at different location from that shown in Figure 11
