STRESS-CORROSION CRACKING IN A NICKEL-BASE ALLOY PRE-HEATER EXPANSION BELLOWS

D. N. Adnyana

STRESS-CORROSION CRACKING IN A NICKEL-BASE ALLOY PRE-HEATER EXPANSION BELLOWS. This paper presents the results obtained from the failure analysis performed on a ruptured expansion bellows of a pre-heater. This bellows is a typical of single ply corrugated bellows consisting of five bellows convolutions and was made of Inconel 625, a standard specification for Ni-base alloy. The fluid circulated within the pre-heater on shell side was steam at the operating temperature and pressure of 265°C and 51.0 kg/cm²g, respectively. The bellows was reportedly ruptured during an accident occurred after the pre-heater had been in service for more than five years. A number of specimens were prepared from the ruptured bellows for laboratory examinations including macroscopic examination, chemical analysis, metallographic examination, hardness test, and SEM (scanning electron microscopy) examination equipped with EDS (energy dispersive spectroscopy) analysis. Results of the failure analysis obtained showed that the ruptured expansion bellows had experienced predominantly to stress corrosion cracking (SCC)

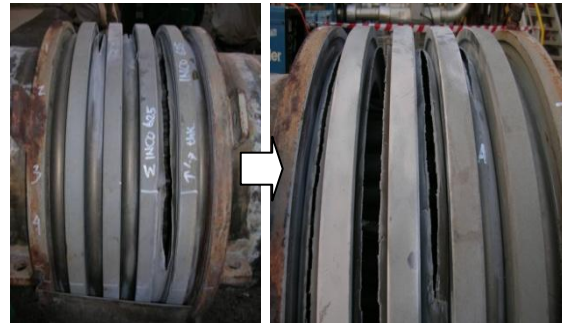
Figure 2. The ruptured expansion bellows showing four of its five bellows convolutions that were severely damaged due to cracking. Most of the cracks rupture occurred on the upper side or top side of the bellows convolutions

From Figs.2 and 3, it can also be seen that four of five bellows convolutions were apparently ruptured or burst. From the four ruptured bellows convolutions, one bellows convolution as indicated in Figs. 2 and 3 is seen to have been experiencing severity of cracking as the fracture area or crack length had reached about fifty percent of the bellows circumference. By considering the difference in fracture area

or crack length of the four bellows convolutions, most likely the rupture occurred on the bellows was not at once (or at one event), but in four consecutive sequences within seconds starting from one bellows convolution, and then followed by the second and third bellows convolutions, and finally the fourth bellows convolution. Most of the crack rupture was found to form on the outer bend or radial outward convolutions, and none was found to form on the inner bend or radial inward convolutions (see also Fig.4). This may be caused by the difference in stress conditions in both side, the outer bend convolution was subjected to tensile bending stress, while the inner bend convolution was subjected to compressive bending stress. In addition, most of the crack rupture took place on the upper or top side section of the bellows convolutions. No any cracking was found in the lower or bottom side section of the bellows convolutions.

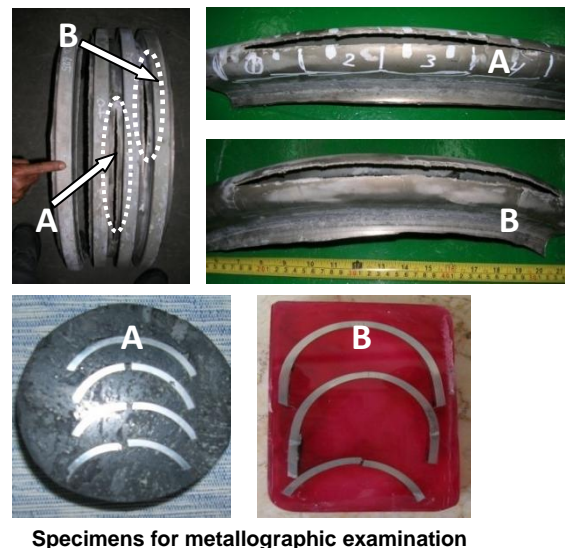
Figure 3. Two ruptured bellows convolutions (A and B) as indicated were cut away for samples preparation, and the as polished and etched specimens obtained are seen on the right hand side.

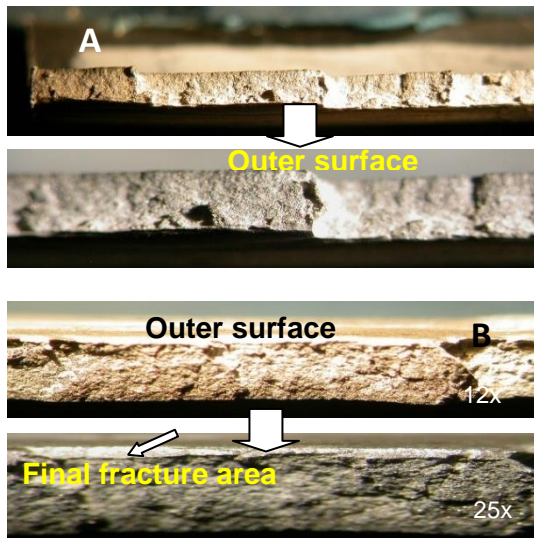
As seen in Figs.3 and 4, most of the fracture surfaces of the ruptured bellows convolutions exhibit stepwise cracking path with little or no ductility. This indicates that most of the cracks occurred on the ruptured bellows convolutions had propagated in brittle manner. In addition, the fracture surfaces shown in Fig.4 generally reveal brittle pattern with flat facets and form stepwise or jump cracking path as indication of crack propagation. It is also clearly seen that most of the cracks were originated from small pits formed on the inner surface or inner wall of the bellows convolution and propagated outward in a brittle manner. This was indicated by formation of several or multiple parallel shallow cracks with some branching. Shortly after the crack reached the outer edge or outer surface of the outer bend bellows convolution, a fast crack grew rapidly through the remaining section. The rough surface left by the fast crack near the outer surface of the bellows convolution is final fracture overload which appears in ductile manner. It can

also be seen from the fracture surfaces shown in Fig.4 that the final ductile fracture overload is much smaller than the brittle crack propagation zone. This may indicate that the fracture pattern of the ruptured bellows convolution was produced by a low nominal stress, probably much below the yield strength of the bellows material ^[3-4]. In addition, most of the fracture surfaces shown in Fig.4 are rough in appearance and may be containing with some corrosion product or deposits as the fracture surfaces were discolored due to reaction with the environment such as steam containing some corrosive agent ^[5].

Figure 4. View of some fracture surfaces of the ruptured bellows convolutions A and B at their outer bend convolutions

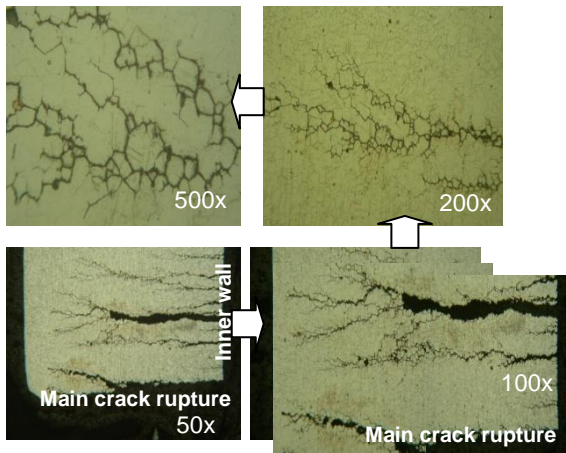
Microstructures obtained from all samples of the ruptured bellows convolution A are very much similar one to the other. Some microstructures obtained from location at right hand side section around the main crack rupture are presented in Fig.5. Most of the microstructures obtained obviously exhibit multiple parallel cracks that were most likely originated from some small pits formed on the internal surface of the outer bend convolution and subsequently propagated to form extensive branching in intergranular manner through the austenitic

grain boundaries of the bellows material, typical of a stress-corrosion cracking (SCC)^[5]. Similar microstructures shown in Fig.5 were also obtained from the other sample located at right hand section at some distance away from the main crack rupture, see Fig.6. However, the cracks that were formed at some distance away from the main crack rupture appear to be less extensive as the tensile bending stress in this area was probably lower than the bending stress formed around the main crack rupture area.

Figure 5. Microstructures obtained from some location of the ruptured bellows convolution A at right hand side section around the main crack rupture

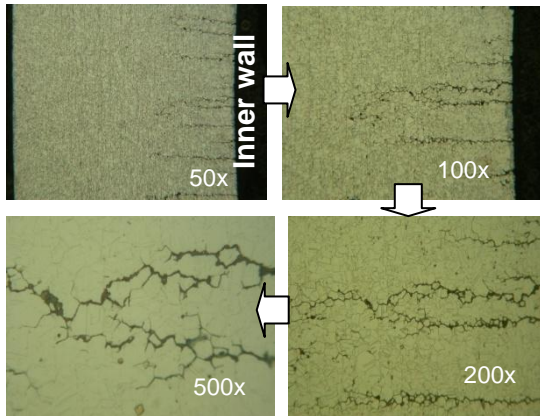
Figure 6. Microstructures obtained from some location of the ruptured bellows convolution A at right hand side section at some distance away from the main crack rupture area

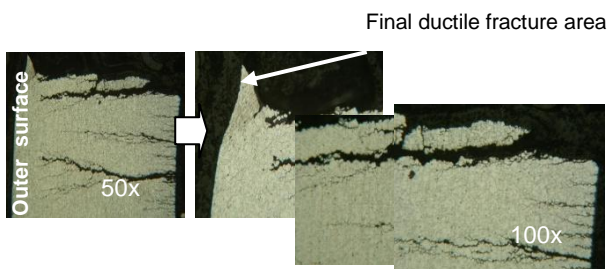
Microstructures obtained from some sample located at left hand side section of the main crack rupture were also very much similar to those obtained from the right hand side section of the main crack rupture of the bellows. Most of the cracks formed around the main crack rupture were generally more extensive in comparison with the crack formed at some distance away from the main crack rupture area. The difference in crack severity as described above may be associated with the difference in stress level occurred on both area. Area subjected to a higher tensile stress level generally experienced more extensive crack compared to that area of lower tensile stress level. As also seen in Fig.7, a small portion at the final fracture area of the bellows convolution exhibits some plastically deformed microstructures with ductile appearance, although at most part of the fracture surface appeared brittle. This indicates that the SCC in bellows convolutions had propagated in brittle manner under a low nominal stress, while the final fracture area exhibits some ductile fracture overload. This may also indicate that the threshold stress for this SCC to occur was relatively low. This threshold stress is generally a function of temperature, the composition and metallurgical structure of the alloy, and the composition of the environment.

Figure 7. Microstructures obtained from some location of the ruptured bellows convolution A at left hand side section around the main crack rupture area, showing some small portion of the final ductile fracture overload

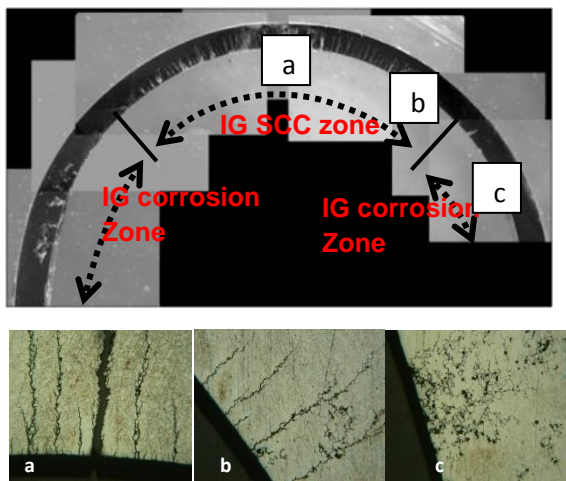
In order to obtain some further confirmation on the failure type and mode that may have occurred on the ruptured bellows, other metallographic examination was also performed on some sample of the ruptured bellows convolution B and the results obtained are presented in Fig.8. Macrostructures shown in Fig.8 also clearly exhibit multiple parallel cracks propagated in intergranular manner with extensive branching especially in area of bellows convolutions that were subjected to high tensile bending stresses. On the other hand, in area of bellows convolution having less or no tensile bending stresses, formation of cracks became less significant

and the damage appeared to be predominant intergranular corrosion. The corresponding microstructures shown in Fig.8 confirm that area having higher tensile bending stresses generally exhibited an intergranular stress-corrosion cracking (IG SCC) pattern with more extensive crack branching, while area having less or lower tensile bending stresses generally exhibited a predominant intergranular corrosion (IG corrosion). The formation of these IG SCC and/or IG corrosion indicates that the ruptured bellows material which was made of Inconel 625 had been experiencing sensitization due probably to some carbides or second phase precipitation in the austenitic grain boundaries^[6]. The lower Cr content found in the bellows material shown in Table 1 may have also to some extent contributed to the lowering of the corrosion resistance of the bellows material.

Figure 8. Macrostructures obtained from some specimen of the ruptured bellows convolution B and the corresponding microstructures at different test locations as indicated

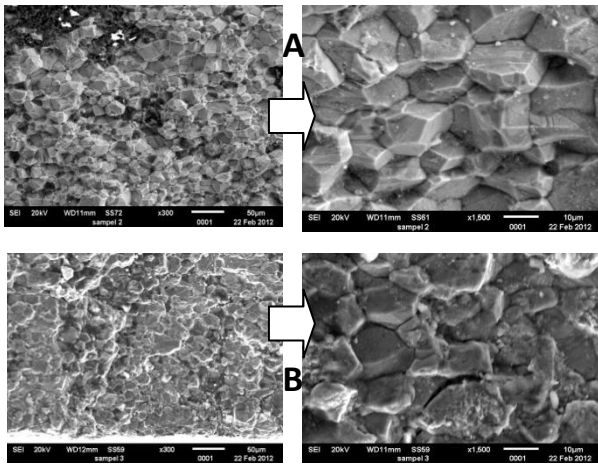
The SEM photofractographs obtained from fracture surfaces of the ruptured bellows convolutions A and B are presented in Fig.9. Most of the intergranular stress-corrosion cracking (IG SCC) of the ruptured bellows material have the classic rock candy appearance, typical of brittle fracture pattern. These SEM photo fractographs further confirm that the ruptured bellows material was most likely subjected to embrittlement during operation caused by grain boundary separation.

Figure 9. SEM photofractographs obtained from the fracture surfaces of the ruptured bellows convolutions A and B

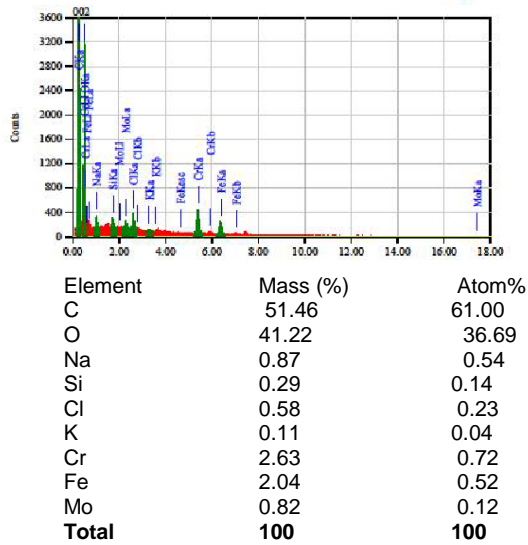
The deposits that may have been present at the fracture surfaces of the ruptured bellows convolutions were analyzed using the EDS technique, and the results obtained are presented in Fig.10. The deposits contained major elements of Ni, Cr, Fe, Mo, C and O, plus minor elements of Al, Ti, Mn and Si. In addition,

the deposits also contained some trace elements of Na, Cl and K.

From the results of EDS analysis obtained, it can be said that Ni, Cr, Fe, Mo, Si, Al, Ti and Mn are the base metal constituents of Inconel 625. The other deposit constituents such as Na, Cl and K may have entered into the pre-heater as trace elements in the shell side steam due to accidental carry-over of dissolved solids, or being trapped in the bellows convolutions after the pre-heater had been periodically cleaned by chemical solution containing such trace elements. Due to its disadvantage in shape and geometry of the bend curvature of bellows convolutions, a lot of fluid was probably allowed being trapped in the corrugations and therefore such trace elements could become concentrated in some particular area especially in the upper or top side of the bellows convolutions where alternating wet and dry conditions were probably present. Other possible source of the trace element present may have been likely coming from the use of any contaminated water during the hydrostatic testing [8]. From the EDS results shown in Fig.10, most likely sodium (Na) was the predominant trace element that may have caused the expansion bellows of the pre-heater susceptible to a caustic induced

stress-corrosion cracking (SCC). The presence of Na that was responsible for SCC may have not been in large quantity or in high concentration^[5,9]. The operating temperature of steam used (265 °C) in the pre-heater may have further activated the process essential to SCC. In addition, other traces of element such as Cl and K, although their presence were considered not significant, but to a limited extent they may have also contributed to the failure of the bellows convolutions. Chloride (Cl) may have influenced to the formation of corrosion pits at the sites where the SCC may have been originated, whereas potassium (K) may have participated to further increase in the caustic concentration^[5].

Figures 10 (a) and (b). EDS spectrum of elements obtained from the fracture surface deposits of the ruptured bellows convolutions A and B (continued)
