FATIGUE FAILURE OF WHEEL STUDS AND NUTS OF LIGHT VEHICLES USED IN COAL MINE OPERATION

D.N. Adnyana

*Light vehicle is a potentially useful and efficient mode of transportation to be utilized in supporting the coal mine operation. However, due to the harsh road condition at the mine site, many light vehicles presently used are frequently experiencing a number of incidents caused by loose wheel. The occurrence of this loose wheel is very much related with some broken or damaged wheel studs and/or nuts of the vehicle. Type of failure and factors that may have caused the damage of the wheel studs and/or nuts of the vehicles are discussed in this paper. The metallurgical assessment was conducted by preparing a number of specimens from the damaged and undamaged wheel studs and nuts of the vehicles. Various laboratory examinations were performed including macroscopic examination, chemical composition analysis, metallographic examination, hardness test and SEM (*scanning electron microscopy*) examination equipped with EDS (*energy dispersive spectroscopy*) analysis. In addition, torsion test was also conducted on several new studs and nuts to measure the relationship between the torque an

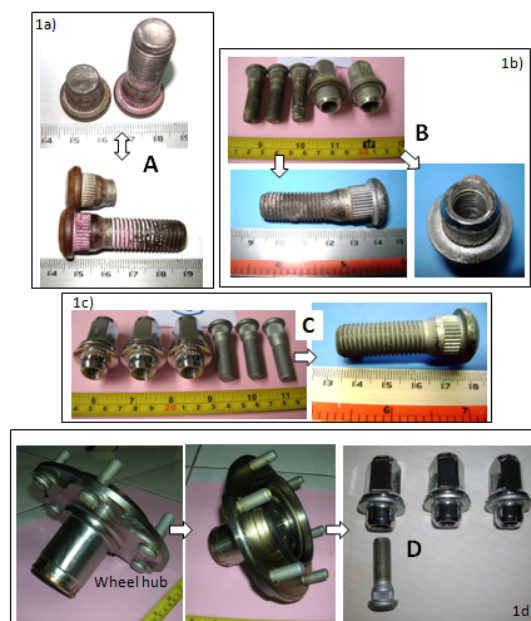
A number of damaged and undamaged wheel studs and nuts of the light vehicles were received and used as representative of failure cases occurred on the mine site for metallurgical assessment. Studs A as shown in Figure 1(a) consist of one broken wheel stud and one undamaged wheel stud recovered from the front left hand wheel of the light vehicle after it had traveled 44675 km prior to the incident. Studs and nuts B as shown in Figure 1(b) consist of two bent studs, one undamaged stud, one damaged nut and one undamaged nut recovered from the other but the same brand name light vehicle as studs A obtained. These studs and nuts B were recovered from the front left hand wheel of the vehicle after it had traveled 46611 km before the incident occurred. In addition, there were also some new wheel studs and nuts selected and used for comparison in this investigation, namely studs C to represent a non OEM (original equipment manufacturer), see Figure 1(c), and studs D to represent the OEM of the same brand name of light vehicle as studs A and studs/nuts B obtained, see Figure 1(d).

Figure 1. The as received damaged and undamaged wheel studs and nuts for metallurgical assessment. (a) Studs A recovered from the well-known brand name LV 4x4; (b) Studs and nuts B also recovered from the same brand name LV as studs A, but from different vehicle; (c) Studs C represent a non OEM; and (d) Studs D represent the OEM of the same brand name LV as studs A and studs B

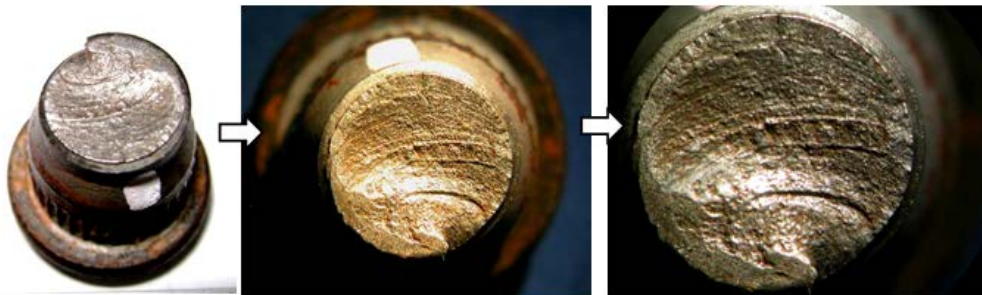
The fracture surface of the broken stud A is shown in Figure 2. It is clearly seen in this figure that the fracture occurs in the first thread of the stud and its fracture surface shows typical fatigue fracture having three distinctive areas of fracture, namely crack initiation, crack propagation and final fracture^[3]. The fracture surface shown in Figure 2 also provides road signs of a unidirectional bending fatigue fracture with the initiation site located on an area having with a high stress concentration at the first stud-thread root immediately adjacent to the edge of the nut on the washer side. This stress concentration site occurs because the stud elongates as the nut is tightened, thereby producing increased loads on the threads nearest the bearing face of the nut, which add to normal service stresses^[4]. The fatigue crack was then propagated along the stud cross section by forming beach marks as indicated in fracture surface in Figure 2. Shortly after the crack reached the other outer edge of the stud, a fast crack grew rapidly through the remaining section. The rough surface left by the fast crack is the final fracture. It can be seen from the fatigue fracture surface shown in Figure 2 that the final fracture zone is much smaller than the crack propagation (beach marks) area. This suggested that the fatigue fracture pattern of the broken stud shown in Figure 2 was produced by a low nominal stress. This is in accordance with the comparison shown in Figure 3, showing the schematic of marks on surface of fatigue fractures produced in smooth and notch components with round cross section under various loading conditions at high and low nominal stress^[5].

Figure 2. Fracture surface obtained from the broken wheel stud A

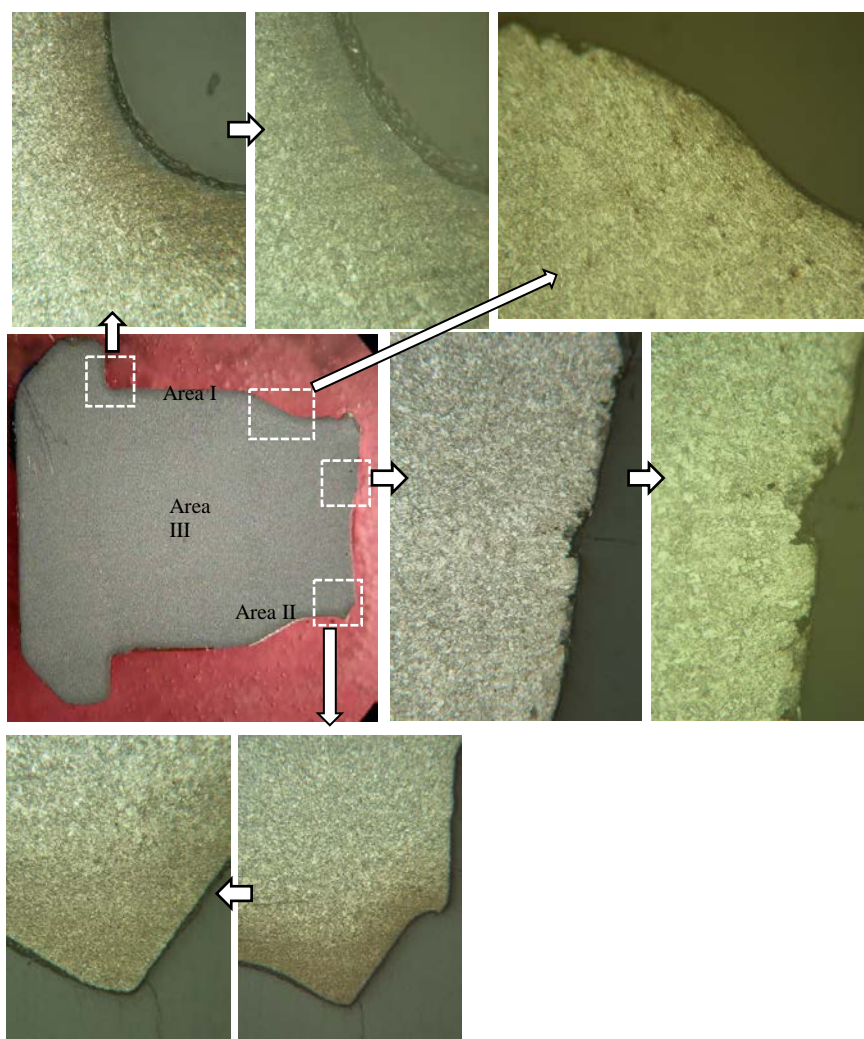
Two polished and etched specimens of the longitudinal cross section of stud A are shown in Figures 4 and 5, which include the broken wheel stud and the undamaged wheel stud, respectively. Most of the microstructures obtained (see Figures 4 and 5) exhibit fine tempered martensite. This indicates that the wheel studs A were manufactured by rolling or forging, and then followed by a quench hardening and tempering heat-treatment. From the microstructures shown in Figures 4 and 5, no any significant manufacturing defect is observed in most area being examined of the wheel studs A. As also seen in Figures 4 and 5, some case hardening layer is also applied to the wheel studs A during their past manufacturing process. The application of this case hardening layer has increased the hardness of the stud skin material quite significantly in comparison with the stud core material. From Table 2, it can be

seen that the hardness value in the range of 305-315 HV is obtained in most of the case hardening layer of the broken stud A, and this hardness range is higher than the hardness value of the stud core material which is only in the range of 269-276 HV. Similarly, the hardness value of the undamaged wheel stud A shown in Table 3 particularly on its thread surfaces is generally high in the range of 320 HV up to 420 HV, while the stud core material generally has a relatively lower hardness value in the range of 266 to 276 HV.

Figure 4. Microstructures obtained from the broken wheel stud A at different locations, showing fine tempered martensite. Etched with 5% Nital solution

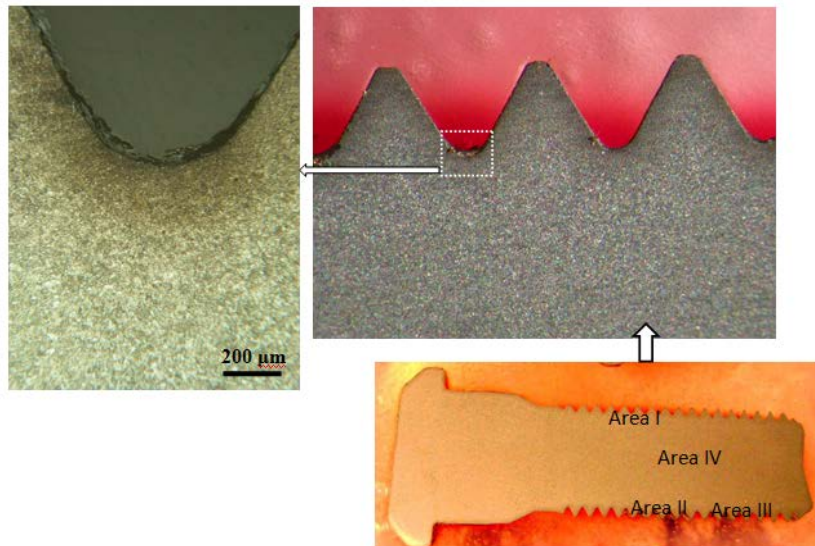
Figure 5. Microstructures obtained from the undamaged wheel stud A at location as indicated by the square grit, showing fine tempered martensite. Etched with 5% Nital solution

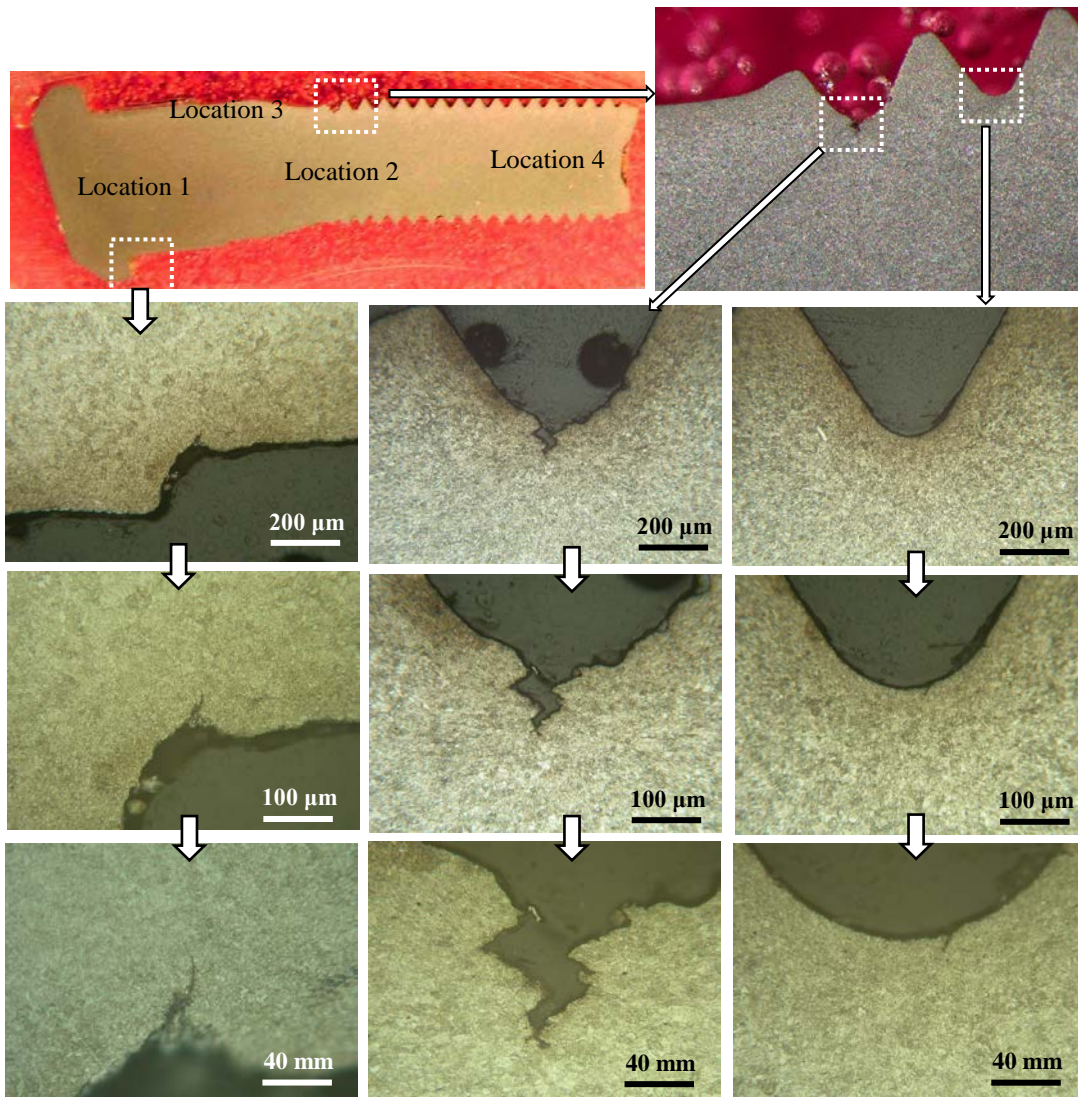
Figure 6. Microstructures obtained from the damaged (bent) wheel stud B at locations as indicated by the square grit, showing fine tempered martensite. Etched with 5% Nital solution

Similar to studs A, the microstructures obtained from studs B also generally exhibit fine tempered martensite, see Figure 6. It is also seen in Figure 6 that a fatigue crack may have been initiating at the first thread root of the bent stud B. In addition, a fine fatigue crack due to bending may have also been developing at the root of its second thread. Furthermore, other fine fatigue crack may have also been initiating from a high stress concentration area at the head-to-shank fillet of the stud (see Figure 6). Moreover, there is no any manufacturing defect observed in most of the fatigue crack area formed in the wheel stud B. Although the microstructures obtained from the wheel studs B are very much similar with that obtained from the wheel studs A, however, the average hardness value of the damaged stud B is relatively lower compared to the average hardness value of the studs A (see Table 4). This difference in hardness may be associated with the difference in the parameters applied during the manufacturing process for the wheel studs B and A. It is also likely that the stud B has not been given with sufficient case hardening layer.

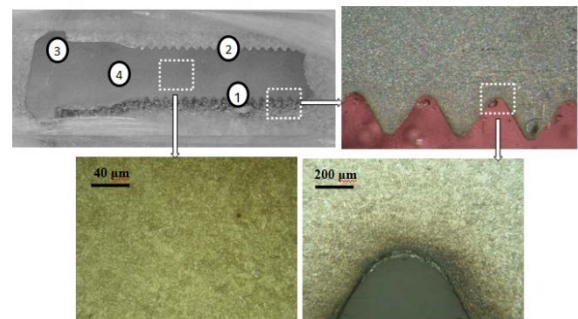
Figure 8. Microstructures obtained from the brand new non-OEM wheel stud C at locations as indicated by the square grit, showing fine tempered martensite. Etched with 5% Nital solution

Most of the microstructures obtained from the non-OEM wheel stud C (see Figure 8) also exhibit fine tempered martensite, similar to the microstructures obtained from the wheel studs A and B. It is also seen from the microstructures that a case hardening is also applied on most of the stud C surfaces. As seen in Table 6, the hardness value of the stud C surface is found in the range of 352 to 441 HV, much higher than the hardness value of its core material which is in the range of 320 to 325 HV. The associated wheel nut C together with

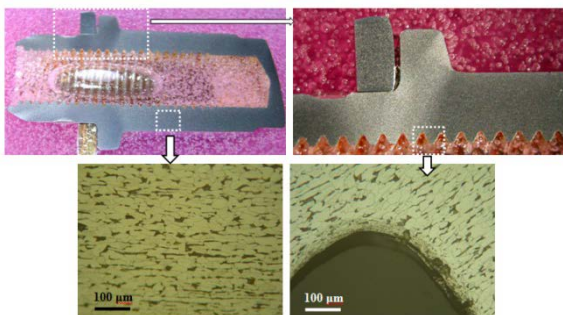
its ring washer is also examined, and its microstructures obtained are presented in Figure 9. It is clearly seen that the entire wheel nut C is made from the same material of a low carbon steel in which its microstructures consisting of a small amount of pearlite in the predominant soft and ductile ferrite matrix. It can also be seen that there is likely not any coating applied to the external surface of the wheel nut C.

Figure 9. Microstructures obtained from the brand new non-OEM nut C at locations as indicated by the square grit, showing ferrite matrix with some small amount of second phase of pearlite. Etched with 5% Nital solution

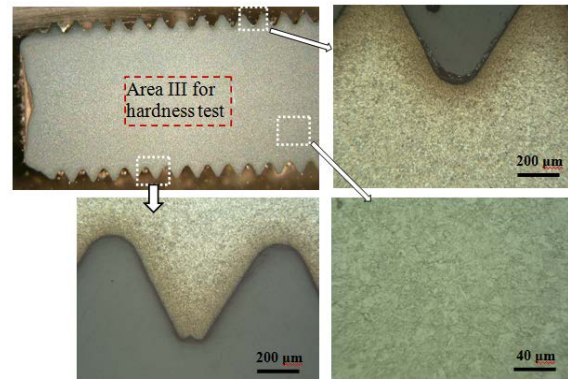
For wheel stud D, its microstructures consist of fine tempered martensite, similar to those obtained from the wheel studs A, B and C (see Figure 10). It can also be seen that a case hardening layer may have also been applied to the wheel stud D. The hardness value obtained from the stud D thread surface is in the range of 330 to 495 HV, while the hardness value obtained from its stud core material is in the range of 283 to 306 HV (see Table 7). This hardness value of the core material of the stud D in average is relatively lower than the hardness value of the core material of stud C, but the stud D has the average surface hardness higher than the average surface hardness of stud C.

Figure 10. Microstructures obtained from the brand new OEM wheel stud D at locations as indicated by the square grit, showing fine tempered martensite. Etched with 5% Nital solution

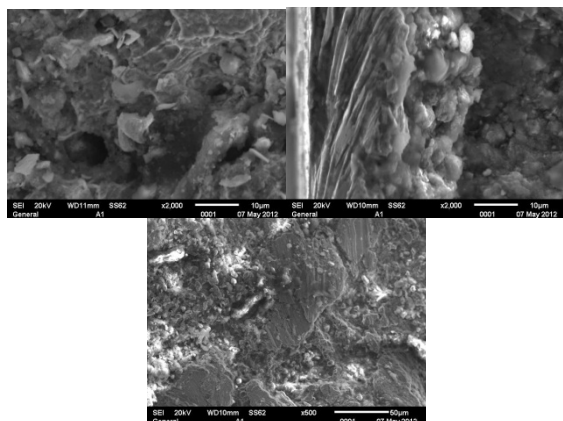
The SEM fractographs of the surface fatigue fracture of the broken wheel stud A are presented in Figure 11. It can be seen that some of the fracture surfaces of the broken stud material exhibit less distinct striations of typical fatigue appearance of low alloy steel^[8]. Although fatigue striations are not well resolvable at any location, but the entire fatigue fracture surface displays similar crystallographic features. Further evidence of the occurrence of fatigue fracture is also indicated by the fact that no any plastic deformation in the form of dimple fracture is observed on most of the SEM fractographs shown in Figure 11^[2].

Figure 11. SEM micrographs obtained from the surface fatigue fracture of the broken wheel stud A

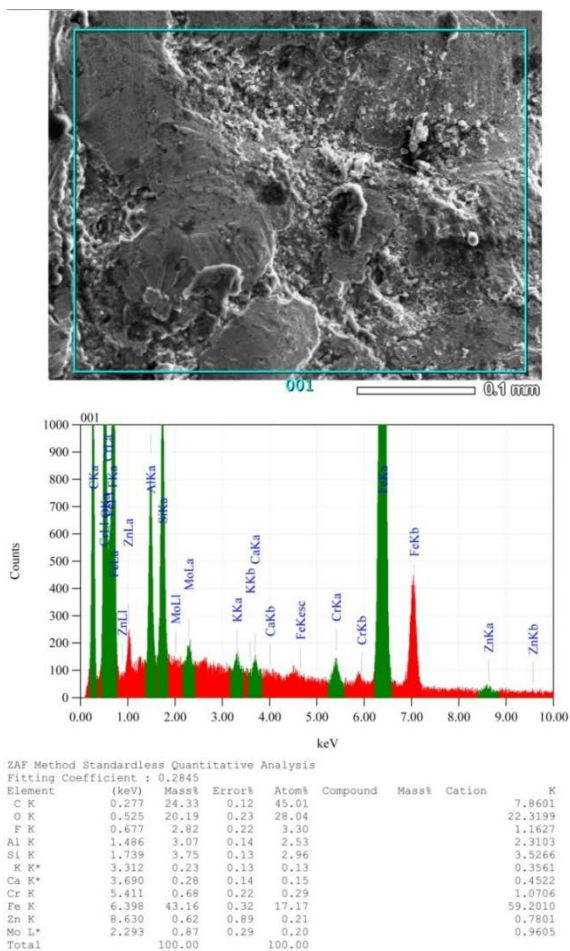
The EDS spectrum obtained from the fatigue fracture surface of the broken wheel stud A at some test location is presented in Figure 12. The EDS spectrum show some major elements of the low-alloy steel containing chromium from which the wheel stud A was made such as: Fe, C, Si, Cr, Al and Mo. In addition, some other elements are also present such as: O, F, Zn, K and Ca. Oxygen (O) is likely coming from the oxide scale that may be present on the fracture surface of the

wheel stud material, whereas Zn is most likely coming from the zinc coating that may have been applied to the stud surface. The source of F, K and Ca is not clearly known, but they may be coming from the road soil and/or from the environment. However, the presence of these elements in small amounts may have not significantly affected to the stud damage as there is no any corrosion by product is observed to form on most of the fracture surface of the broken stud A.

Figure 12. EDS spectrum of elements representing the corresponding composition of fracture surface of the broken wheel stud A

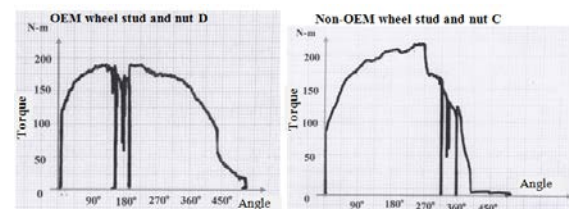
Some of the test results of torque and angular displacement measurement obtained from the wheel stud/nut joint of studs D (OEM new stud/nut) and studs C (non-OEM new stud/nut) are presented in Figure 17. All of the test results obtained are then summarized and presented in Table 8. It can be seen from Table 8 that all studs D of the OEM wheel stud/nut could provide the torque at elastic limit higher than the non-OEM of studs C. On the other hand, the torque at maximum plastic limit of the OEM wheel stud/nut of studs D is relatively lower compared to the non-OEM wheel stud/nut C. The difference in torque versus angular displacement relationship between the OEM wheel stud/nut D and the non-OEM wheel stud/nut C might be associated with the difference in material used and/or by the difference in manufacturing process applied on both studs and nuts (see the chemical composition shown in Table 1 and the microstructures of studs D and C in Figures 8 and 10). Generally accepted that the wheel stud/nut having with higher torque at elastic limit is preferable being used for joint application. The higher the torque at elastic limit that the wheel stud/nut could withstand,

Furthermore, it can be seen from Table 8 that when the initial torque of 50 N-m is taken into account, then the maximum permissible torque that could be given to the OEM wheel stud/nut of studs D is in the range of 125 to 175 N-m or 12.74 to 17.83 kg-m, whereas for the non-OEM wheel stud/nut C, the maximum permissible torque that could be given is in the range of 90 to 140 N-m or 9.17 to 14.27 kg-m. According to the information obtained from a Car Dealer, stated that by experience, the preload torque is usually applied to the wheel stud/nut joint with a maximum torque of 11.50 kg-m, whereas in the manual book shows that the preload torque is recommended being 10.70 kg-m.

Figure 17. The torque and angular displacement curves obtained from the test of the wheel studs and nuts
