## STRESS CORROSION CRACKING OF CAGE SUPERHEATER TUBES OF A NEWLY BUILT BOILER

**Dewa Nyoman Adnyana**

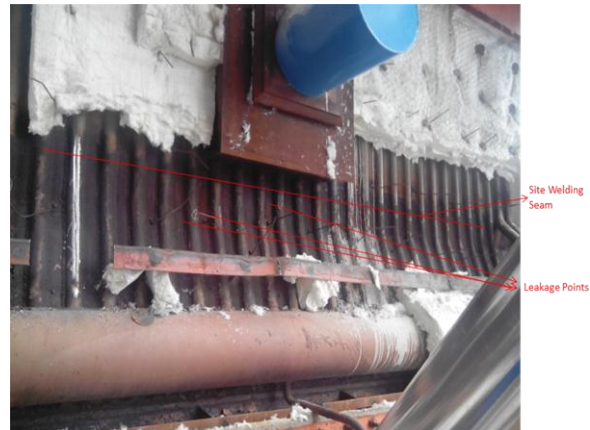
Figure 1. Photograph of cage superheater tubes after the accident showing locations of tube leakages

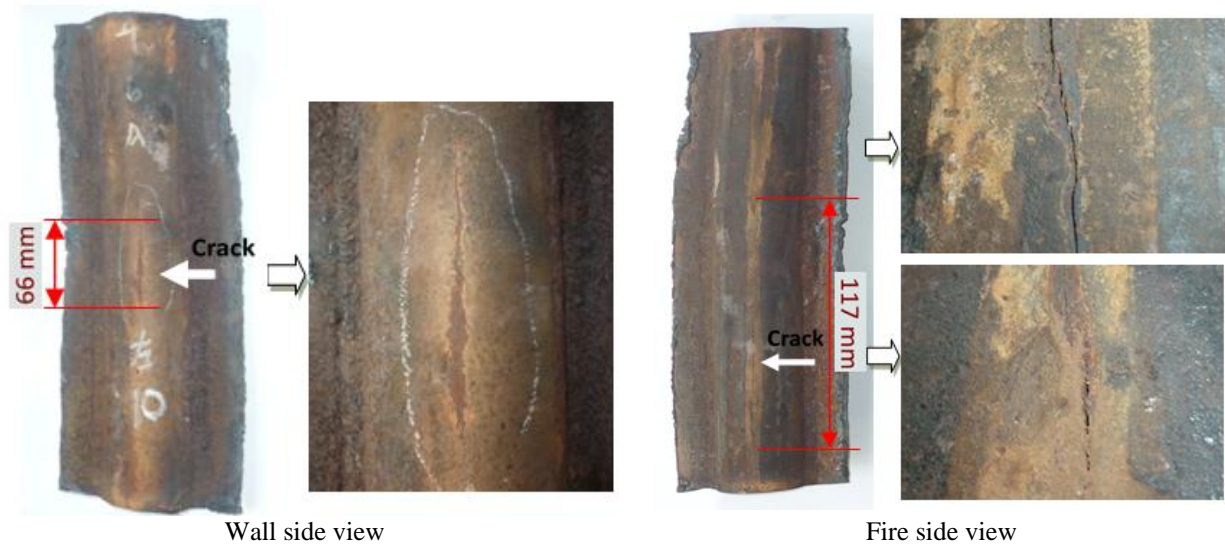
The as-received tube section shown in Figure 2 revealed longitudinal cracks on both sides of the tube. As seen in Figure 2, the

cracks length on the tube surface that facing to the insulation wall (wall side) was about 66 mm, whereas on the tube surface that facing to the fire side, its crack length was about 117 mm.

Figure 2. The as-received leaked cage superheater tube

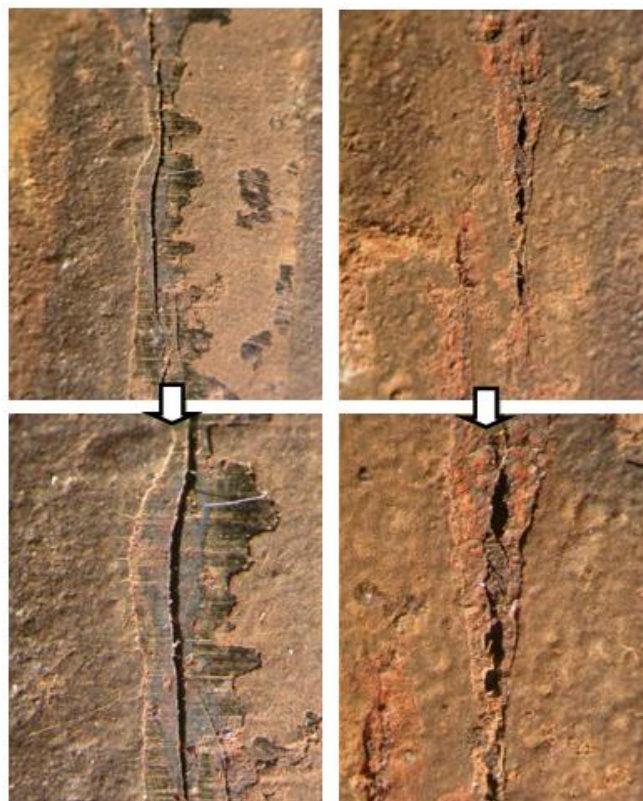
Figure 3. Macroscopic view of some longitudinal cracks area obtained from the external surface of the tube shown in Figure 2

The cracks on the external tube surfaces were originally coming from the cracks formed on the internal wall of the tube. Enlargement of some longitudinal cracks that formed on the external surface of the tube at the fire side position is shown in Figure 3. Some fireside deposits also observed to have formed on most of the tube external surface. There also seen in Figure 4 that the tube internal wall slightly covered by some deposits. One section of the fire side tube portion was cut away for macroscopic examination and fracture surface of the fire side tube portion obtained from some longitudinal cracks are presented in Figure 5, showing brittle fracture appearance with the cracks were originated from the internal wall of the tube where pits were present [8]-[10]. In addition, one section of the wall side tube portion was also cut away for macroscopic

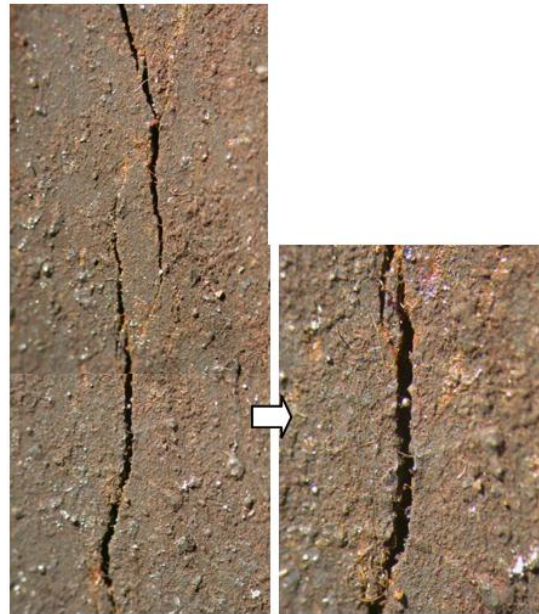
Figure 4. Macroscopic view of some longitudinal cracks area obtained from the internal wall of the tube shown in Figure 2

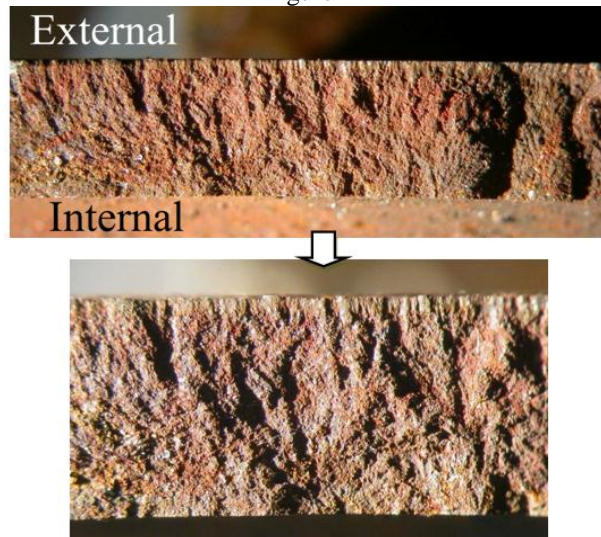
Figure 5. Fracture surface of the fire side tube portion

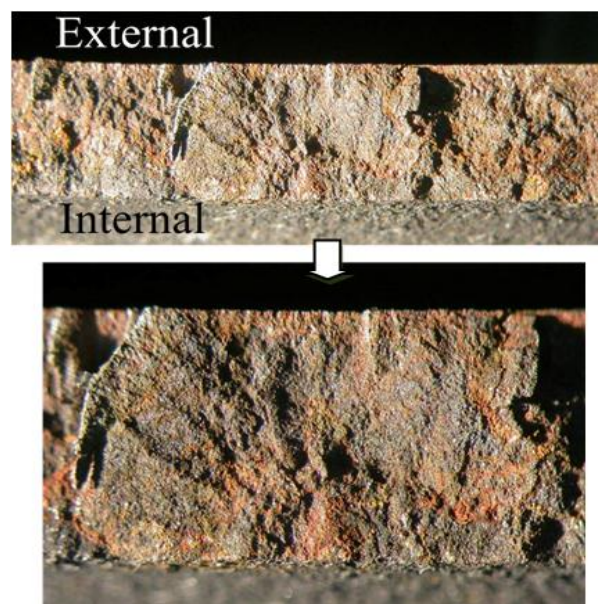
Figure 6. Fracture surface of the wall side tube portion

examination and fracture surface of the wall side tube portion obtained from some longitudinal cracks are presented in Figure 6 showing brittle fracture appearance with the cracks were originated from the internal wall of the tube where pits were present.

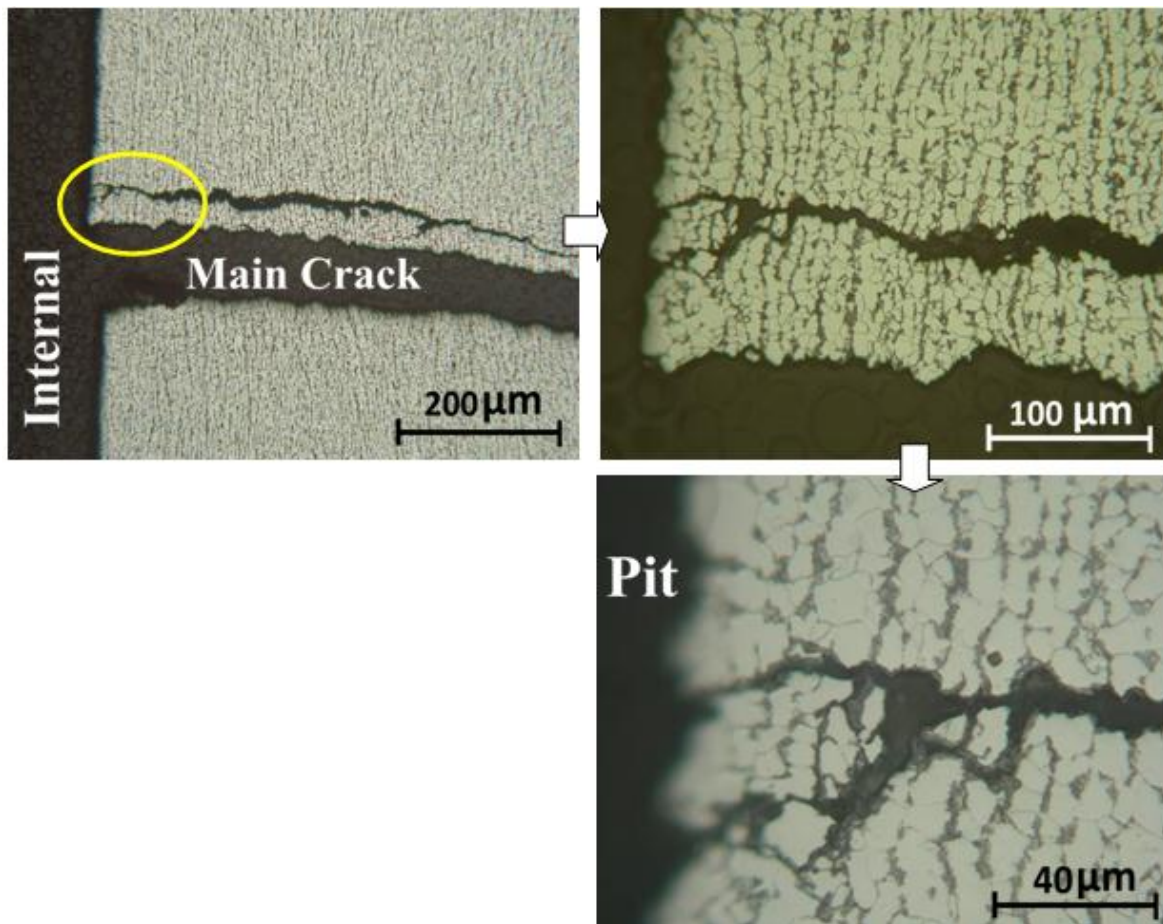
Figure 8(a). Microstructures of sample A obtained from the fire side position of the tube at location as indicated by the square grit in Figure 7, showing ferrite phase as matrix and pearlite as second phase typical of a low carbon steel tube. All the cracks obviously originated from the internal wall of the tube where the corrosion pits were present. The cracks propagated toward the external surface of the tube through the pearlite phase and/or ferrite grain boundaries, typical of stress-corrosion cracking (SCC). Etched with 5% Nital solution

from the fire side position of the leaked tube piece exhibited ferrite phase as matrix and pearlite as second phase typical of a low carbon steel tube. As also clearly seen in Figures 8-10, all the cracks originated from the internal wall of the tube where the corrosion pits present. The cracks propagated toward the external surface of the tube through the pearlite phase

and/or ferrite grain boundaries, typical of stress-corrosion cracking (SCC). Formation of this SCC was most likely caused by the combined effect of corrosion and tensile stress [8]-[10]. The corrosive agent that may have been responsible in causing the SCC in the superheater tube under study will be shown later from the results of SEM/EDS analysis. Whereas formation of high tensile stresses occurred on both tube surfaces that were located at approximately 180° from one side to the other side of tube may have been affected by some hot spots that could produce different thermal expansion or deformation on the tube and resulted in high tensile bending stresses generated at the internal wall of the tube. In addition, the total tensile stresses occurred on the internal tube surface was also affected by the circumferential tensile stress due to the internal working pressure in the tube.

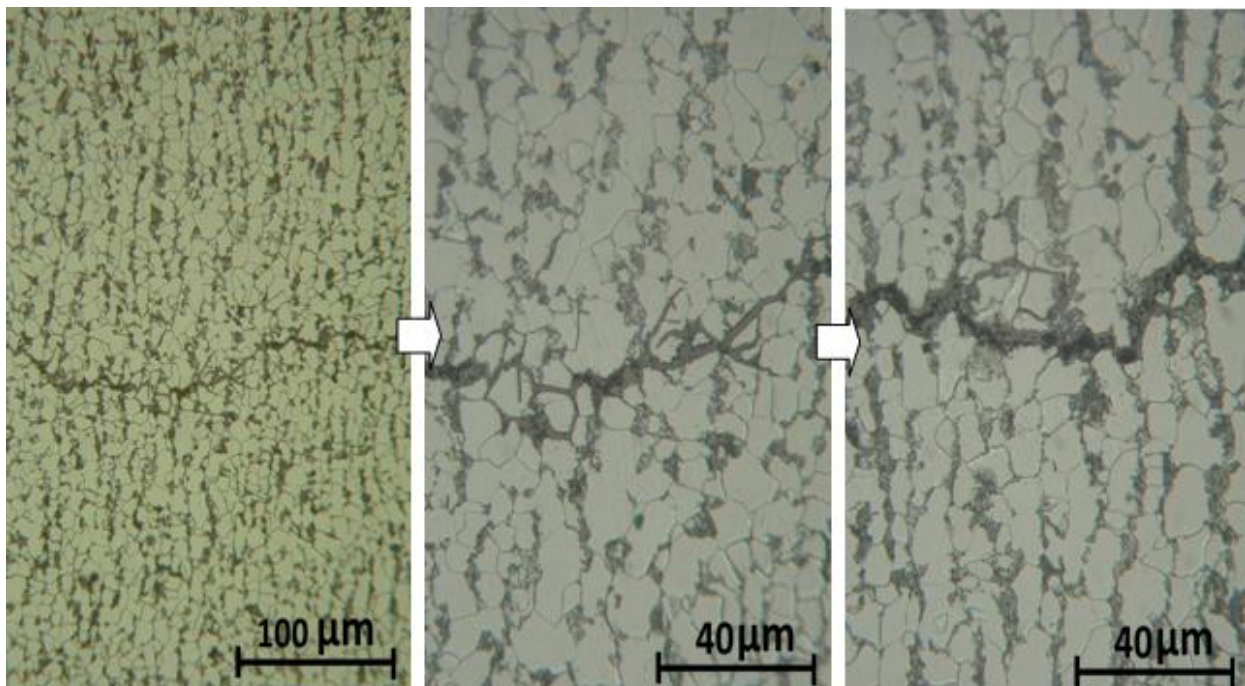
Figure 8(b). Microstructures of sample A shown in Figure 7 obtained from the fire side position of the tube at location around the middle of tube thickness, continued. Etched with 5% Nital solution

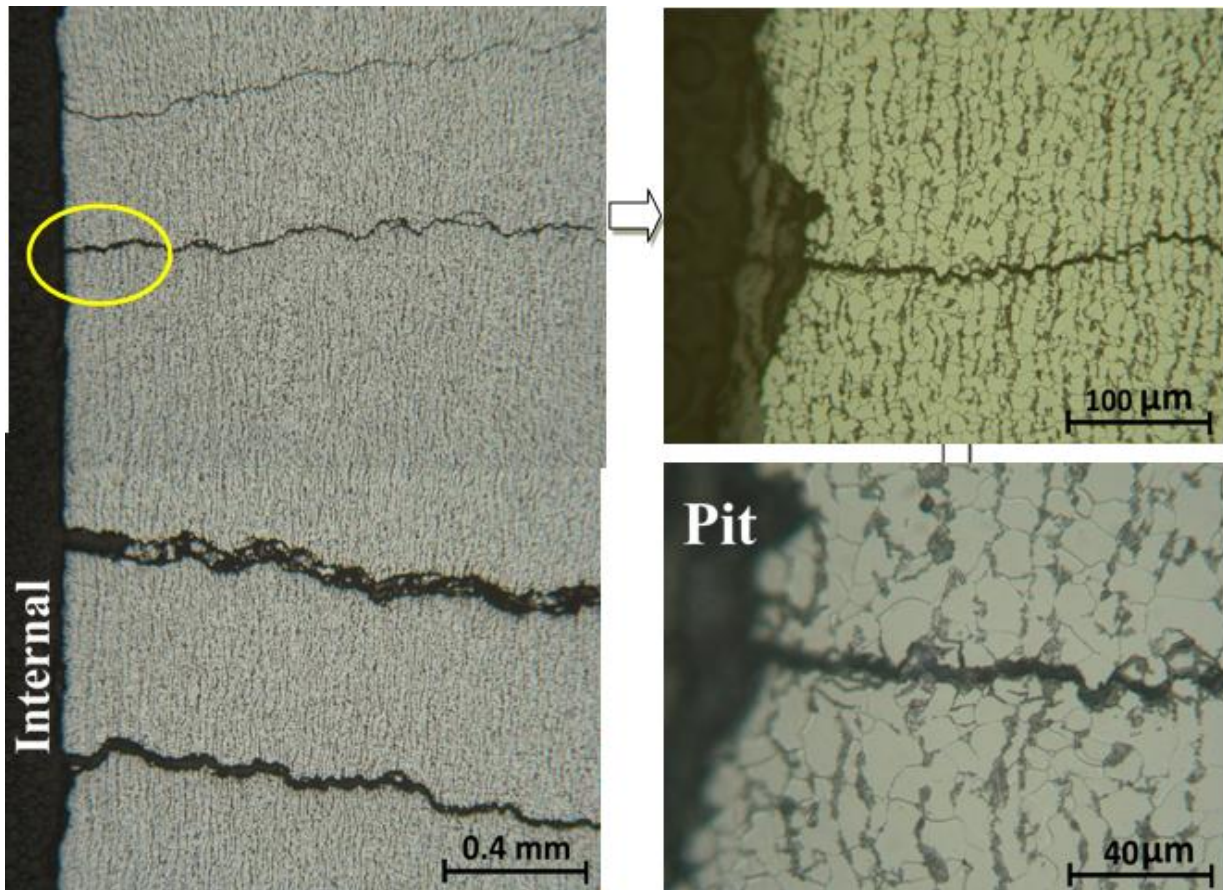
Figure 9. Microstructures of sample B obtained from the fireside position of the tube at location as indicated by the square grit in Figure 7, showing ferrite phase as matrix and pearlite as second phase typical of a low carbon steel tube. All the parallel cracks obviously originated from the internal wall of the tube where the corrosion pits were present. The cracks propagated toward the external surface of the tube through the pearlite phase and/or ferrite grain boundaries, typical of stress-corrosion cracking (SCC). Etched with 5% Nital solution

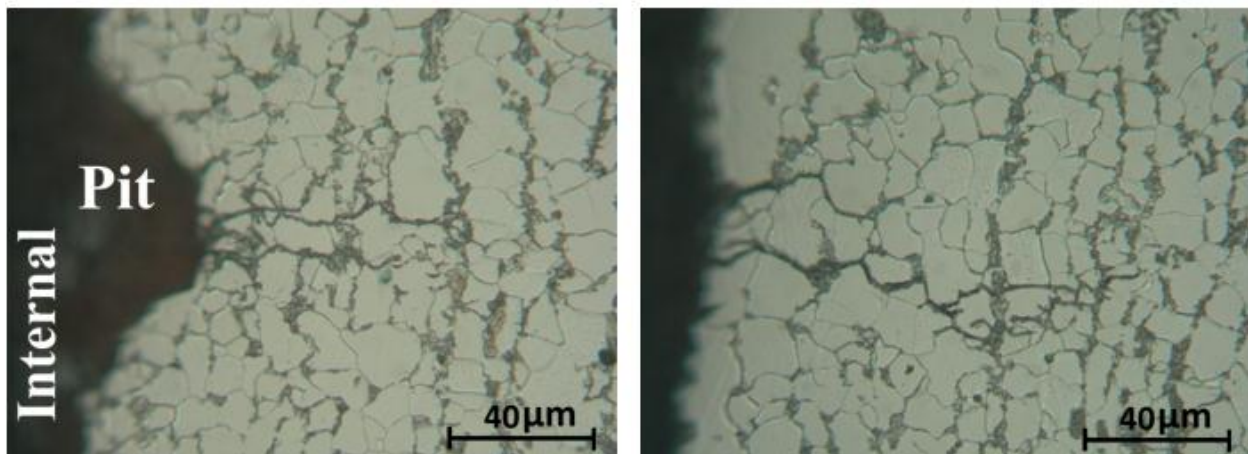
Figure 10. Microstructures of sample C shown in Figure 7 obtained from the fire side position of the tube at location as indicated by the square grit. Etched with 5% Nital solution

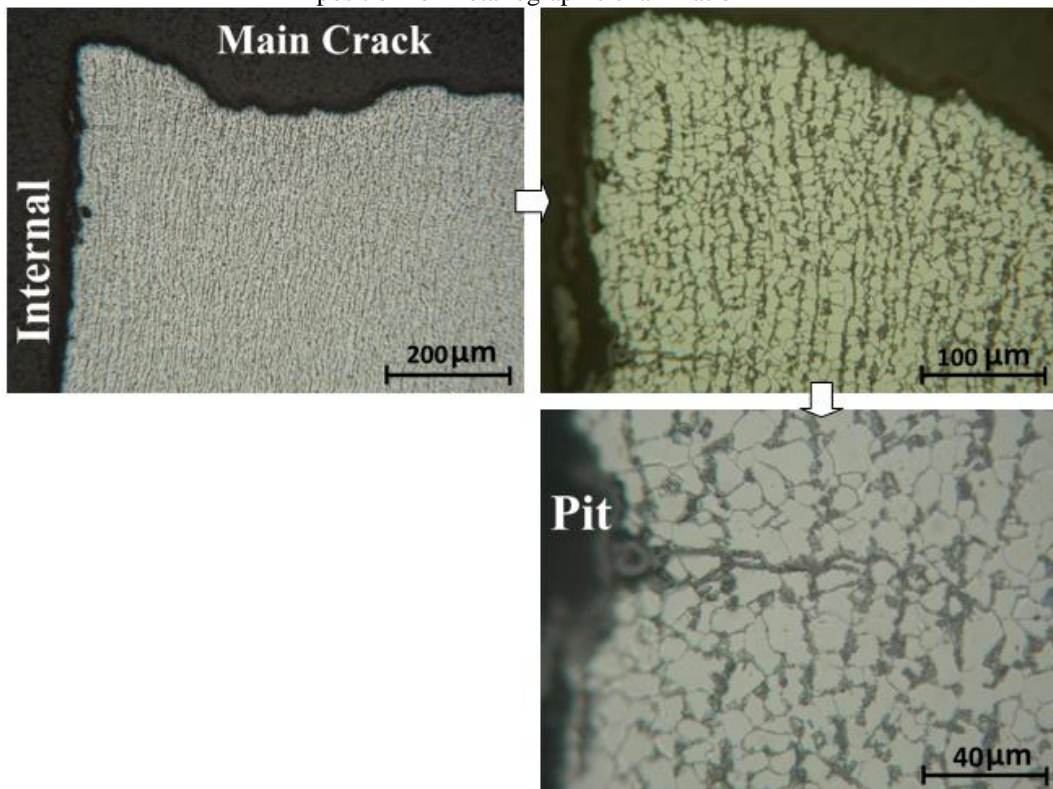
Two other specimens in transverse cross section (D and E) were also cut away from the leaked tube piece at its wall side position (see Figure 11), and the microstructures obtained are presented in Figures 12 and 13. All the microstructures of samples D and E obtained from the wall side position of the leaked tube piece also exhibited similar microstructures as obtained from samples A, B and C at the fireside position of the leaked tube piece. The tube material microstructures consisted of matrix ferrite phase with pearlite second phase. Similarly, all the cracks formed in samples D and E were also typical of stress-corrosion cracking (SCC), originated from the corrosion pits that were present at the tube internal wall and propagated toward the external surface of the tube by cracking through the pearlite phase and/or ferrite grain boundaries.

Figure 12. Microstructures of sample tube D obtained from the wall side position of the tube at location as indicated by the square grit in Figure 11. Etched with 5% Nital solution

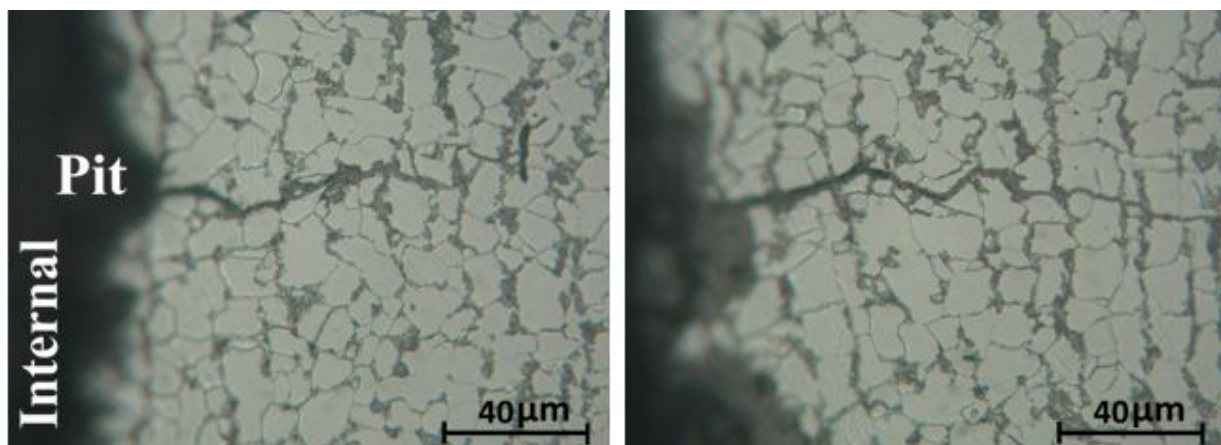
Figure 13. Microstructures of sample tube E obtained from the wall side position of the tube at location as indicated by the square grit in Figure 11. Etched with 5% Nital solution

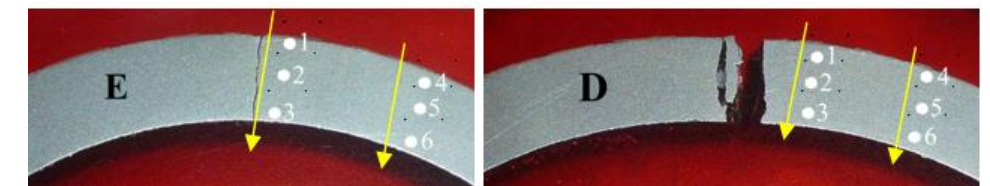
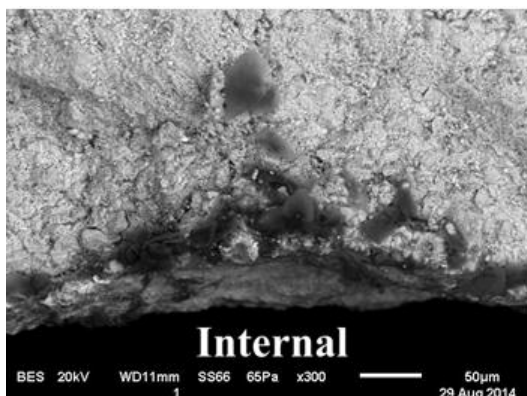
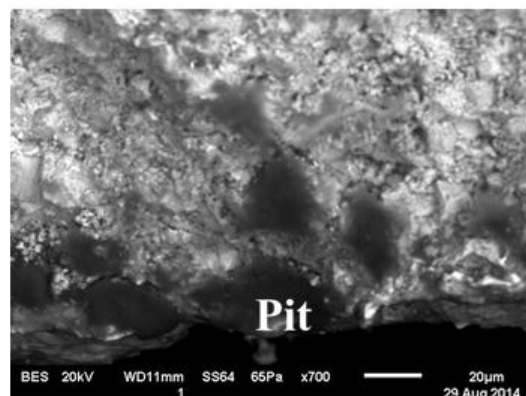
SEM photographs of some fracture surface of sample obtained from the fire side tube portion are presented in Figure 14 and the corresponding EDS spectrum of elements are presented in Figure 15. Most of the SEM photographs obtained obviously exhibited brittle fracture appearance and covered by some deposits. Most of the EDS spectrum of elements obtained from some deposits formed in the corrosion pits around the internal wall of the tube contained trace elements such as: Na, Ca, Cl, S and some P. Furthermore, SEM photographs of some fracture surface of sample obtained from the tube portion located at its wall side presented in Figure 16 and the corresponding EDS spectrum of elements obtained presented in Figure 17. Similarly, most of the SEM photographs shown in Figure 16 obviously exhibited brittle fracture appearance. Also, most of the EDS spectrum of elements obtained in Figure 17 from some deposits in the corrosion pits around the internal wall of the tube contained trace elements such as: Na, Ca, Cl and S [8-10].

Figure 14. SEM photographs of some fracture surface of cage superheater obtained from the fire side tube portion

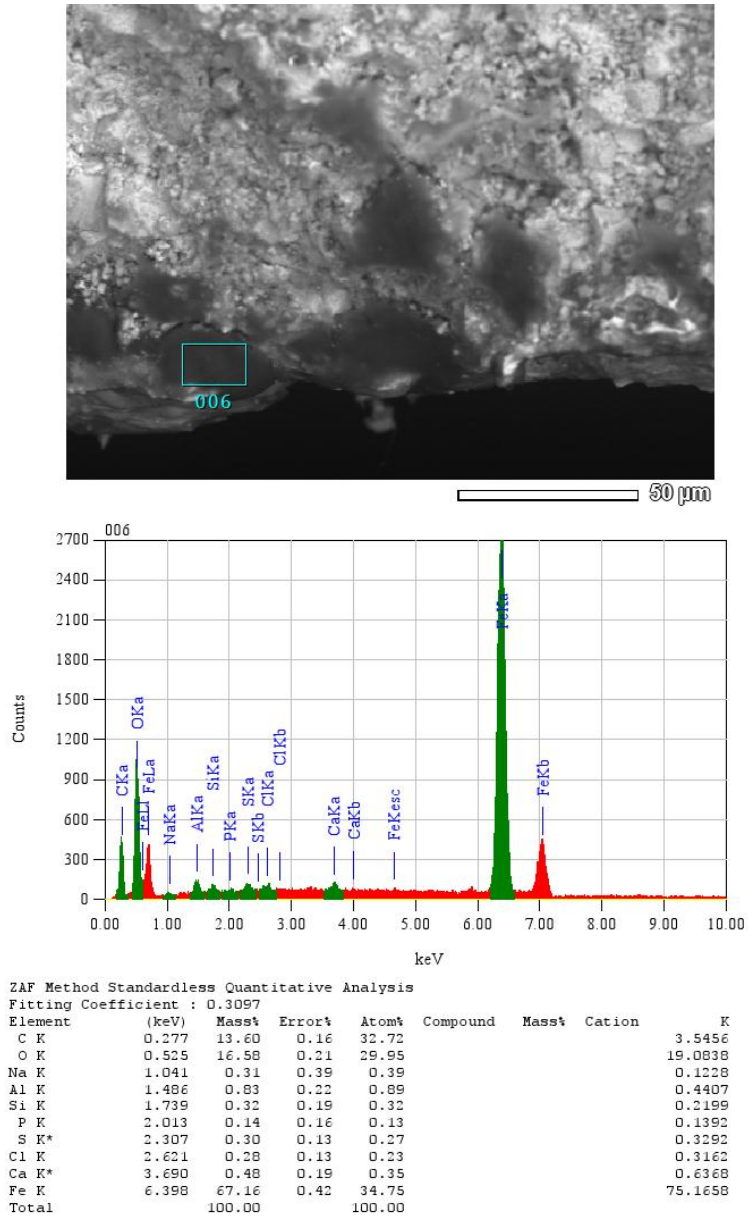
From the results of SEM fractography and EDS analysis obtained it showed that the corrosive agents that may have been responsible to the occurrence of stress-corrosion cracking (SCC) in the tube was mostly due to caustic sodium (Na) and other trace elements in lesser extent such as Ca, Cl, S and P. This condition indicated that the leaked tube(s) were most likely experiencing some caustic related embrittlement which is a form of stress-corrosion cracking characterized by surface initiated cracks that occur in tubing exposed to caustic [8]-[10].

Figure 15. EDS spectrum of elements of some fracture surface of cage superheater obtained from the fire side tube portion

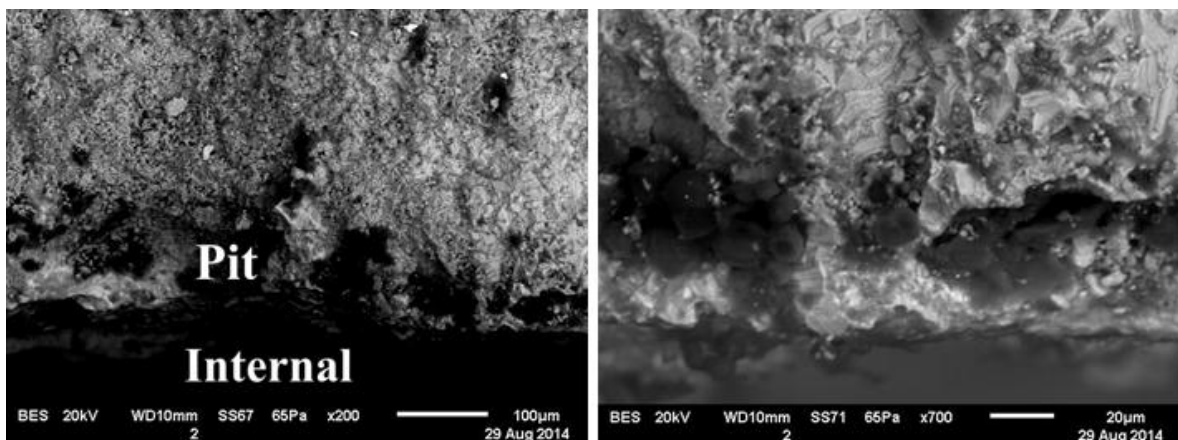
Figure 16. SEM photographs of some fracture surface of cage superheater obtained from the wall side tube portion

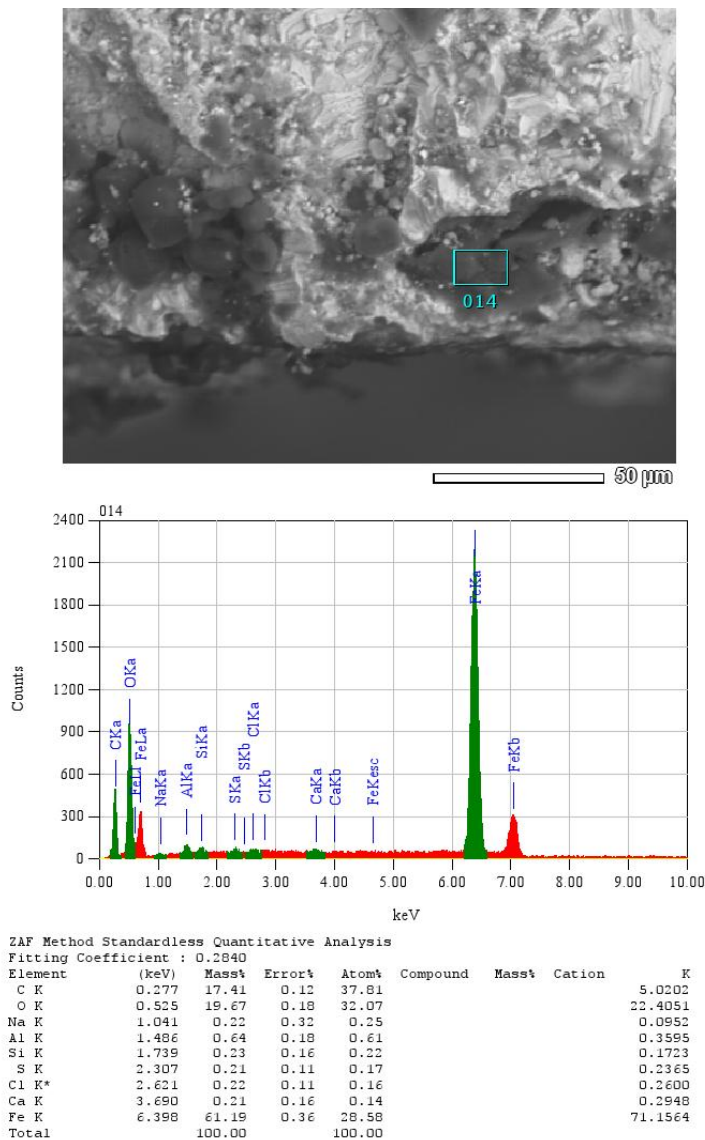
Figure 17. EDS spectrum of elements of some fracture surface of cage superheater obtained from the wall side tube portion
