FAILURE OF A HEAT EXCHANGER RETURN BEND DUE TO LONG-TERM LOCALIZED OVERHEATING

Dewa Nyoman Adnyana

This paper presents a metallurgical assessment performed on a return bend of a heat exchanger that had failed due to bursting after it had been only about 2.5 years in service. The heat exchanger was used to transfer heat from hot combustion gas on the shell side to the feedstock oil on the tube side. The return bend material was made of standard wrought carbon steel of ASTM A-234 Gr.WPB, having a diameter of 2 inches and wall thickness of SCH 80. The metallurgical assessment was conducted by preparing several specimens from the as-received burst and unburst return bends. Various laboratory examinations performed including visual and macroscopic examination, chemical analysis, metallographic examination, hardness testing by Vickers method, and SEM (scanning electron microscopy) equipped with EDS (energy-dispersive spectroscopy) analysis. Results of the metallurgical assessment obtained showed that the burst return bend had been experiencing fracture overload due to a local hot spot or long-term localized overheating occurred on the outer bend external surface. Consequently, the hoop

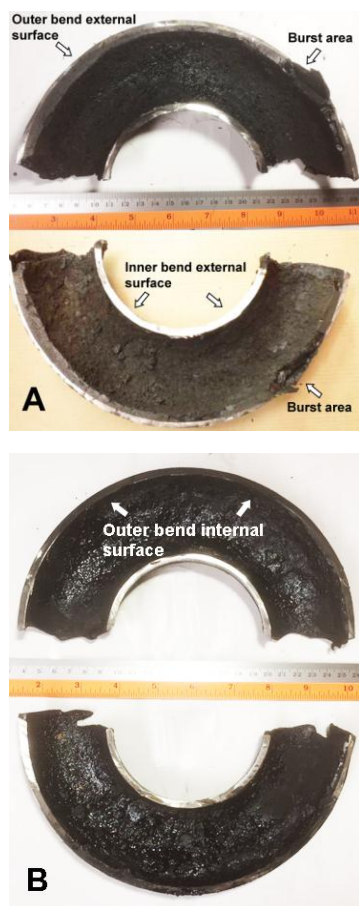
In this failure analysis, two return bends of the damaged heat exchanger were used. One of this return bends had experienced bursting after the heat exchanger had been only about 2.5 years in service. The as-received two returns bends for analysis are seen in Figure 1. Visually, bursting shown in Figure 1 occurred at one of the outer bend external surfaces. The return bends shown in Figure 1 are typical elbow 90° LR, having a diameter of 2 inches and the wall thickness of SCH 80. The return bend material was made of ASTM A-234 Gr. WPB, a standard specification for the piping fitting of wrought carbon steel for moderate and high-temperature service. The heat exchanger was used to transfer heat from hot combustion gas on the shell side to the feedstock oil on the tube side. The tube material of the heat exchanger was made of ASTM A-106 Gr. B, a standard specification for seamless carbon steel pipe for

Figure 1. The as received two return bends A and B for analysis (A: burst return bend, and B: unburst return bend). Both return bends were cut away into two half sections

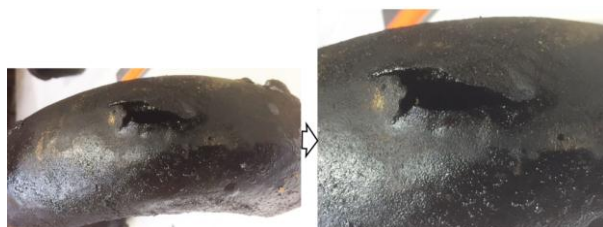
Figure 2. Close up view of the burst return bend, showing some excessive thinning or metal loss occurred around its burst and bulging area on the outer bend external surface

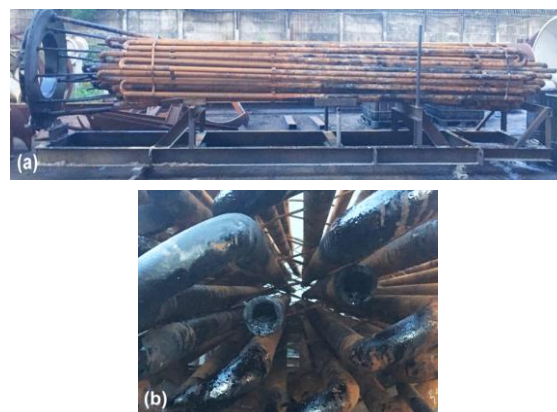
Figure 3. (a) Disassembled tubes bundle from the heat exchanger shell, (b) End section of the tubes bundle showing the location of the burst return bend that was cut away

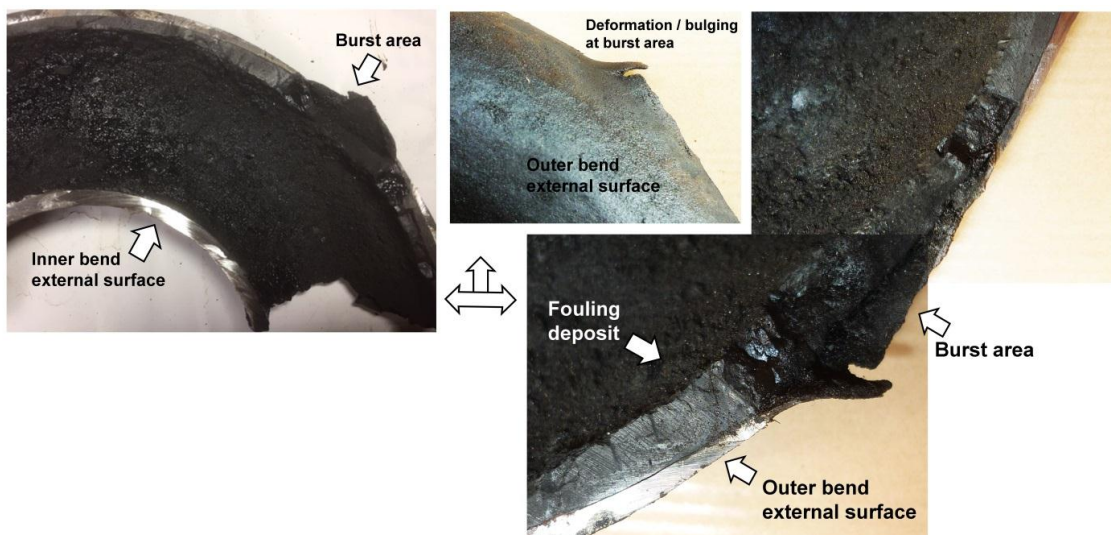
Like those above, the formation of a thick deposit on the outer bend internal wall of the burst return bend caused by laminar flow and abrupt pressure changes that were present on the outer bend internal wall [9]-[10]. This may have caused some inadequate cooling effect of the feedstock oil to the outer bend wall and resulted in local hot spot or long-term localized overheating on the outer bend external surface. Consequently, this local hot spot may have increased the rate of corrosion significantly on the outer bend external surface, and eventually it could also increase the thinning or metal loss thereon.

Figure 4. Close up view of the sectioned burst return bend around its outer bend section where the failure occurred. Note the build-up of massive fouling deposit on the outer bend internal wall where most of the excessive thinning happened on the outer bend external surface

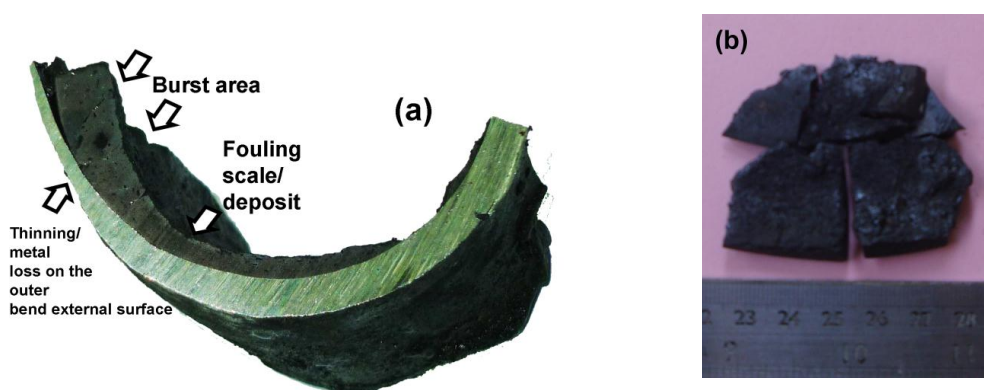
Figure 5. (a) Appearance of some internal deposits that formed on the outer bend inner wall of the burst return bend. (b) Note some collected fouling deposit that obtained from the outer bend internal wall

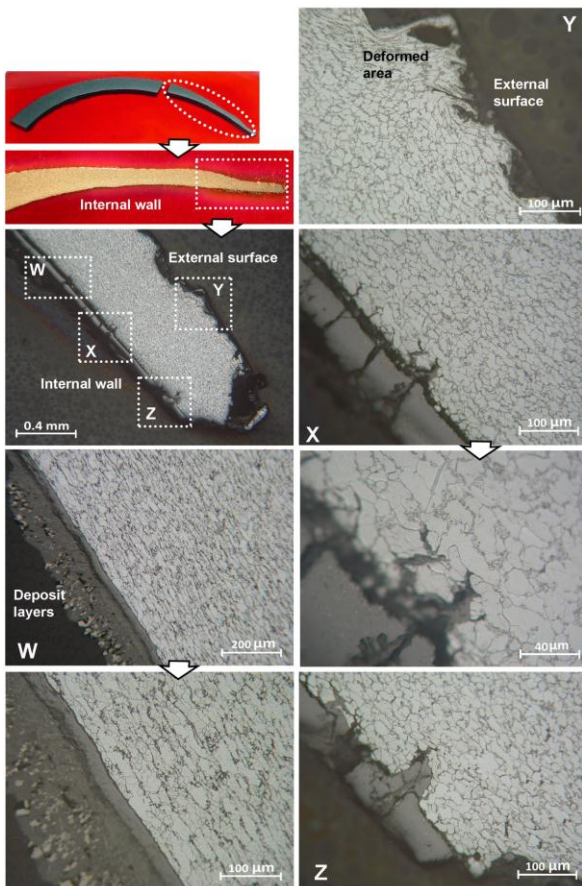
Microstructures obtained from the outer bend transverse section around the burst area presented in Figure 5. The microstructures received show matrix ferrite phase (light color) and a small of second pearlite phase (dark color), typical of low carbon steel. The microstructures obtained also supported to or following the result of chemical analysis shown

in Table 1. In addition, the microstructures obtained also show some possible formation of carbide spheroidization or graphitization, although it may be still in its early stage. Furthermore, it also noticed that from Figure 5 a few number of isolated creep cavities may have formed. Moreover, from Figure 5, it can also be seen that general uniform corrosion along with some localized corrosion such as under-deposit corrosion or stress corrosion may have also formed on some internal wall of the burst return bend.

Figure 6. Microstructures obtained from the outer bend transverse section of the burst return bend (around the burst area) at different locations indicated by the square grids. Etched with 5% Nital solution

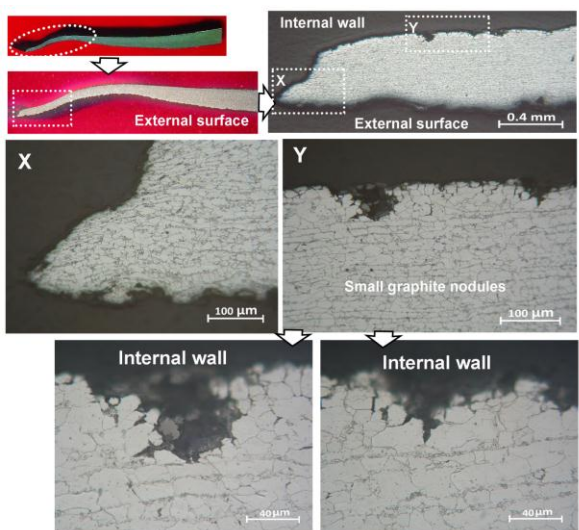
Microstructures obtained from the outer bend longitudinal section of the burst return bend presented in Figure 6. The microstructures obtained are very much similar to those obtained from the outer bend transverse sectional area of the burst return bend in which some carbide spheroidization and isolated creep cavitation may have started to form in the microstructures. Also, there were also likely several small graphite nodules formed. Furthermore, from Figure 6, it can also be seen that both of the outer bend surfaces, either the internal surface or the external surface had damaged by corrosion. The external surface may have been experiencing some pitting and surface corrosion, while the inner surface where some thick deposit formed, it may have been experiencing some localized corrosion such as under-deposit corrosion and/or stress corrosion. It appeared that this localized corrosion might have produced some strong adherent deposit layers on the outer bend internal surface. However, the formation of this localized corrosion may have also contributed to the acceleration of the return bend failure.

Figure 7. Microstructures obtained from the outer bend longitudinal section of the burst return bend (around the burst area) at different locations indicated by the square grids. Etched with 5% Nital solution

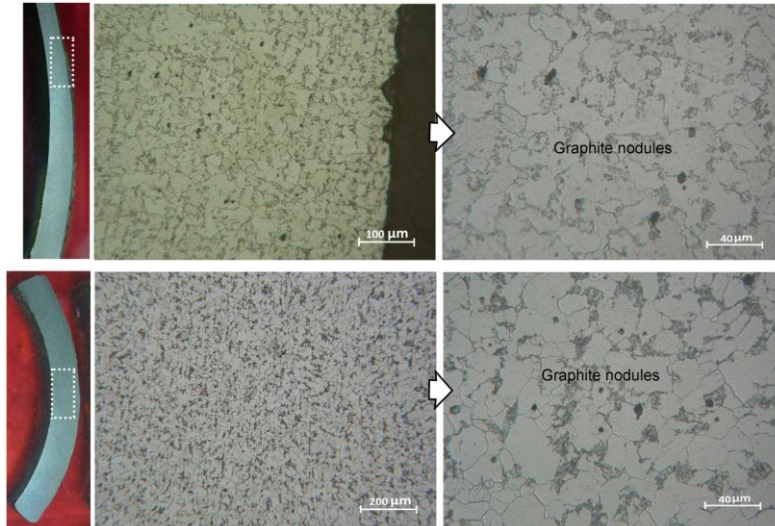
Formations of carbide spheroidization and graphitization observed on the microstructures obtained from the outer bend transverse section of the unburst return bend (see Figure 7). According to Figure 8, this carbide spheroidization is a change in the microstructure of certain carbon steels and low-alloy steels after long-term operation in the 440 °C to 760 °C, and may cause a loss in strength and/or creep resistance [15]. Spheroidization can occur in a few hours at 552 °C, but may take several years at 454 °C [16]. At elevated temperatures, the carbide phases or pearlitic microstructures in these steels are unstable and may agglomerate from their normal plate-like form to a spheroidal form. As seen in Figure 8, in addition to spheroidization, other decomposition mechanisms, which are known as graphitization may also occur [15]-[16]. The temperature has an important effect on the rate of graphitization.

Figure 8. Microstructures obtained from the outer bend transverse section of the unburst return bend at different locations indicated by the square grids. Etched with 5% Nital solution

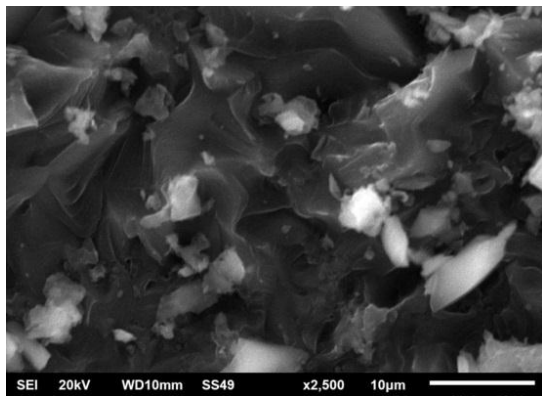
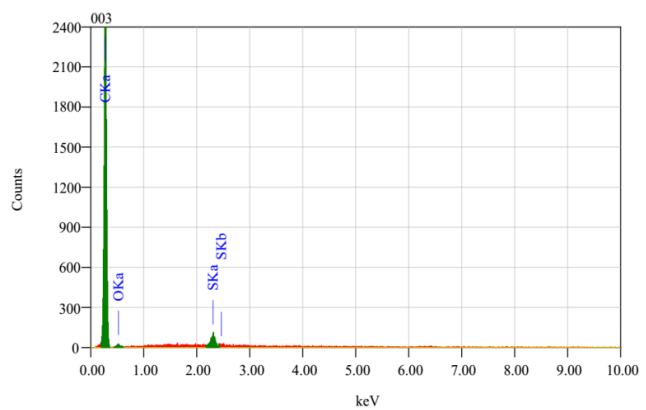
SEM (scanning electron microscopy) micrographs and the corresponding EDS (energy dispersive spectroscopy) spectrum of elements from some external and internal deposits obtained around the burst area presented in Figures 9 and 10. From the results obtained, it indicated that most of the deposit formed on the outer bend internal wall surface of return bend was containing with significant carbon elements from which the coke deposit may have formed. In addition, some other aspects in relatively lower percentage such as O (oxygen), S (sulfur), and probably some Fe (iron) also obtained in the internal fouling deposit. Most of these elements may be coming from the flowing feedstock oil on the tube/return bend side. It considered that iron sulfide (FeS) and coke deposition are likely among the most critical causes of formation of such fouling deposit on the bend internal wall surfaces [9]-[10]. Similarly, the deposit that may have formed on the outer bend external surface also

Element	C	O	S
Mass Percentage %	95.54	3.01	1.44

Figure 10. SEM and EDS analysis obtained from some inner deposit formed around the outer bend internal wall of the burst return bend

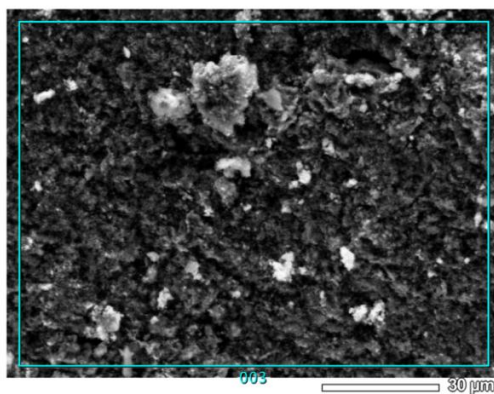
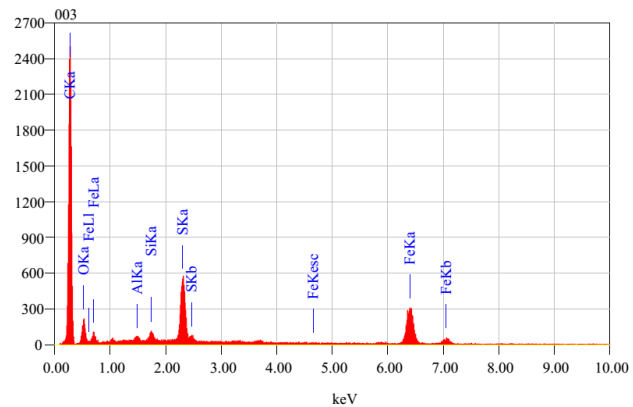
containing with significant carbon (C) elements, oxygen (O), iron (Fe) and sulfur (S), whereas the other features in small percentage may have also formed including aluminum (Al) and silicon (Si). Some of these elements such as O, C and S may have been contributing to the oxidation, pitting or corrosion that could cause thinning or metal loss occurred on some of the return bend external surface. Most of the elements are containing in the external deposit may be coming from the flowing hot combustion gas on the shell side.

Element	C	O	Al	Si	S	Fe
Mass Percentage %	73.0	12.22	0.26	0.49	3.96	10.07

Figure 11. SEM and EDS analysis obtained from some external deposit formed around the outer bend external surface of the burst return bend
