## CARBURIZATION STUDY ON A FIRED HEATER TUBE OF A PETROLEUM PROCESSING REFINERY

**Dewa Nyoman Adnyana**

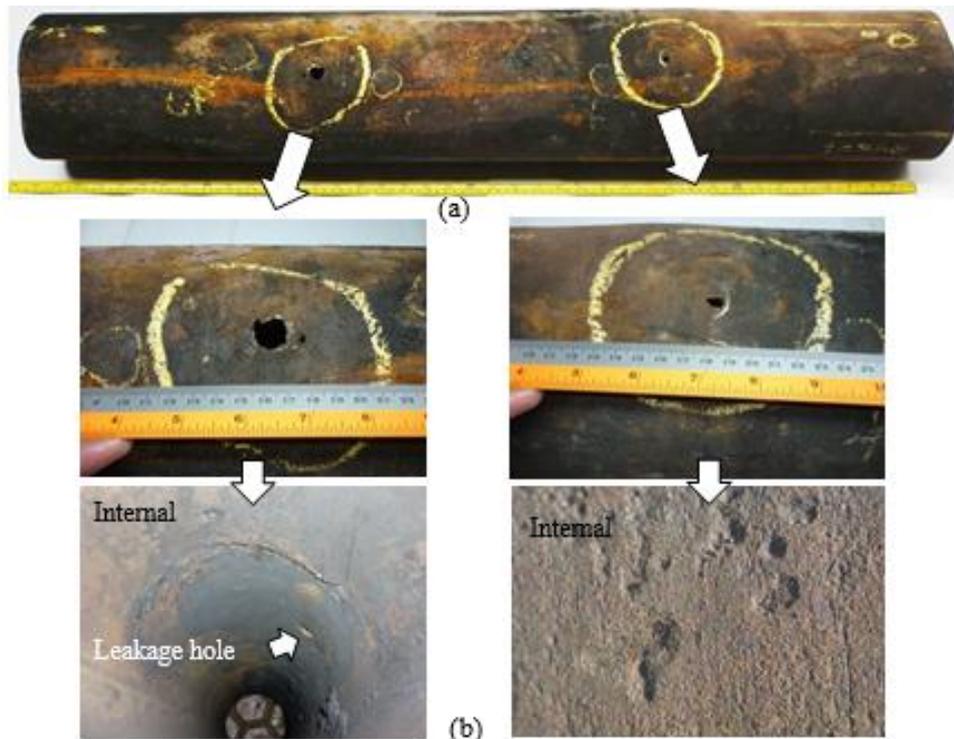
Figure 1. (a) As-received convection tube, showing two leakage holes that formed on the internal tube wall, (b) Close-up view of each of the two leakage holes shown in Fig.1(a), showing the damaged topology that formed around the tube inner surfaces

Close-up view of some damaged area obtained from the as-received convection tube shown in Figs. 1 and 2 showed the leakage hole(s), some remaining deposits, and a number of pits that formed at the internal tube wall. From Fig. 2, it can also be seen that the formation of the leakage hole was due to some local thinning that has occurred at the internal tube wall. In addition to a large hole shown in Fig. 1, a small hole was also observed to have

formed at a location approximately close to the large hole (see also Fig. 2(b)).

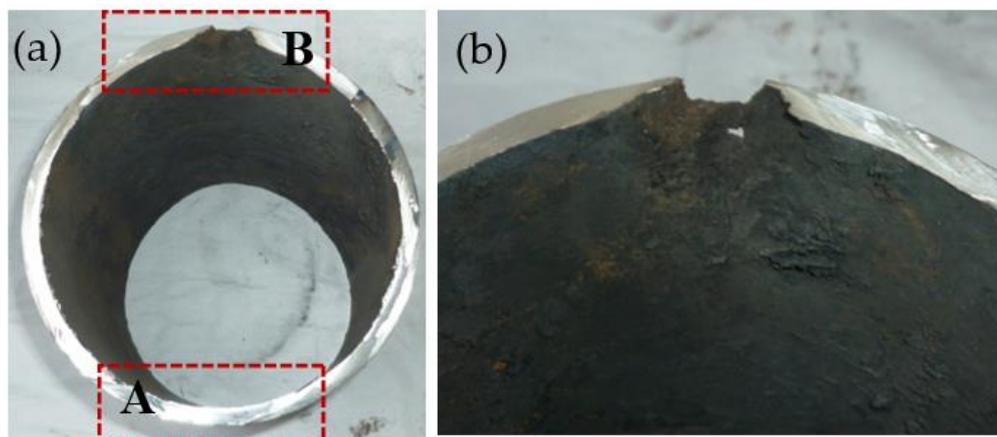
Figure 2. (a) Cross-section of the damaged tube that cutaway through one of the leakage holes, showing two areas A and B for specimen preparation, (b) Close-up view of the damaged tube around the leakage hole at area B shown in Fig. 2(a)

For metallographic examination, two areas A and B on the damaged tube were selected for specimen preparation (see Fig. 2(a)). The specimens were cut and prepared both in transverse and longitudinal sections of the tube. Area A has shown in Fig. 2(a) was located approximately at the opposite side from the leakage hole of area B.

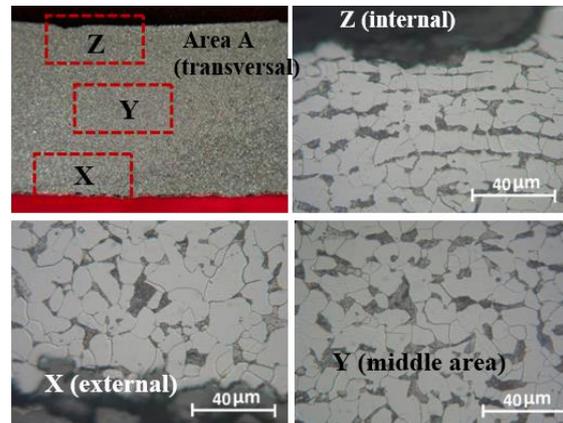
Microstructures obtained from area A, which was located at the opposite side from the leakage hole area B, both in transverse and longitudinal sections are presented in Figs. 3 and 4, showing matrix ferrite phase (light color) with second pearlite phase (dark color), typical of low to medium carbon steels in as annealed condition [1]-[2], [11]. Most of the microstructures obtained are seen nearly equiaxed. This indicated that the tube was manufactured by hot rolling and followed by some annealing or normalizing heat treatment. Pattern and morphology of the microstructures obtained are well clearly defined and homogeneously distributed, no any metallurgical defect such as inclusion or crack observed. This clearly indicated that the tube material in area A which was located at the opposite side from the leakage hole area B was approximately still in normal condition, no any

signification change or degradation in the microstructures observed. The only damage that remained seen at area A was some slight surface damage, either on the tube surface exterior or on the tube surface interior (see Figs. 3 and 4). These surface damages may have been caused by the effect of surface corrosion and or oxidation that occurred on the tube during elevated temperature service.

Figure 3. Microstructures at area A located approximately 180° from the leakage hole of area B (as shown in Fig. 2(a)) obtained at areas indicated by X, and Z shows all a mixture of ferrite matrix phase (light color) and second pearlite phase (dark color). Etched with 5% Nital solution

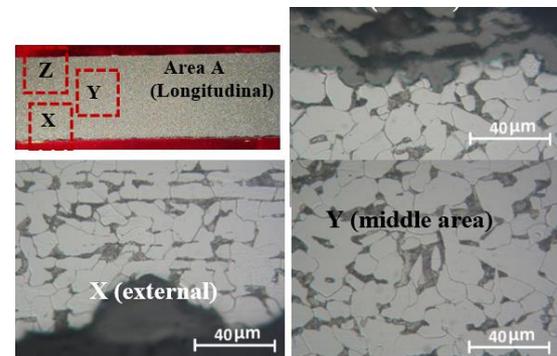
Figure 4. Macrostructure of specimen obtained from the longitudinal section at area A located approximately 180° (or at the opposite side) from the leakage hole of area B shown in Fig. 2(a). The corresponding microstructures obtained at areas indicated by X, Y and Z show all a mixture of ferrite matrix phase (light color) and second pearlite phase (dark color). Etched with 5% Nital solution

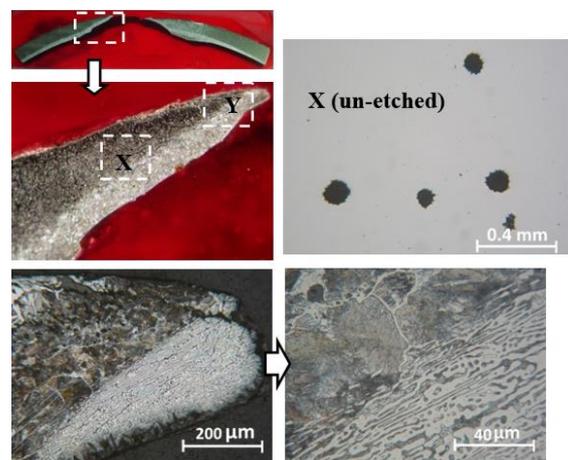
pearlite as in its normal condition. Still, instead most of the microstructures obtained consisted of a mix of several transformed phases such as pearlite, cementite or iron carbide and/or ledeburite together with a number of graphite nodules or graphite flakes, see Figs. 5 to 9. The formation of these microstructures was most likely caused by some carburization in which carbon was absorbed into the internal wall of the tube at an elevated temperature while in contact with a carbonaceous material or carburizing environment. The temperature that allowed diffusion of carbon into the metal was probably high enough, typically above 593 °C [5]. In carbon steels and low-alloy steels, carbon reacts to form a hard, brittle structure at the internal surface of the tube that may crack or spall upon cooling. Carburization can result in the loss of high temperature creep ductility, loss of ambient temperature mechanical properties (especially toughness/ductility), loss of weld-ability, and corrosion resistance [13].

As the microstructures change occurred only around the leakage hole area shown in Figs. 5 to 9, this indicated that the damaged convection tube had been experiencing some localized overheating or local hot spot [14]. This local hot spot may have resulted from the internal deposit build-up, causing an inadequate cooling effect of the flowing process stream. It is likely, the type of fouling deposit that built upon the internal tube wall was some carbonaceous material that promoted some carburization.

Furthermore, the formation of a number of graphite in the microstructures shown in Figs. 5 to 9 indicated that the damaged tube, particularly in the leakage area, had been experiencing some severe carburization as the level of carbon that may have been absorbed by the metal surface of the tube was quite high. This severe carburization was characterized by rapid metal wastage as a number of pits were found in most of the leakage hole area. Several pits that formed on the internal tube surface may have been containing soot or graphite dust. This phenomenon is known as metal dusting, which usually occurs in the operating temperature range of 482 °C to 816 °C [10].

Figure 5. Microstructures obtained at the area indicated by X of un-etched specimen (as shown in Fig. 2(a)), show some formation of graphite nodules, whereas at the area indicated by Y of etched specimen shows a mixture of several transformed phases of ledeburite, iron carbide (cementite), pearlite, and some remaining ferrite and pearlite. Etched with 5% Nital solution

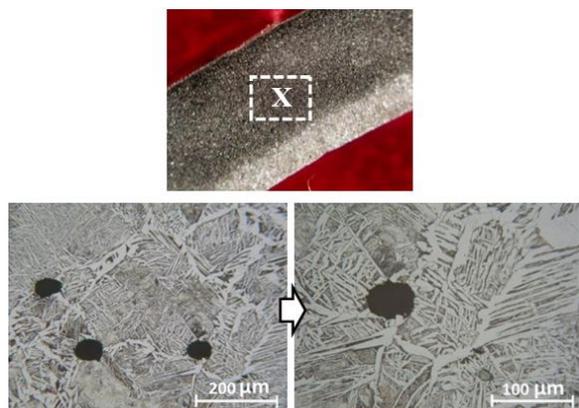
From Figs. 5 to 9, it can also be seen that the graphite formation in the microstructures had two types of morphology. First is a graphite nodule, which was observed in some middle area of the tube, and secondly is a graphite flake that was observed in some internal surface of the tube. The difference in this graphite morphology may have been influenced by the difference in sulfur content. Due to carburization, the material of steel tube which containing low sulfur content ( $< 0.05\%$ ) may have transformed the steel structure (iron carbide) into nodular graphite (or graphite nodules), while on the tube wall surface where sulfur content was probably high, the iron carbide was transformed into flake graphite [1]. This high sulfur content that presents in the leakage hole area of the damaged tube may have been associated with some form of scale or deposit containing higher sulfur content. The presence of this high sulfur content will be later confirmed by the results of EDS analysis obtained from the surface deposit that formed around the leakage hole area.

Figure 6. Microstructures of the cross-section area B (shown in Fig. 2(a)) of the leakage hole at the area indicated by X (middle area of a tube), showing a Widmanstatten structure containing several graphite nodules. Etched with 5% Nital solution

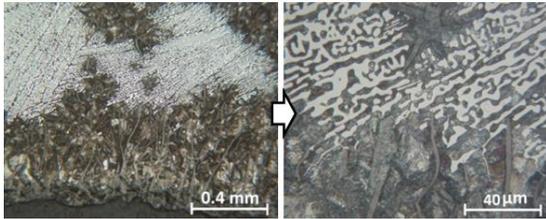
Figure 7. Microstructures of the cross-section area B (shown in Fig. 2(a)) of the leakage hole at the area indicated by Y (internal tube), showing several transformed phases of ledeburite, pearlite, iron carbide (cementite), and graphite flakes. Etched with 5% Nital solution

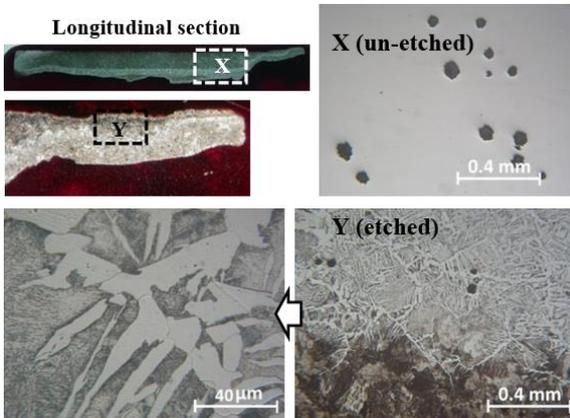
Figure 8. Macrostructure of specimen obtained from the longitudinal section of area B around the leakage hole shown in Fig. 2(a). The corresponding microstructures obtained at area indicated by X of un-etched specimen show formation of several graphite nodules (see Fig. 8(a)), whereas at area indicated by Y of etched specimen (see Fig. 8(b)) show a mixture of several transformed phases of iron carbide (cementite), pearlite, Widmanstatten structure and some graphite nodules. Etched with 5% Nital solution

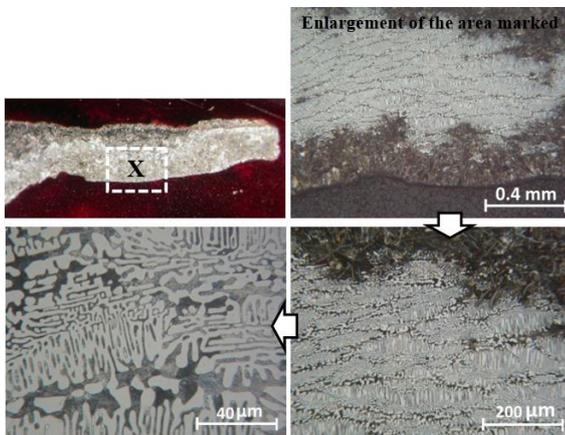
Figure 9. Microstructures obtained from the longitudinal section of specimen at area B of the leakage hole at area indicated by X, showing a mixture of several transformed phases of ledeburite, pearlite, iron carbide (cementite), and several graphite flakes at around the internal tube wall. Etched with 5% Nital solution

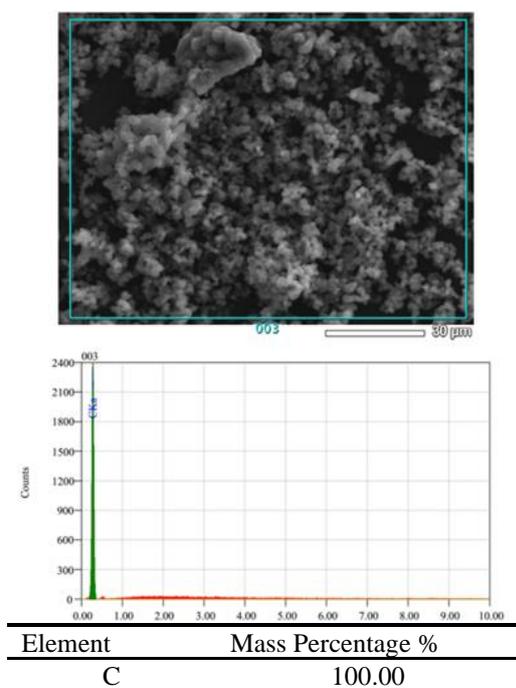
Figure 10. SEM and EDS analysis obtained from some deposits that formed on the damaged internal tube surface around the leakage hole area

SEM micrographs and the corresponding EDS spectrum of elements from some internal and external deposits obtained around the leakage hole area are presented in Figs. 10 and 11. From the results obtained, it is indicated that most of the deposits formed on the internal tube surface were containing major elements of carbon (C) from which the coke deposit may have formed (see Fig. 10). Coke deposits are a source of carbon that may promote carburization, particularly during decoke cycles where temperatures exceed the normal operating temperatures, accelerating the carburization [15]-[16]. On the other hand, the deposits that may have formed on the external tube surface, as seen in Fig. 11 containing with major elements of Fe, C, and O, where the other elements in small percentage may have also formed including Si, S, Ca, Al and K. Some of the elements such as S and Ca or Si may have been contributing to the oxidation,

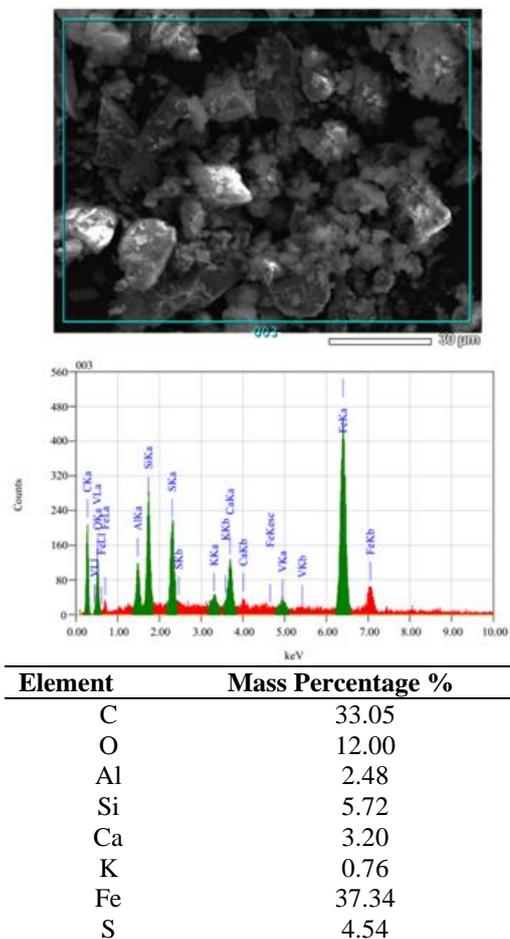
pitting and/or corrosion occurred on some external tube surface. Most of the elements containing in the external deposit may be coming from the flue gas in the heater.

Figure 11. SEM and EDS analysis obtained from some deposits that formed on the damaged tube external surface around the leakage hole area
