## CAVITATION-EROSION STUDY IN ELBOW TUBES OF A LOW-PRESSURE EVAPORATOR OUTLET HEADER

**Dewa Nyoman Adnyana**

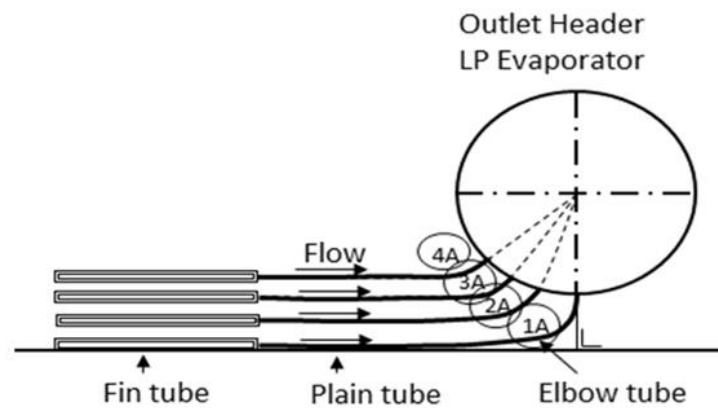
This study aims to research elbow tubes that often experience leaks, where the elbow tubes are connected to the low pressure evaporator outlet header on an HRSG plant. Figure 1 shows the sketch of the arrangement and construction of 4 (four) elbow tubes connected to the low pressure evaporator outlet header. From the operating manual, it is known that the four elbow tubes in the low pressure evaporator outlet header are connected to the low pressure evaporator inlet header located on the other side of the HRSG through 4 (four) panel tube lines as a heat exchanger system which is heated using flue gas from a gas turbine power plant. Each line of the heat exchanger panel uses finned tubes, while the elbow section uses plain tubes. Material tubes and elbow tubes, as well as the two headers, use low carbon steel, and the working fluid flowing therein is hot water with a maximum pressure of 10 bar(g) and a maximum temperature of 160 °C. Both panel tubes and elbow tubes have an outer diameter of 31.8 mm and a wall thickness of 2.6 mm. From Figure 1, it can be seen that the elbow tube 1A at the lowest position forms an angle of 90° with the low pressure evaporator outlet header. In contrast, in the above position, other elbow tubes are connected at an angle of 75° (elbow tube 2A), 60° (elbow tube 3A), and 45° (elbow tube 4A). From Figure 1, it can also be seen that the higher the angle of the elbow tube connected to the header, the smaller the elbow or bend radius that is formed, and this can affect the level of wall thinning occurred in the elbow tube.

Figure 1. The elbow tube's connection angle with the low pressure evaporator evaporator outlet header, i.e 90° (elbow tube 1A), 75°(elbow tube 2A), 60° (elbow tube 3A), and 45° (elbow tube 4A)

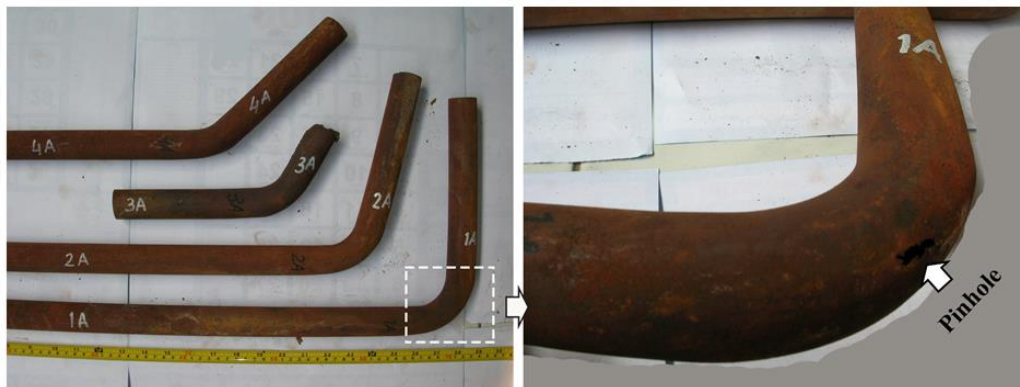
In this research work, four damaged elbow tubes shown in Figure 2 were cut away from the low pressure evaporator outlet header in which one of the elbow tubes that connected at 90° to the outlet header showed a leaking hole (pinhole) on its outside curvature. Each elbow

Figure 2. Four elbow tubes (1A to 4A) cut away from the low pressure evaporator evaporator outlet header, where one of the elbow tubes (1A) shows a pinhole on the outer side of the elbow curvature

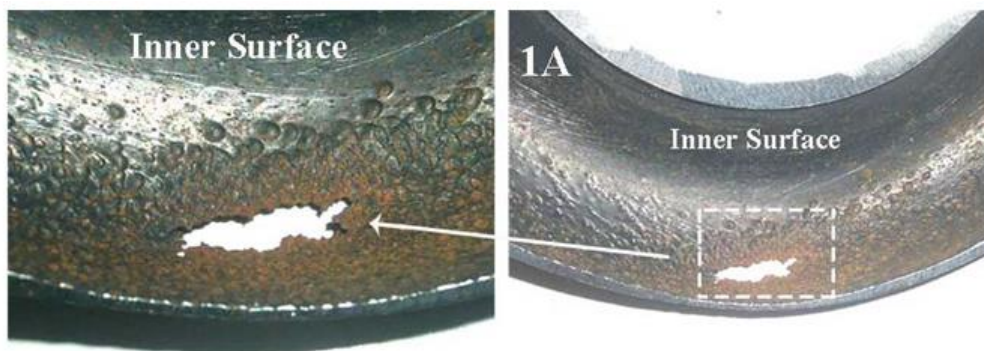
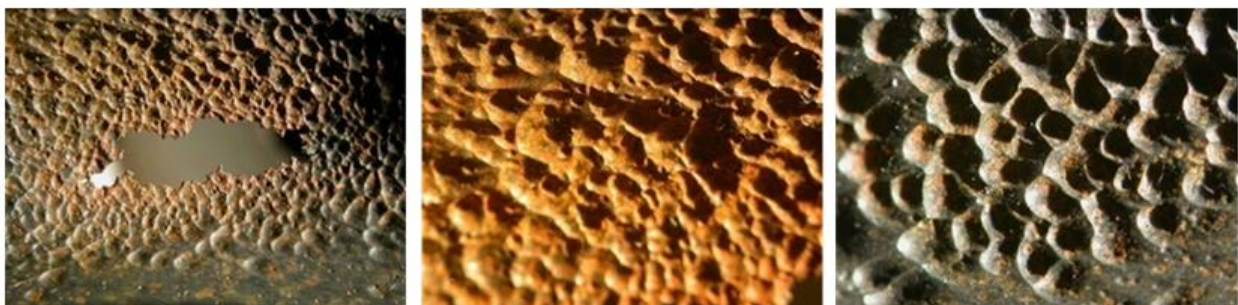
The macroscopic observation results on the inner walls of the four halves of the elbow tubes 1A, 2A, 3A, and 4A are shown in Figures 4-7. It is clearly seen that most of the inner walls of the four elbow tubes exhibit a rough and jagged appearance. This indicates that all of the elbow tubes had experienced cavitation-erosion [9]-[10],[12]. Figures 4-7 show that most of the wall thinning on the elbow tube due to cavitation-erosion only occurs on the inner wall around the elbow's outer curvature. While on the inner wall at the elbow's internal shape, there is no wall thinning occurred. The thinning that occurs on

the outer surface of the elbow tube looks insignificant. The thinning is probably caused by corrosion and or oxidation due to flue gas flow through the HRSG unit. Moreover, in Figures 4-7, it can be seen that the higher the connecting angle or, the smaller the radius of the elbow tube, the higher the level of cavitation-erosion that occurs. The high rate of cavitation-erosion experienced by the four elbow tubes is also related to the level of turbulence of the working fluid flow [4]-[5], [8]-[9], [12], i.e., the elbow tube with an angle of  $90^\circ$  (1A) experiences more considerable turbulence when compared to the elbow tube with an angle of  $75^\circ$  (2A),  $60^\circ$  (3A) and  $45^\circ$  (4A).

Figure 4. The inner wall of the elbow tube 1A showing a pinhole and a rough and jagged appearance in the cavitation-erosion area

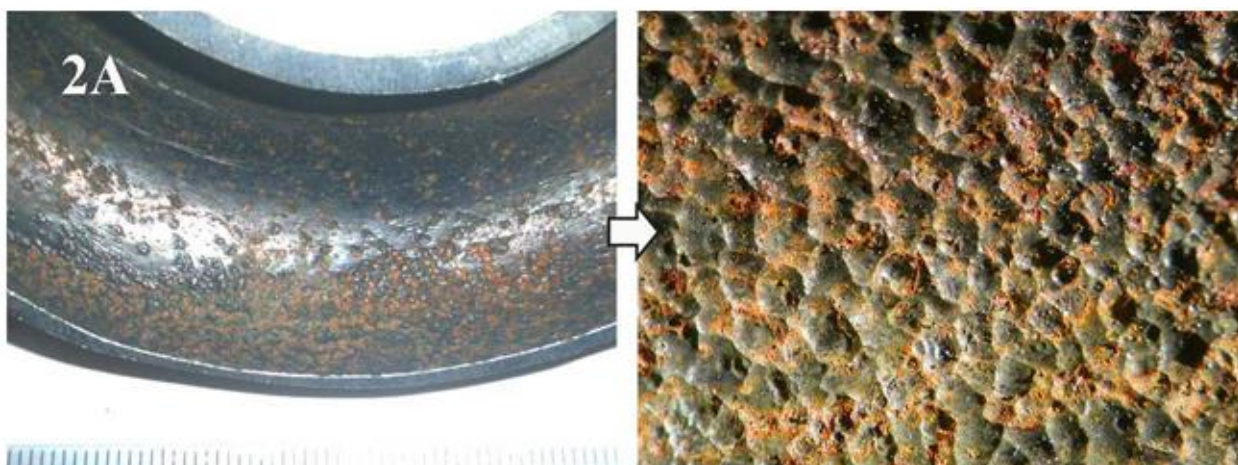
Figure 5. The damaged area due to cavitation-erosion in the elbow tube 2A showing similar rough and jagged appearance as shown in Figure 4, but at a lesser degree and no formation of any pinhole observed

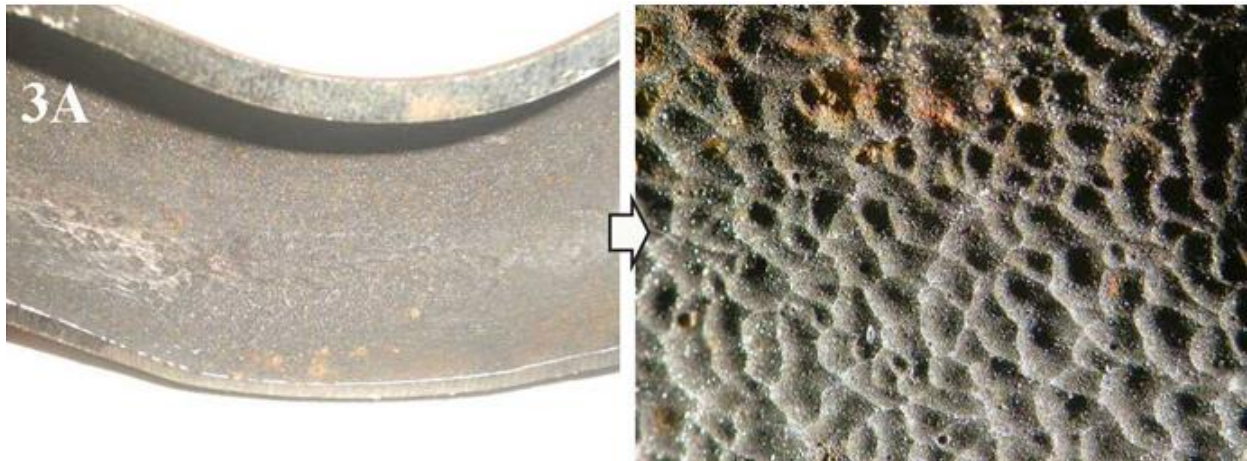
Figure 6. The damaged area due to cavitation-erosion in the elbow tube 3A showing similar rough and jagged appearance as shown in Figures 4 and 5, but at a lesser degree and no formation of any pinhole observed

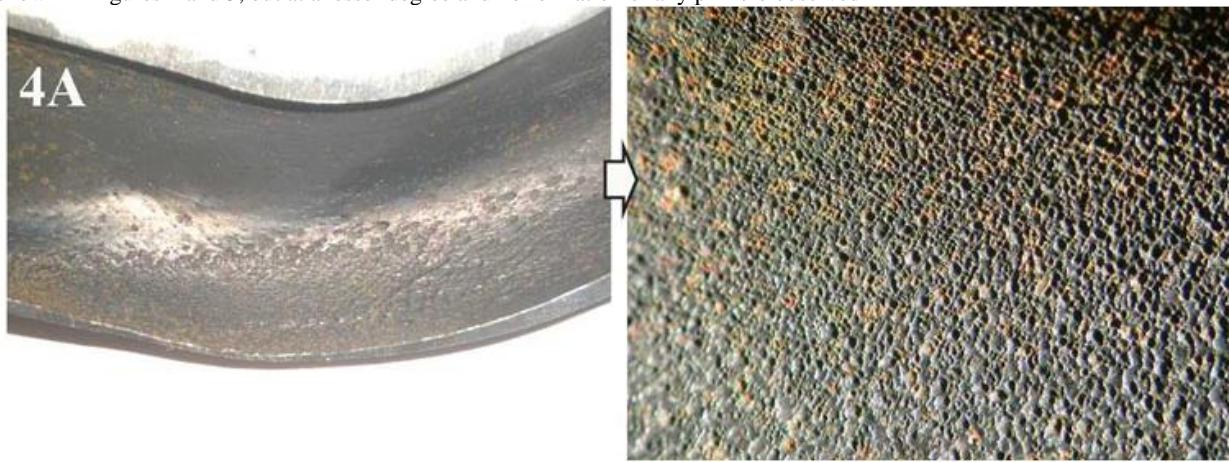
Figure 7. The elbow tube 4A showing the lowest degree of cavitation-erosion damage due to the largest its bend radius

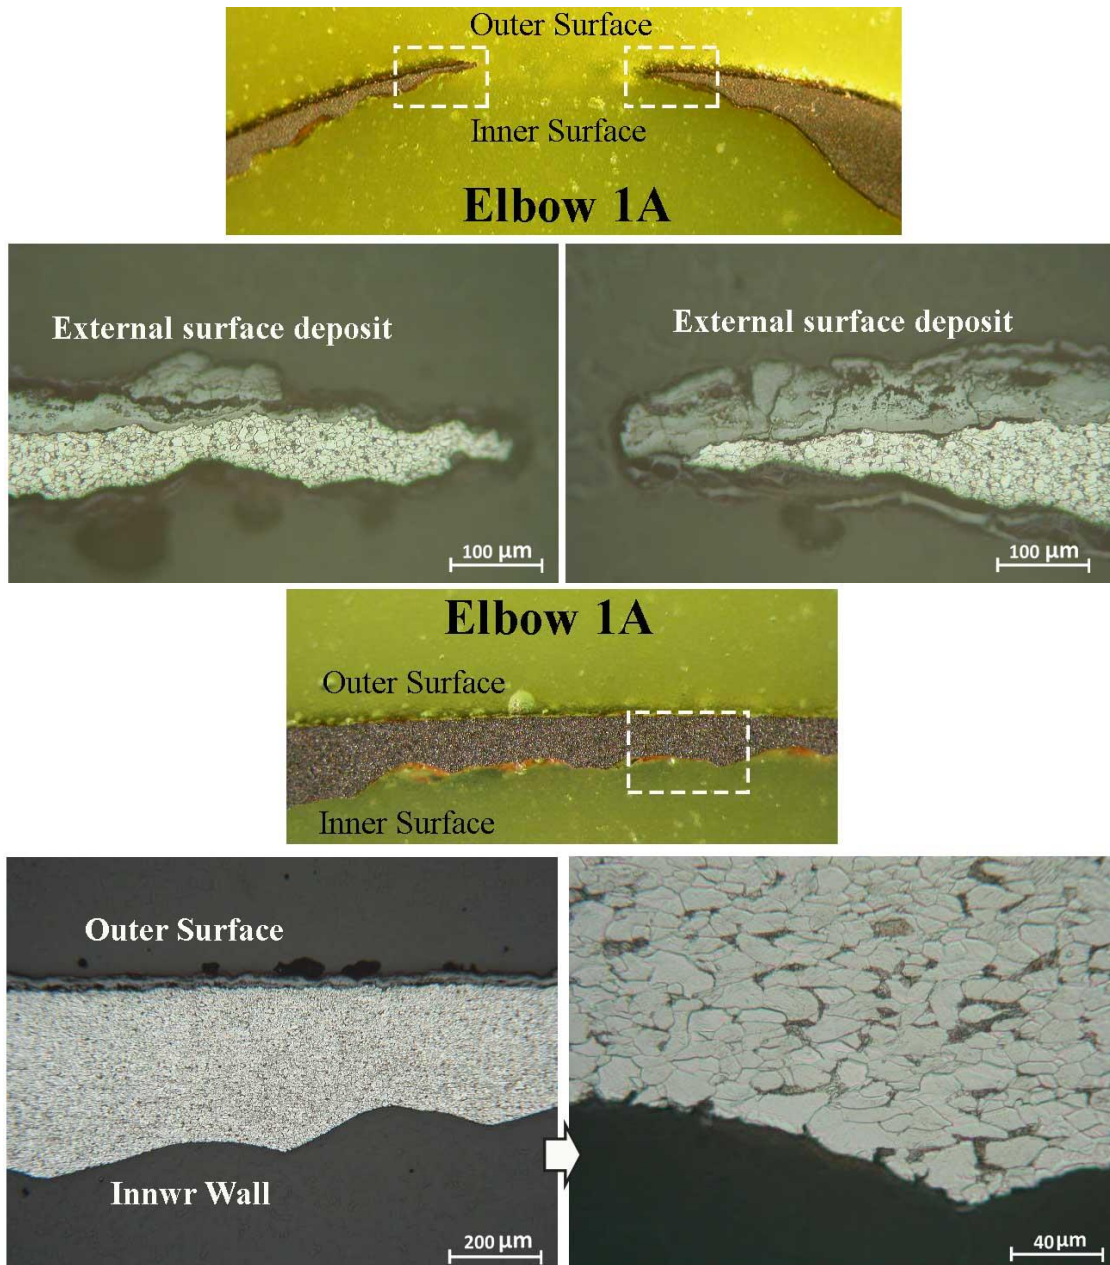
The microstructure conditions in the four elbow tube materials are still in good condition

where the ferrite and pearlite structure patterns are always clear; no significant change or degradation formed. This may be caused by the fact that the elbow tube is operated at a relatively low temperature (below 200° C). Figures 8-11 also shows that scales or deposits in relatively low amounts generally only form on the outer surface of the elbow tube, while on the elbow tube inner walls whose experiencing moderate to severe cavitation-erosion, there is almost no significant scales or deposits formed. This indicates that the inner wall of the elbow tube

does not undergo substantial corrosion. Corrosion seems to occur only on the outer surface of the elbow tube. However, its level is thought to be still at an early stage and is insignificant compared to the level of damage that occurs in the inner walls of the elbow tube due to cavitation-erosion. Besides that, in Figures 8-11, it can also be seen that almost all of the elbow tube inner walls that are experiencing cavitation-erosion show a surface with a fluctuating or wavy pattern.

Figure 8. Microstructures obtained from the elbow tube material 1A at different locations (etched with 5% Nital solution)

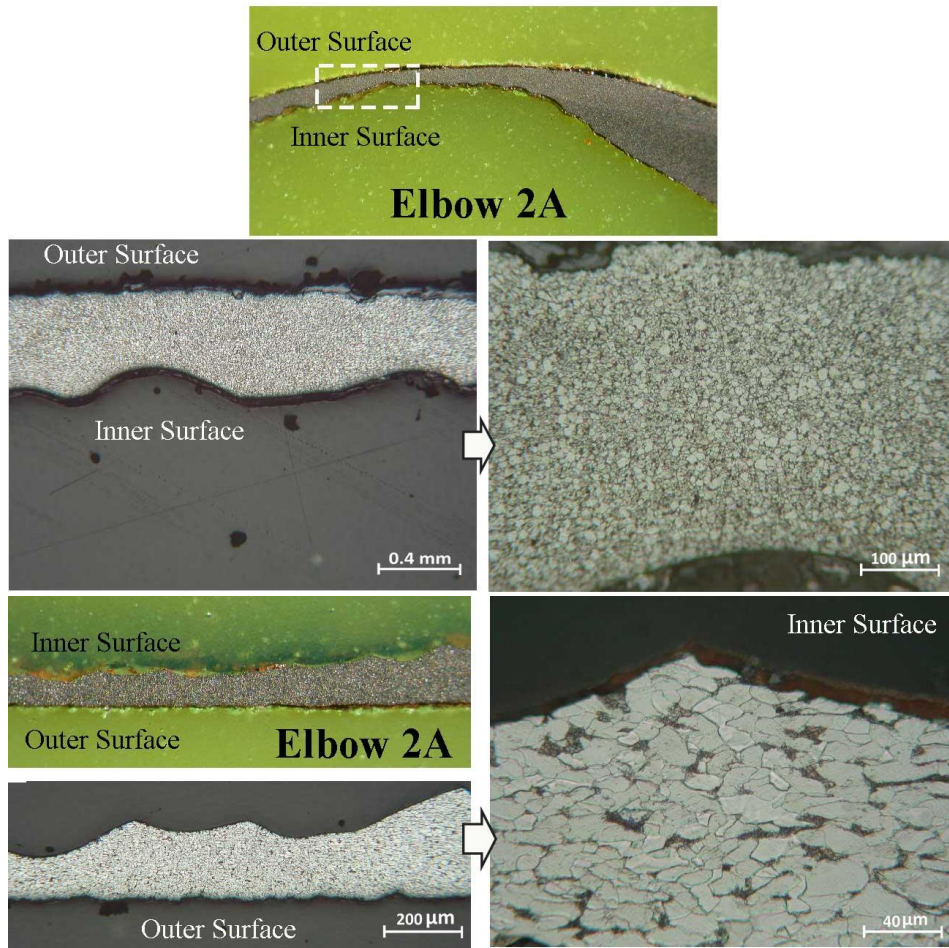
Figure 9. Microstructures obtained from the elbow tube material 2A at different locations (etched with 5% Nital solution)

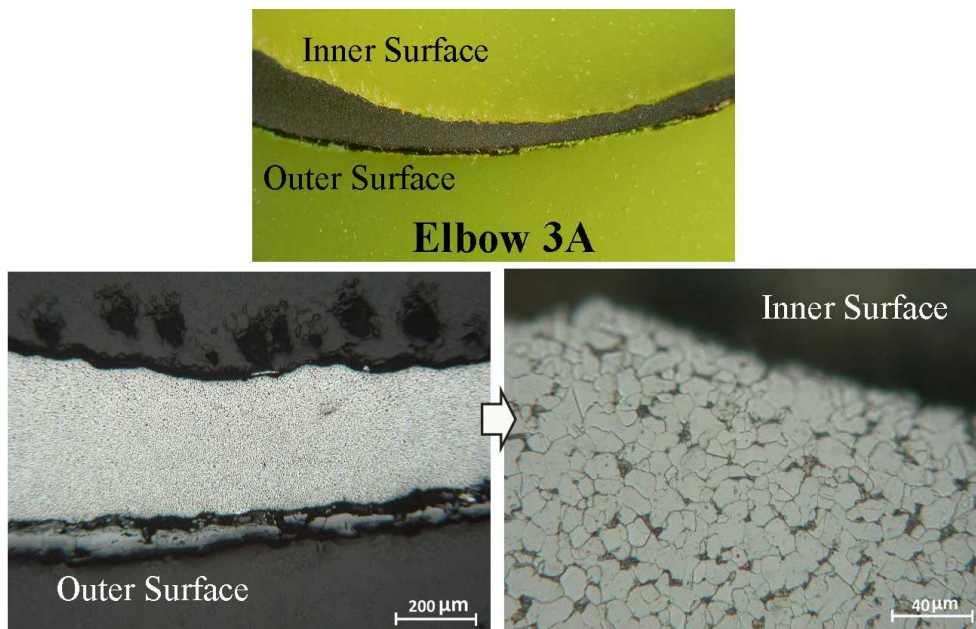
Figure 10. Microstructures obtained from the elbow tube material 3A at different locations (etched with 5% Nital solution)

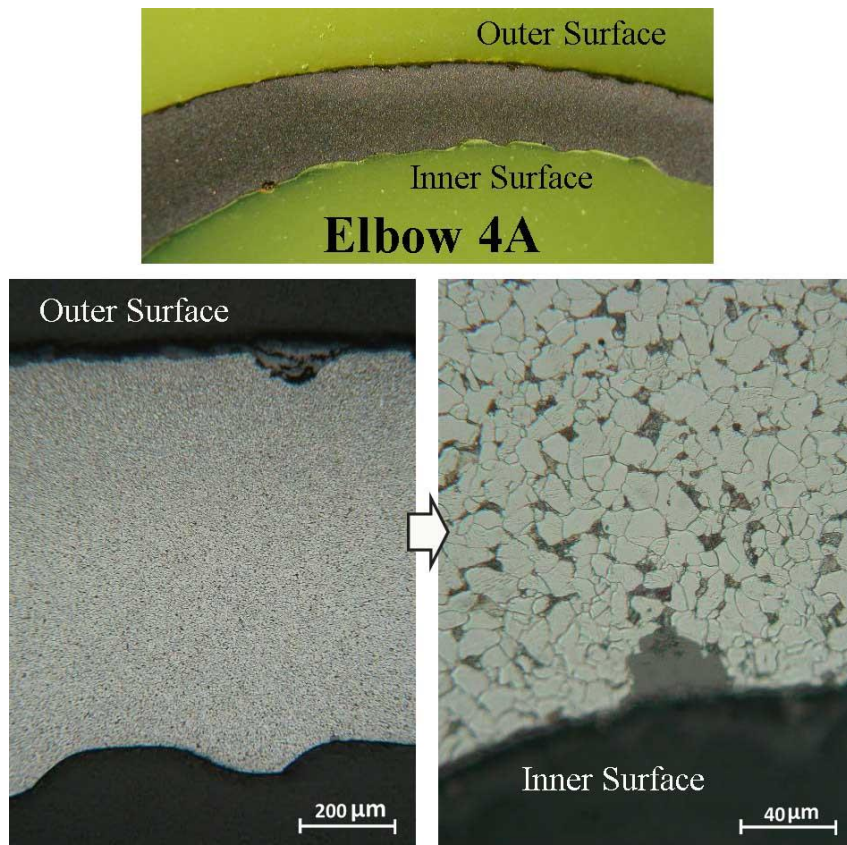
Figure 11. Microstructures obtained from the elbow tube material 4A at different locations (etched with 5% Nital solution)

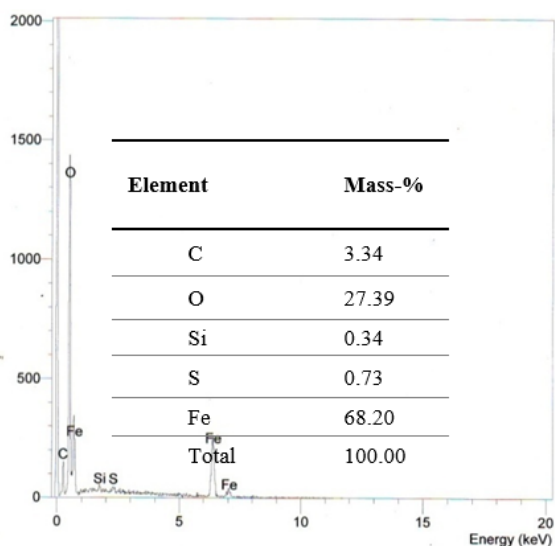
The EDS (energy dispersive spectroscopy) analysis obtained from the elbow tube 1A around its leaked area is presented in Figures 12-13, in which Figure 12 was showing some deposits that formed on the external surface, while Figure 13 was showing some deposits that formed on the inner wall around the cavitation-erosion area. The deposits that formed in both surfaces shown in Figures 12 and 13 contained iron (Fe) as a major element from which the elbow tube is made. Besides that, both deposits are shown in Figures 12, and 13 also contained oxygen (O) and carbon (C) as other significant elements coming from some oxides and or other surface contamination. There are also some trace elements found in the deposits formed on both surfaces of the elbow tube. Most of the trace elements found in the external surface deposits included S and Si, while the trace elements found around in the cavitation-erosion area included Si and Al. The trace elements found in the outer surface deposit may be coming from the flue gas circulated in the HRSG's evaporator tube panel. They may have been responsible for some surface corrosion on the outer elbow tube. Whereas, the trace elements found in the internal wall deposit may be coming from the HRSG water used. The presence of these trace elements may not have been significantly contributing to some corrosion in the inner walls of the elbow tube that experiencing the cavitation-erosion.

Figure 12. Result of EDS analysis obtained from some surface deposits that formed around the external surface of the elbow tube 1A

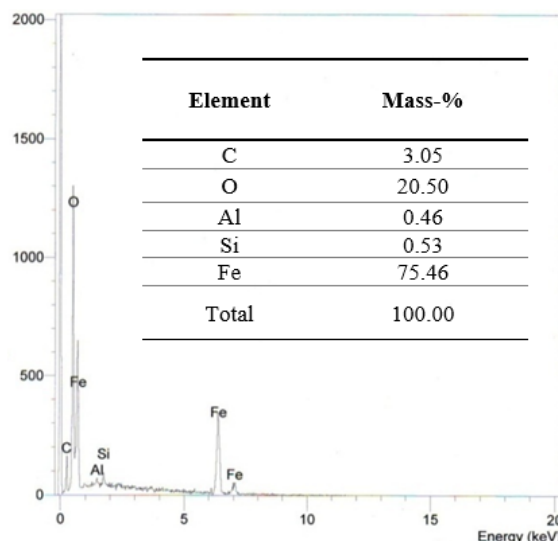
Figure 13. Result of EDS analysis obtained from some inner surface deposit that formed around the cavitation-erosion area of the elbow tube 1A
