## DAMAGE INVESTIGATION ON WELD ALUMINUM COMPONENT OF A COMPRESSOR AFTER-COOLER

**Dewa Nyoman Adnyana**

*This study was carried out on a compressor heat exchanger (after-cooler) which leaked in the welded joint of a component made of non-heat-treatable aluminum alloys. The purpose of this study is to determine the type, cause, and mechanism of failure/damage in relation to the metallurgical structure that occurs. In this study, several tests were carried out including visual and macroscopic examinations, metallographic and hardness testing, and SEM (scanning electron microscope) analysis equipped with EDS (energy dispersive spectroscopy). The results show that the type of failure that occurs in the compressor after-cooler is intergranular corrosion due to the sensitization that occurred in the microstructure. In addition, the damage that occurs may also be influenced by the weld defect in the form of gas porosity.*

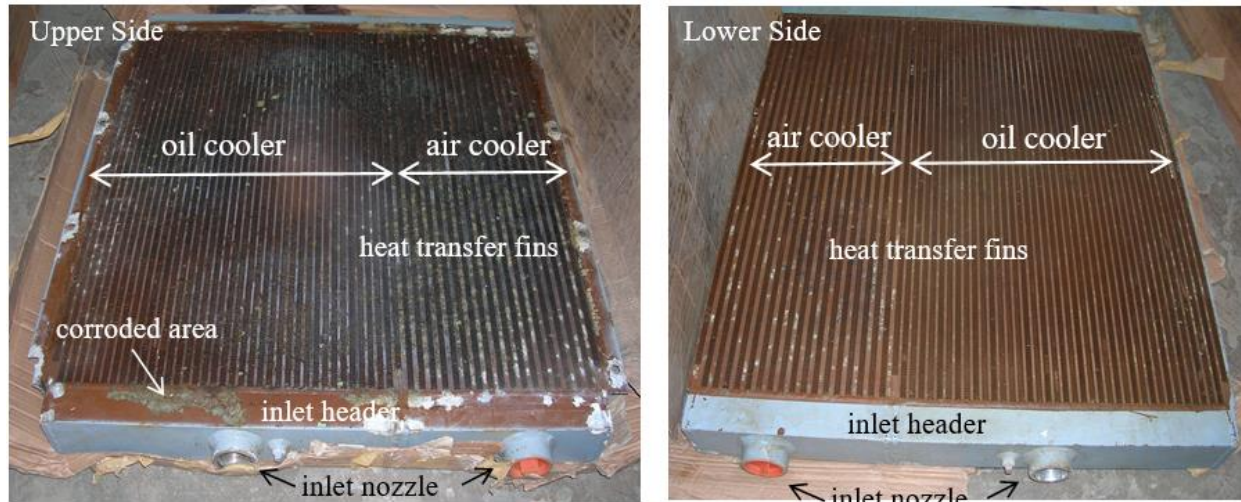
The present work aims to study the damage mechanism that has caused a compressor after-cooler to leak. Figure 1 shows a leaked compressor after-cooler used in the present study. The after-cooler is equipped with two separated pressure chambers, namely compressor air cooler and compressor lubricating oil cooler. The operating data of the compressor after-cooler is as follows: duty of 897 BTU/min., and maximum working pressure of 150 psi. As indicated in Fig. 1, the leak is located at the oil cooler around the corroded area on the weld joint between the inlet header and the sidebar/parting sheet.

Figure 1. The leaked compressor after-cooler used in the present study, showing its upper side and lower side, respectively

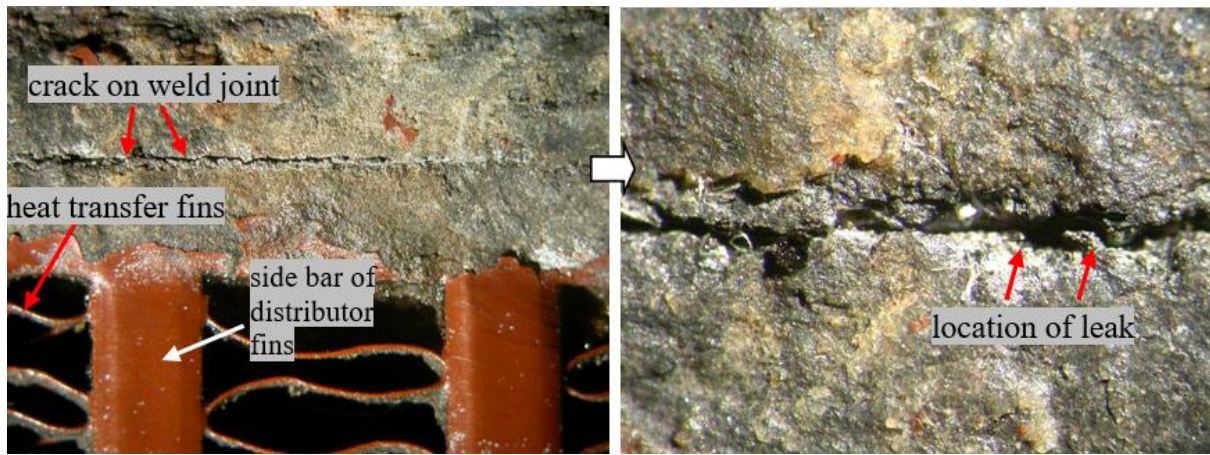
A close-up view of the failed after-cooler shown in Fig. 4 reveals that the oil leak located on the linear crack that formed on the parting line of weld joint between inlet header and sidebar/parting sheet.

Figure 4. Close up view of the corroded surface around the weld joint of the leaked compressor after-cooler

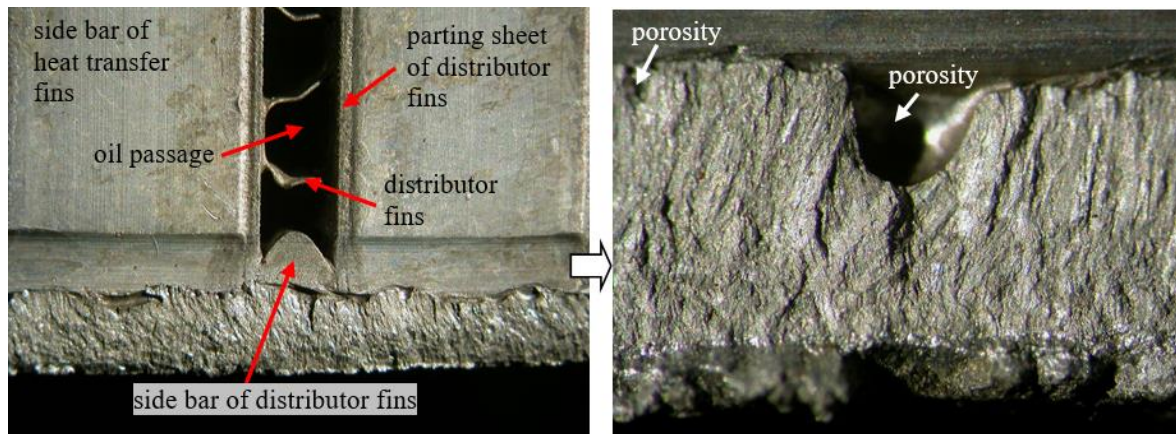
Figure 5. Fracture surface of the weld joint between header and sidebar/parting sheet

The results of the macroscopic examination obtained from the leaked area on the weld joint between the inlet header and the sidebar/parting sheet of the compressor after-cooler (see Fig. 4) are presented in Fig. 5. It can be seen from Fig. 5

that most of the weld fracture surface contained several voids due to gas porosity. In addition, the corrosion seems to have entered into the weld fracture surface. Besides that, the application of one single fillet weld may have further reduced the load-carrying capacity of the weld joint

between the inlet header and the sidebar/parting sheet and therefore it was prone to cracking.

In addition to the external corrosion and weld defect, the premature failure of the compressor after-cooler was also likely caused by insufficient weld design as the weld joint between the header and the sidebar/parting sheet of the after-cooler only used a single fillet weld. The application of another fillet weld on the inside parting line between header and sidebar/parting sheet may improve the load-carrying capacity of the weld joint structure, and hence it may increase the operating life of the after-cooler significantly.

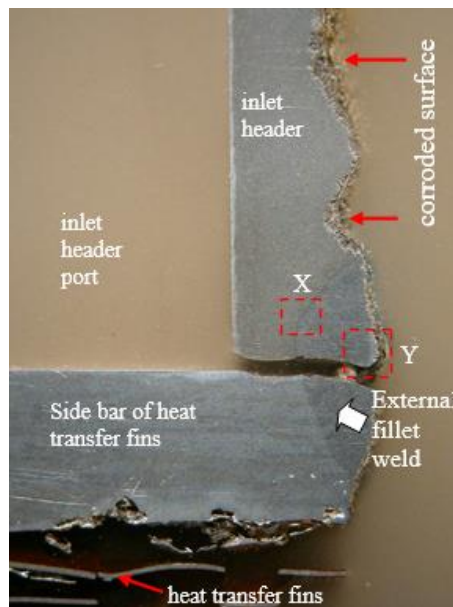
Figure 6. Cross section of a polished and etched specimen obtained from the leaked weld joint between header and sidebar/parting sheet

Figure 6 shows a cross-section of a polished and etched specimen obtained from the leaked weld joint between the inlet header and the sidebar of the after-cooler/oil cooler. The specimen shows a fracture line lied along the parting line between the header and the sidebar of heat transfer fins. The crack leading to the fracture was likely originated from the corroded weld surface. Microstructures obtained from the specimen shown in Fig. 6 are presented in Fig. 7 at different locations. In the weld joint of the header side shown in Fig. 7, the microstructures obtained are located around the WM (weld metal), HAZ (heat affected zone), and around the BM (base metal HAZ). The microstructure of weld metal generally shows a dendritic type, while the microstructure of the header material at its base metal shows typical wrought aluminum alloy microstructure containing fine particles of the intermetallic second phases [1],[2],[8]–[9]. Similarly, the microstructure obtained from the weld metal shown in Fig. 5 also apparently exhibits several large voids or porosity (see Fig. 8). This further confirms that the fillet weld between the inlet header and the sidebar/parting sheet of the compressor after-cooler contained some amount of weld defect. In addition, the microstructures are shown in Fig. 9 also exhibit the area with heavy damage of external corrosion. The corrosion damage on the weld metal surface in general shows typical interdendritic corrosion.

This interdendritic corrosion may have been caused by sensitization that occurred on the weld metal due to formation of a number of intermetallic phases during welding process or in service at extended high-temperature exposure [1]–[2],[8]–[9].

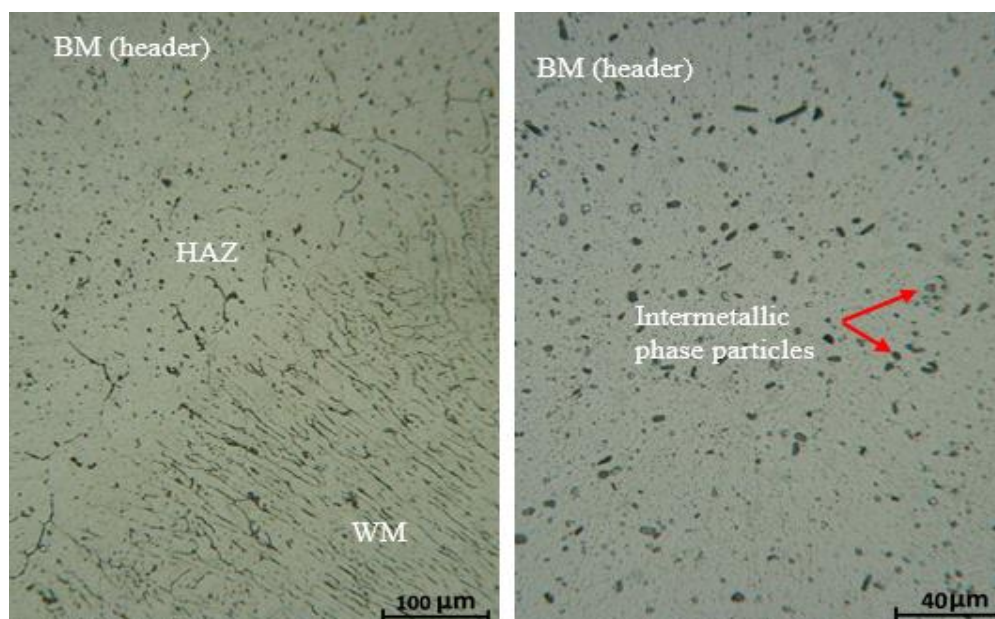
Figure 7. Microstructure obtained from the weld joint between header and sidebar/parting sheet at location X as indicated in Figure 6 (etched with Keller solution). Note BM is base metal, HAZ is heat-affected zone, and WM is weld metal

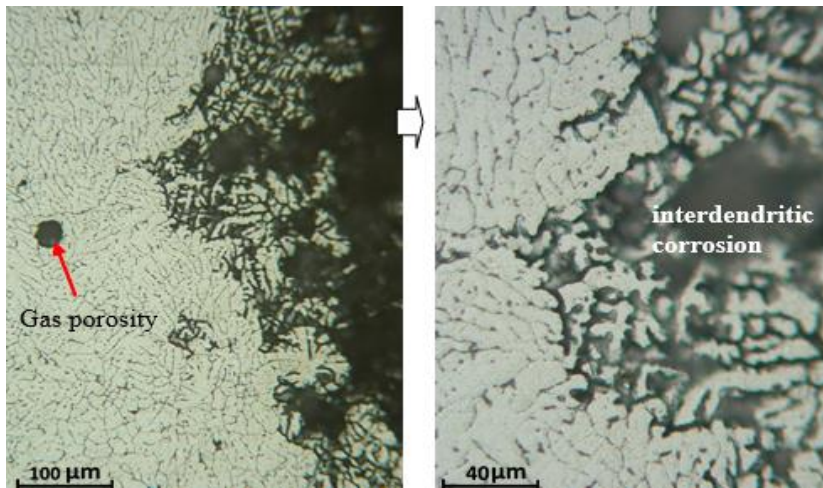
Figure 8. Microstructure obtained from the corroded weld metal of the header side at location Y as indicated in Figure 6 (etched with Keller solution)

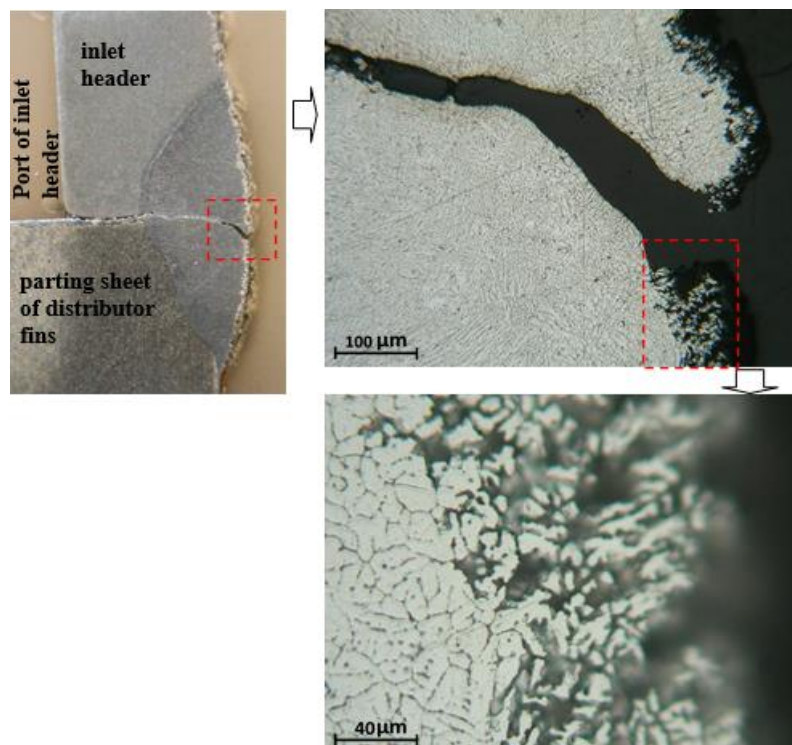
Another specimen of metallographic examination was also obtained from the leaked weld joint between the inlet header and the parting sheet of distribution fins (see Fig. 9). The microstructures obtained are very much similar to those observed from the previous microstructures shown in Figs. 7 and 8. The fracture shown in Fig. 9 was most likely originated from the corroded weld surface that was heavily damaged by interdendritic corrosion and progressed into the internal port of the inlet header through the parting line between the header and the parting sheet of distributor fins. Similarly, the extended crack or fracture that occurred was most also likely influenced by some weld defect (porosities) that formed in the weld joint between the header and the parting sheet.

Figure 9. Microstructure obtained from the weld joint between header and parting sheet of distributor fins at location as indicated (etched with Keller solution)

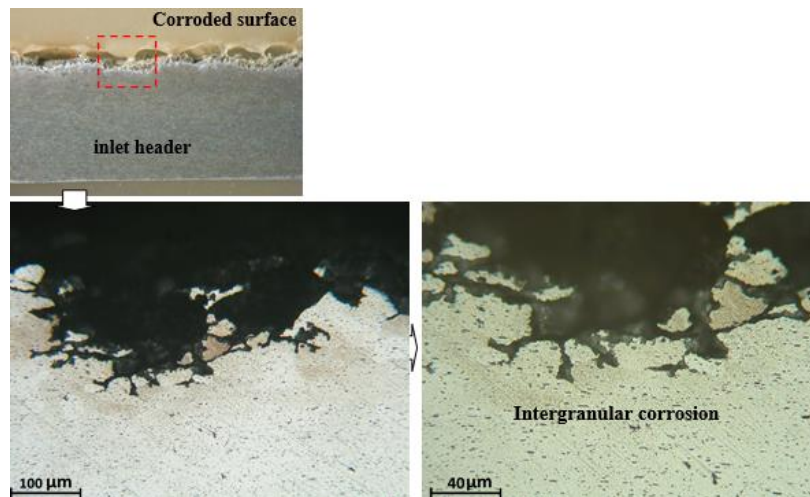
Details of the microstructure obtained from the corroded surface area of the inlet header are depicted in Fig. 10. It is seen that most of the header surface was severely affected by intergranular corrosion. Similar to the microstructures shown in Figs. 7, 8 and 9, this intergranular corrosion was most likely caused by sensitization due to the formation of some intermetallic phases at the grain boundaries [1]–[2],[8],[9].

Figure 10. Microstructure obtained from the corroded area of the header surface at location as indicated (etched with Keller solution)

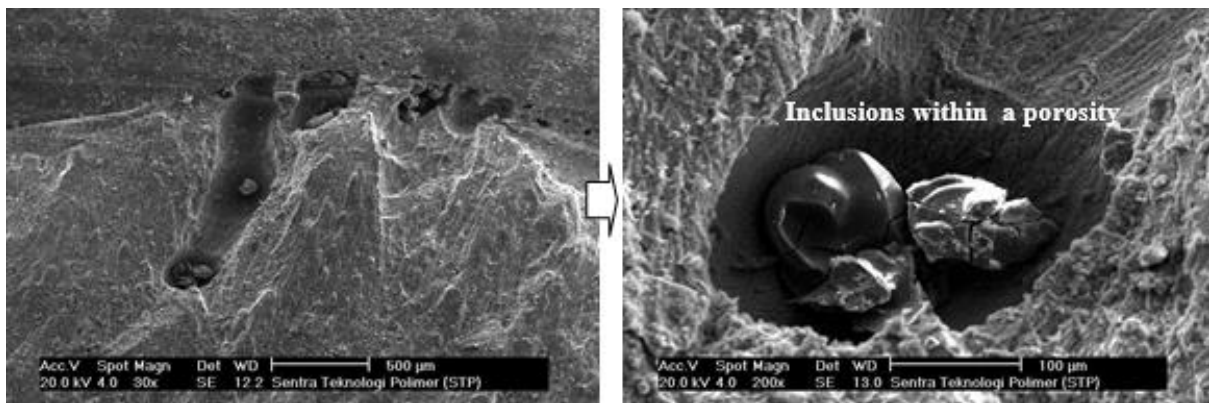
SEM fractography obtained from the fracture surface of the leaked after-cooler are presented in Fig. 12. The fractography obtained show the fracture surface of the weld joint between the header and the sidebar/parting sheet that contained many porosities. These porosities in some extent may have contributed to the crack or fracture formation. The crack seemed to initiate from the corroded surface of the weld joint and propagated into the weld defect (porosity) where the crack may have come to stop. However, the crack may have further continued to the nearest parting line between the header and the sidebar to complete the crack path. As seen clearly in Fig. 12, a large porosity appears to fill with some inclusions.

Figure 12. SEM micro fractography of the through fracture surface obtained from the leak area of the weld joint between the header and the sidebar/parting sheet, showing some inclusions within the weld defect

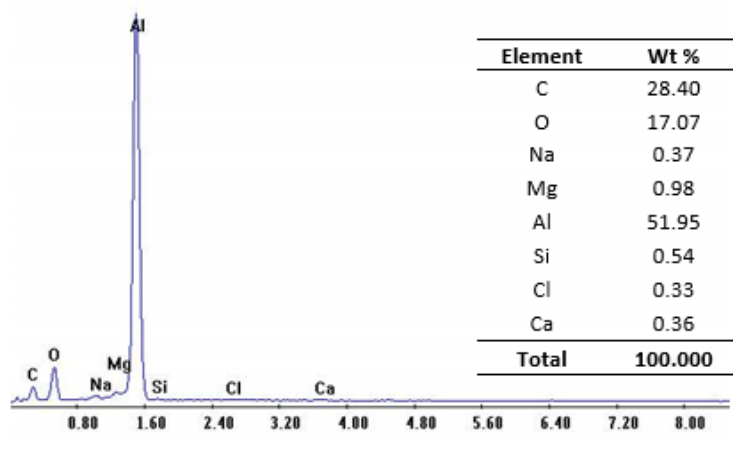
The EDS spectrum of elements obtained from the header fracture surface shown in Fig. 12 that experienced corrosion damage shows some major elements such as aluminum (Al), carbon (C), and oxygen (O) (see Fig. 13). The oxygen content obtained is much likely affected by the oxide formation due to corrosion (as corrosion product). Whereas the high carbon content found in the EDS spectrum may be influenced by some leakage of compressor hot lubricating oil that entered into the oil cooler. In addition to those elements, there are also other elements observed in the EDS spectrum such as magnesium (Mg), silicon (Si), sodium (Na), chloride (Cl) and calcium (Ca). Both elements of Mg and Si are the alloying elements of the aluminum alloy AA5xxx. The source of Na and Cl was most likely coming from the seawater and/or its moisture or maybe present from other aqueous environments. Figure 14 also shows the EDS spectrum of elements representing the corresponding composition of inclusion that formed inside a large porosity shown in Fig. 12. The inclusion is a typical aluminum oxide that likely formed from the filler metal used during welding.

Figure 13. EDS spectrum of elements obtained from the header fracture surface shown in Fig. 12

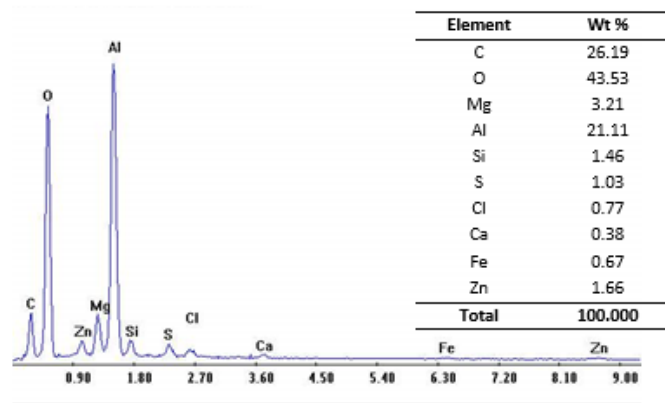
Another result of the EDS analysis obtained from the corroded surface area located around the edge of the header and the weld fracture surface is presented in Fig. 15. Most of the result obtained indicated that oxygen (O) and carbon (C) along with aluminum (Al) and its alloying elements such as Si, Mg, Fe, Zn and some sulfur (S), chloride (Cl) and calcium (Ca) were detected on much of the corroded surface scale/corrosion product.

Figure 15. EDS spectrum of elements obtained from the corroded header surface shown in Fig. 10
