## FATIGUE FAILURE IN A LONGITUDINAL WELDED ELBOW OF A PROCESSING VESSEL

**Dewa Nyoman Adnyana**

*Longitudinally welded elbow made of austenitic stainless steel type 316 and used as a drain line on a processing vessel had suffered damage (leakage) after it had only been in operation for a few years. Process fluid that was drained out of the vessel consists of fatty acid-containing hydrogen gas at a temperature of 150 °C and a pressure of 60 bar(g). Initially, the draining process was carried out only once a year, but recently due to frequent changes in the types of product being made, the frequency of the draining process has increased to several times a month. This study aims to determine the type and factors that have caused leakage in the elbow. The metallurgical assessment was carried out by preparing many specimens from the leaking elbow. A number of laboratory examinations were performed, including visual and macroscopic tests, chemical composition analysis, metallographic examination, hardness tests, and SEM (scanning electron microscope) equipped with EDS (energy-dispersive spectroscope) analysis. The results obtained indicate that the leaking elbow has experienced fatigu

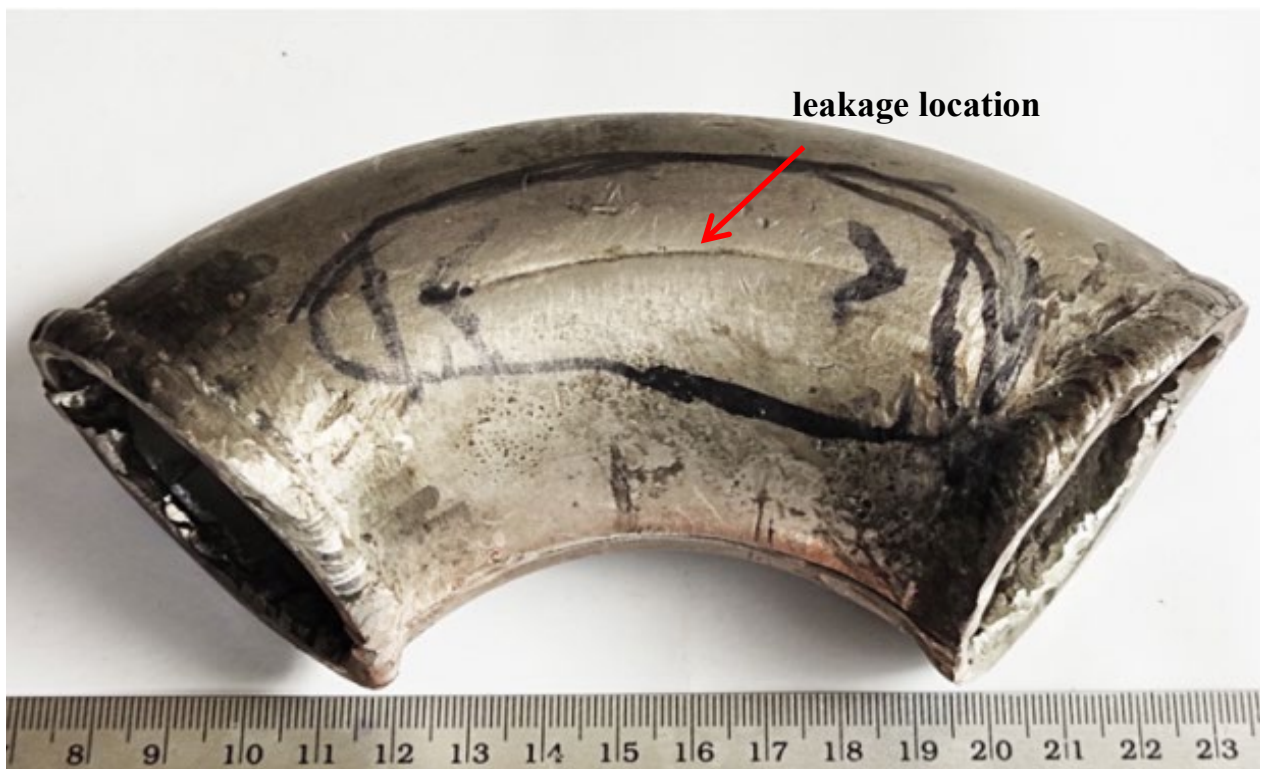
The leaking elbow as shown in Figure 1, having outside diameter of 2" was made of austenitic stainless steel 316 type. The elbow was used as a drain line of fatty acid fluid containing hydrogen gas out of a processing vessel. The elbow and its processing vessel were operated at maximum temperature of 150°C and under a pressure of 60 bar(g). According to the plant information, the drain process was initially carried out approximately once a year, but recently due to changes in the types of products made, the drain process has increased several times a month.

Figure 1. As-received elbow for laboratory examination, showing a longitudinal line mark formed at the leakage location

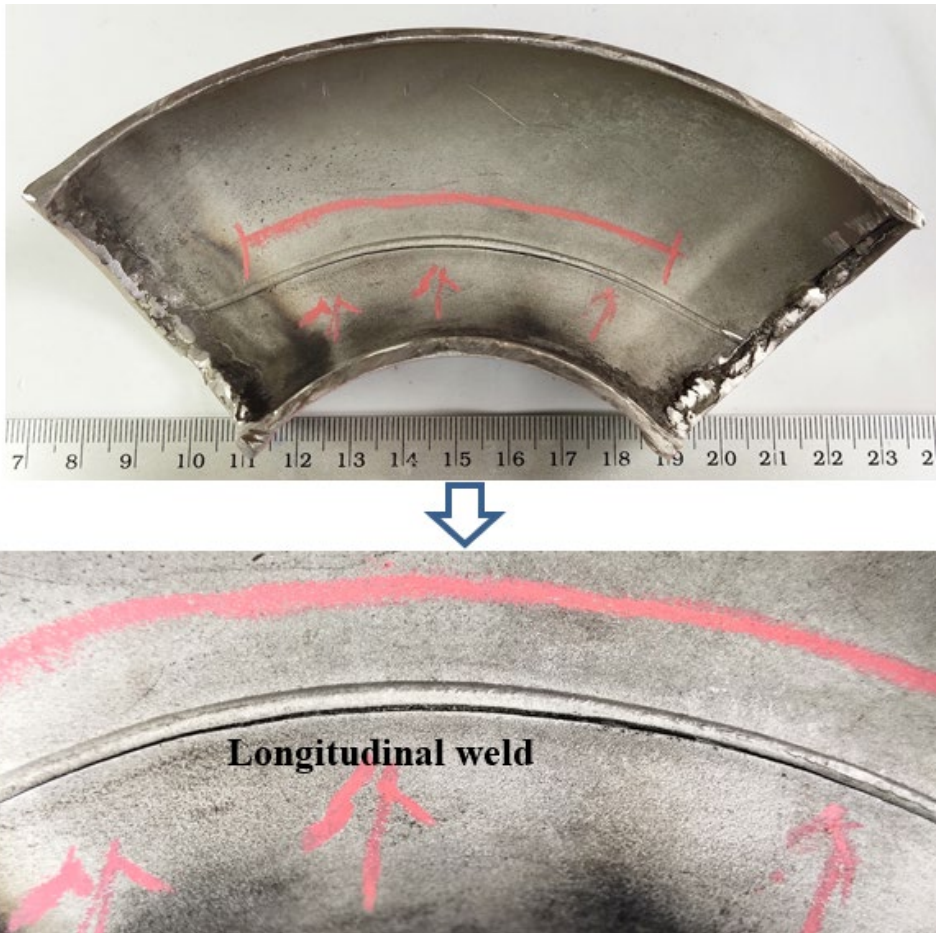
In order to determine the location of the leak, the damaged elbow as shown in Figure 1 was cut-off into two halves. Figures 2 and 3 show one of the elbow halves showing the inside of the elbow. From Figures 2 and 3 it can be seen that the leaking elbow was actually made of a longitudinally welded tube and the leakage was caused by some longitudinal crack formed in the area around the longitudinal weld located between the weld metal (WM) and the heat-affected zone (HAZ), or around the fusion boundary.

Figure 2. Close-up view at the internal surface after cutting the elbow into two halves showing a longitudinal weld that had been applied for fabricating the elbow

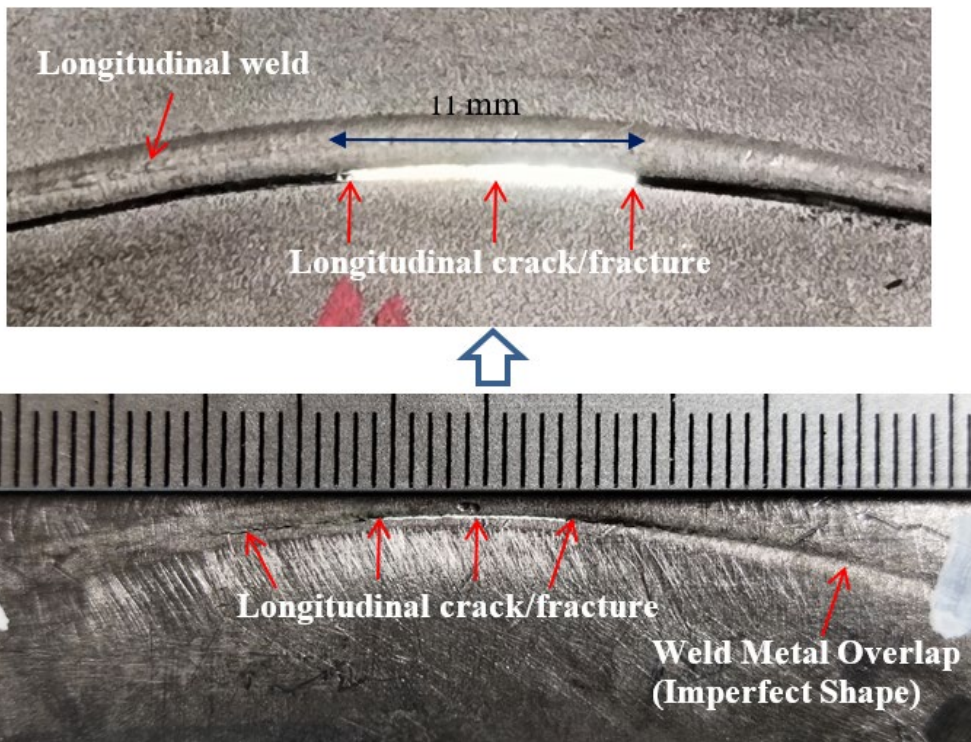
Figure 3. Close-up view of some internal wall of the elbow at leakage location revealing a crack or fracture in the longitudinal direction at the HAZ/fusion boundary of the longitudinal weld

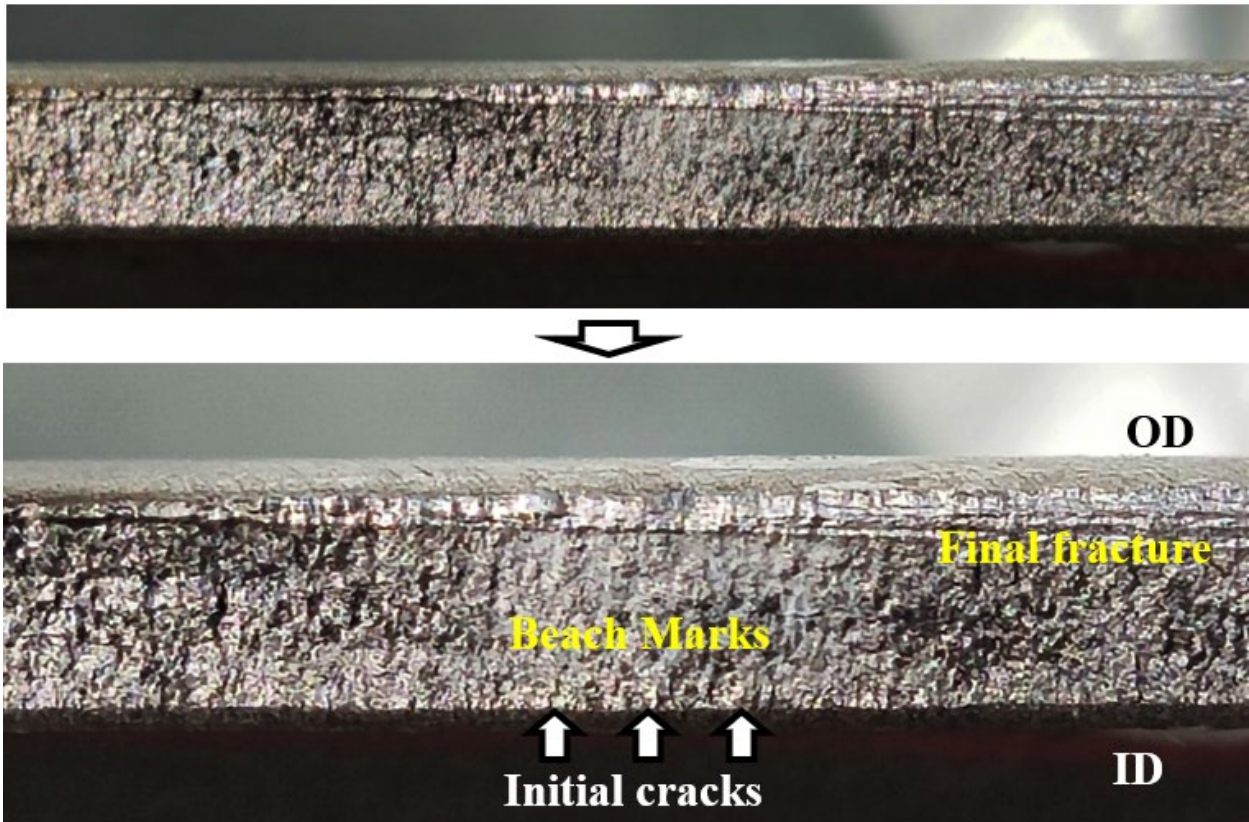
The fracture surface obtained along the crack path of the elbow as shown in Figures 2 and 3 is presented in Figure 4. According to the crack topography and damage pattern, the cracked elbow as shown in Figure 4 is presumed to have suffered a fatigue fracture. This fatigue fracture is characterized by the formation of smooth beach marks [1]-[2], [17] on almost the entire fracture surface of the elbow section. Fatigue cracks can be seen clearly starting from the weld defect of imperfect shape due to weld overlap formed on the inner wall of the elbow where a high stress concentration may present.

Prior to the fatigue crack approaches the OD side of the elbow, the crack grows very rapidly and penetrates the remainder of the cross section causing a leak in the elbow. The rough fracture surface left by the fast crack is the final fracture. It can be seen from the fatigue fracture surface shown in Figure 4 that the final fracture surface area is relatively smaller than the crack propagation (beach marks) area. This suggested that the fatigue fracture of the failed elbow was produced by a low nominal stress, but under an abnormal high or severe stress concentration [17]. The low nominal stress indicated that the elbow material located around the cracked area was subjected to a low and normal loading condition during its operation, whereas the severe stress concentration was most likely taking place on the internal wall of the elbow where the weld defect due to imperfect shape present. Formation of weld defect was likely as the result of weld metal overlap occurred during elbow fabrication and could generate a high tensile stress concentration and initiated the fatigue crack. The cyclic loadings that may result in fatigue cracking at the elbow were likely affected by the frequent removal of the fatty acid liquid containing hydrogen gas out of the vessel.

Figure 4. Low-magnification view of fracture surface of the leaking elbow pointing toward crack initiation from ID surface as well as beach marks and the final fracture at the OD side

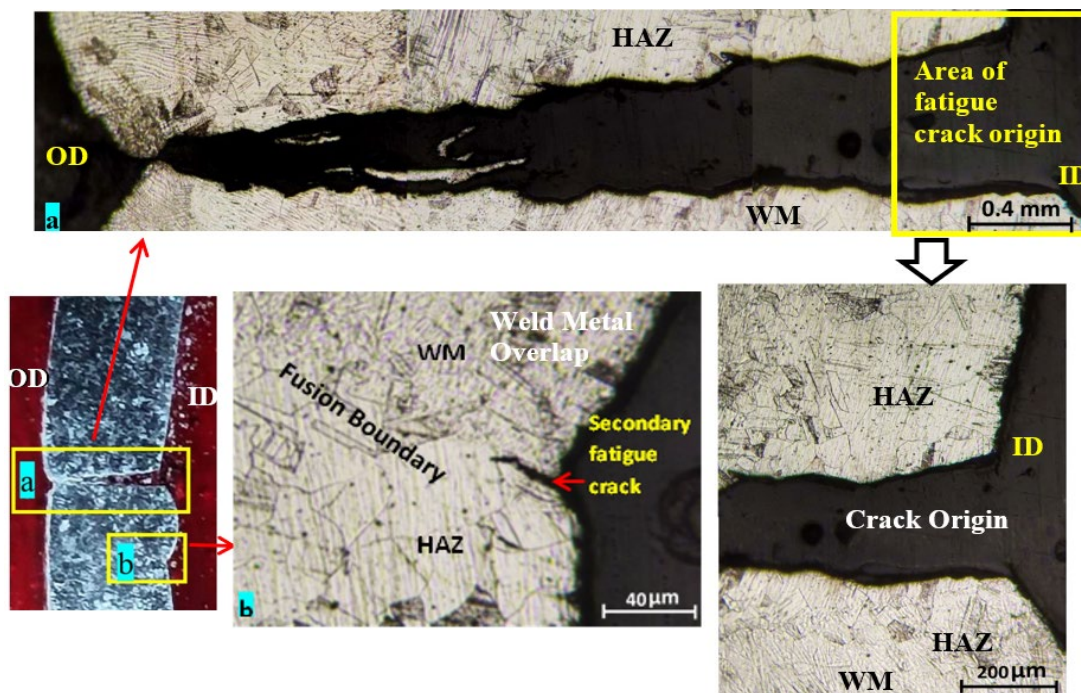
The macrostructure and microstructures obtained from specimen A are presented in Figure 5, showing the different examination areas including the initial fatigue crack area occurring at the HAZ/fusion boundary of the weld defect, fatigue crack path or fracture surface, final fracture and secondary fracture area. The microstructures obtained consisted of all austenitic phase matrix with several twin boundaries, typical of AISI type 316 austenitic stainless steel. Figure 5 also shows that fatigue crack origins occur on the elbow's ID surface at a location between WM and HAZ or around the fusion boundary. In this area, it is clearly seen that there is some weld defect in the form of discontinuity or imperfect shape due to weld

overlap. It is estimated that in this area a high stress concentration may be present so that it can initiate the occurrence of fatigue cracks. The fatigue crack then propagates toward the OD side of the elbow forming a more or less straight path in transgranular manner and unbranched, typical of fatigue crack mechanism. Further from Figure 5 it is found that secondary fatigue cracks have also formed in the area around the fusion boundary between WM and HAZ at other location nearby the WM bead area.

Figure 5. Macrostructure and microstructures of specimen A obtained from the leaking area showing one of the fatigue cracks that had penetrated through the elbow's wall thickness to cause leakage (etched by aqua-regia solution)

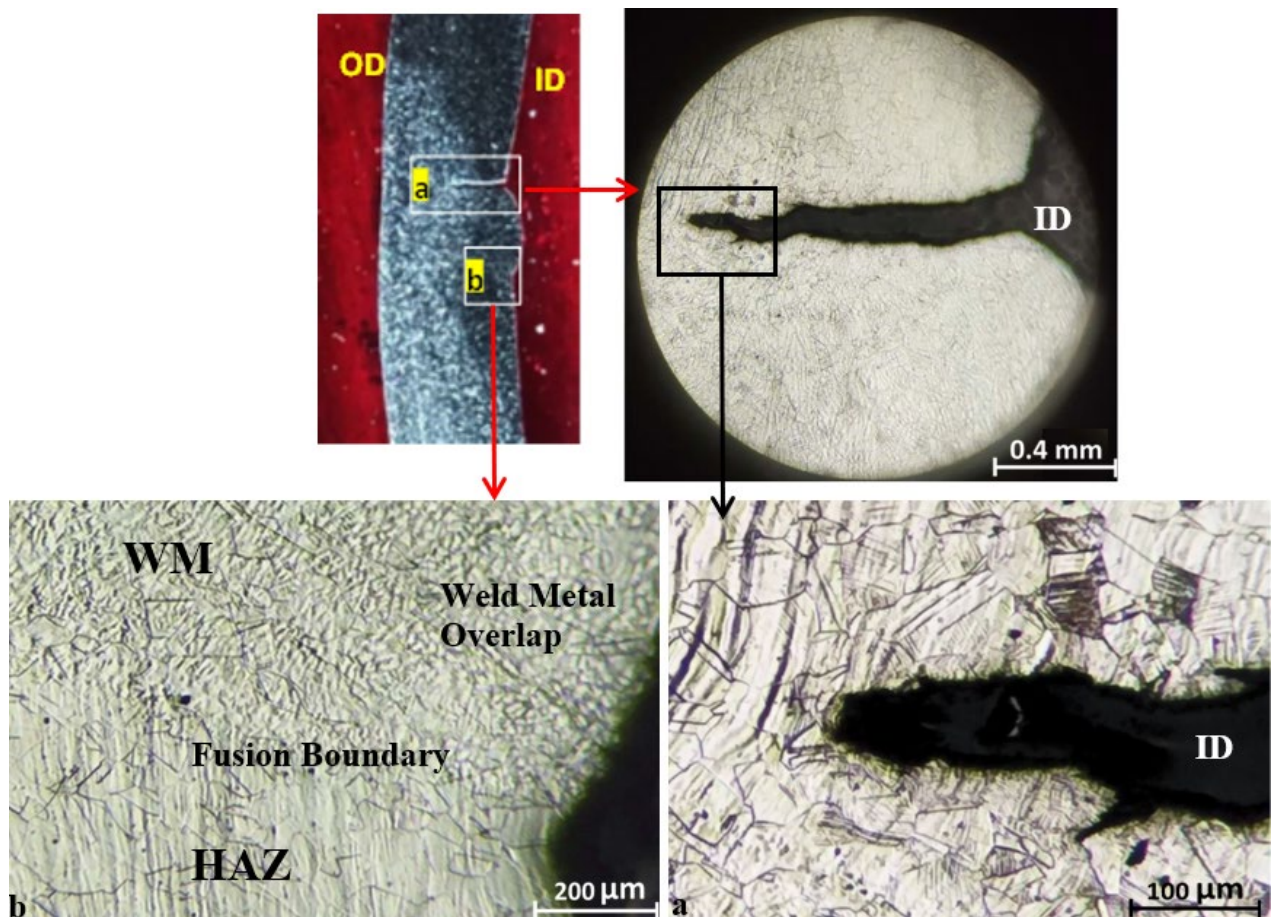
Macrostructure and microstructures obtained from specimen B at location outside of the leaking area of the elbow are presented in Figure 6. The microstructures obtained were all similar to that obtained from specimen A, consisting of austenitic phase matrix with several twin boundaries

Similarly, fatigue cracks can also be seen starting from the inner wall of the elbow, namely from a weld defect formed at the HAZ/ fusion boundary which is located between HAZ and WM. Fatigue crack propagation toward the OD side appears to form a more or less straight path in transgranular manner without crack branching. However, from Figure 6 it can be seen that the secondary fatigue crack that observed in specimen A has not formed in specimen B. From Figures 5 and 6, it apparently shows that the cracks propagated in transgranular manner typical of fatigue failure.

Figure 6. Macrostructure and microstructures of specimen B obtained from the other cracked area at different location from that shown in specimen A (Figure 5) showing formation of one fatigue crack that only penetrated up to the middle of the elbow's wall thickness. The fatigue crack is apparently seen to have initiated from the ID surface at location around the HAZ/fusion boundary of the longitudinal weld of the damaged elbow (etched by aqua-regia)

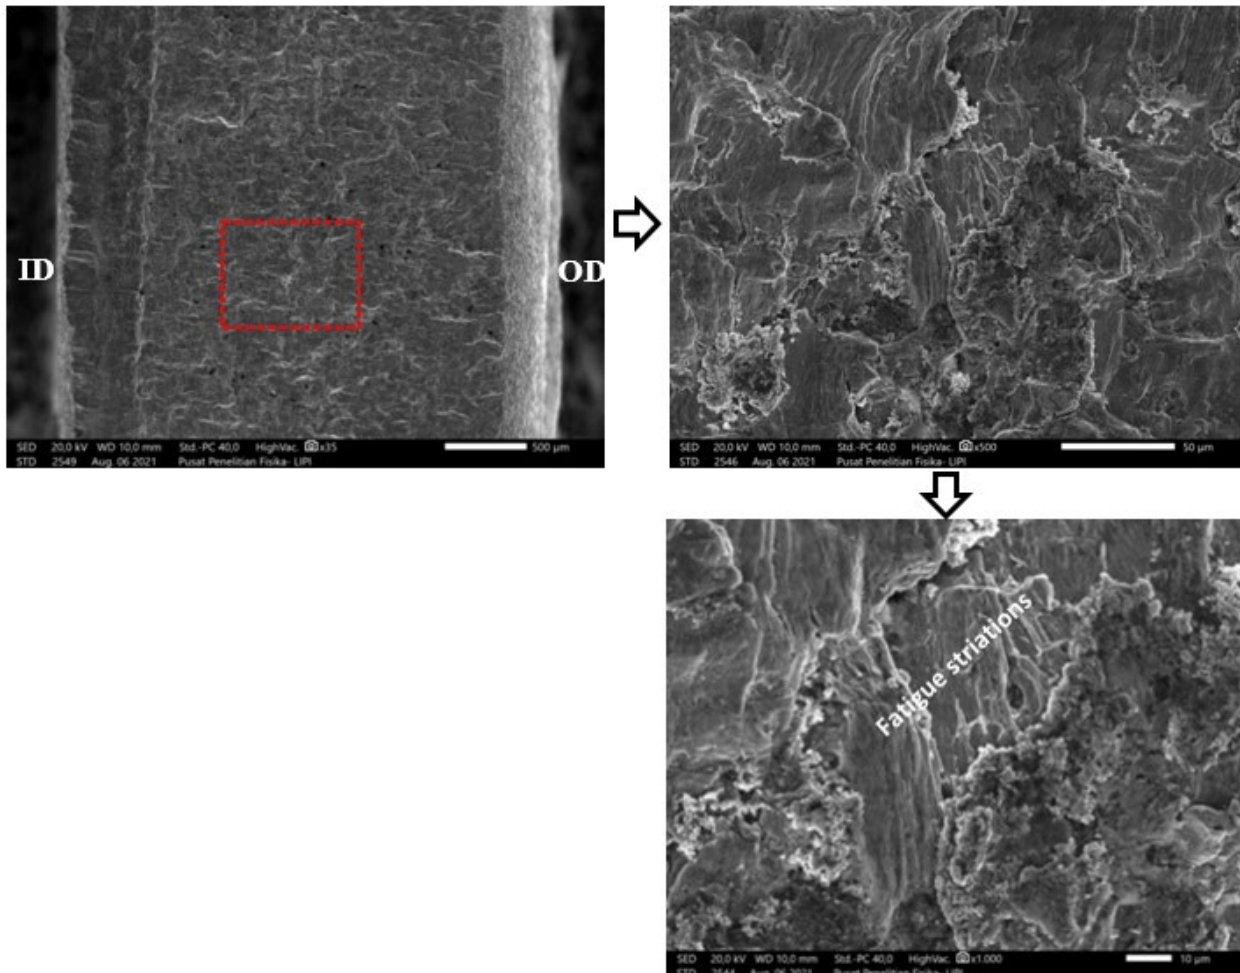
SEM photographs and the corresponding EDS spectrum of elements obtained from some areas around the fatigue fracture surface of the damaged elbow are presented in Figures 7 and 8. The presence of fatigue striations shown in

Figure 7 indicated that a fatigue crack has been growing in that particular area of the damaged elbow as a result of some cyclic loadings [15]-[16]. As seen in Figure 7, the crack is growing from left to right or from inner side to the outer side of the elbow. Further from Figure 8, it is found that the damage or fracture surface deposit generally contained a number of elements from which the elbow made, such as Fe, Ni, Cr, Mo, Si and Mn. The fracture surface deposit also contained oxygen (O) and carbon (C) as elements

Figure 7. SEM image showing fatigue striations on the fracture surface of the leaking elbow. Formation of fatigue striations are from left to right, or from the ID side to the OD side of the damaged elbow

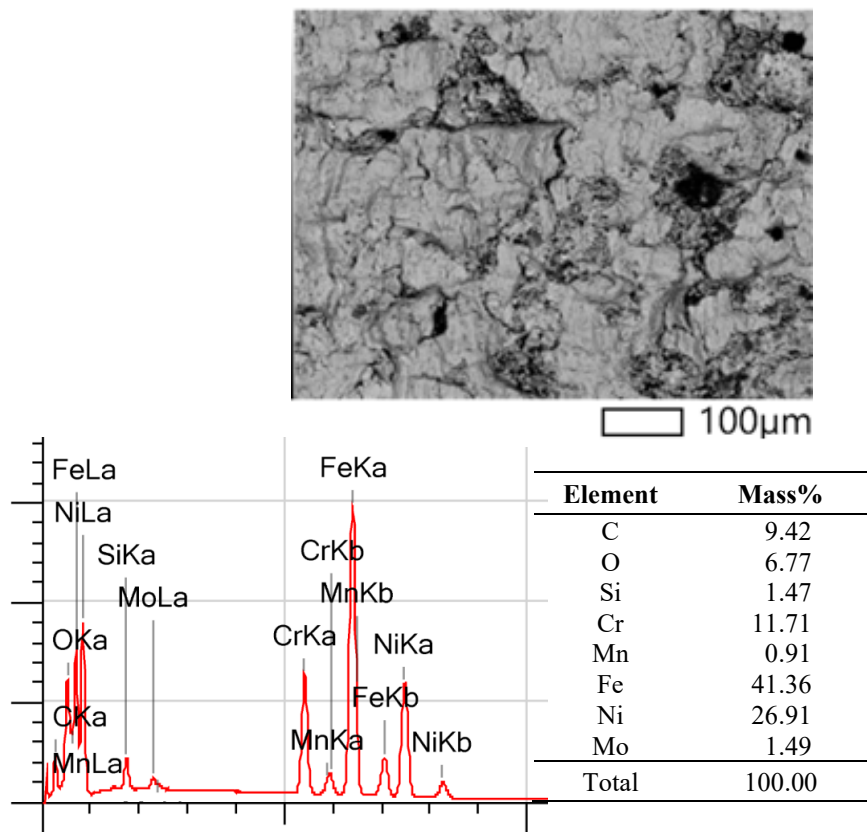
that may be coming from some oxides and/or other surface contamination. It can also be seen from Figure 8 that there were no particular trace elements found in the fracture surface deposit. This indicates that there was likely no any trace elements contributed to the failure of the elbow. This also confirms that the fatigue crack occurred in the elbow is apparently caused by mechanical fatigue and not due to corrosion fatigue.

Figure 8. EDS analysis obtained from some fatigue fracture surface of the leaking elbow
