INVESTIGATION OF FAILURE MECHANISMS IN U-BEND TUBES OF SHELL-AND-TUBE HEAT EXCHANGERS

^aDepartment of Foundry Engineering, Bandung Polytechnic for Manufacturing

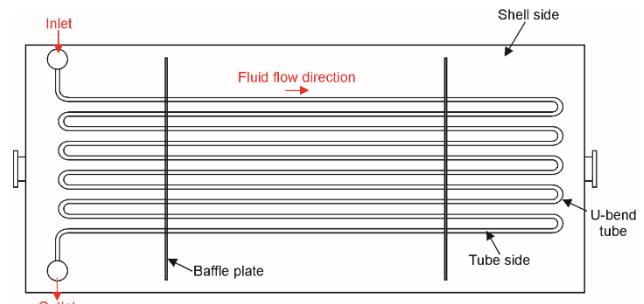
The operating conditions on the tube side of the shell-and-tube heat exchanger in the chemical plant were 275 °C and 58.48 barg. According to the design specifications, the heat exchanger tubes were rated to withstand temperatures up to 360 °C and pressure up to 72 barg. Figure 1 shows a schematic of the failed shell-and-tube heat exchanger that was investigated in this study. The materials used for the U-bend tube are carbon steel, specifically SA-234 Grade WPB.

Figure 1. Schematic of the failed shell-and-tube heat exchanger

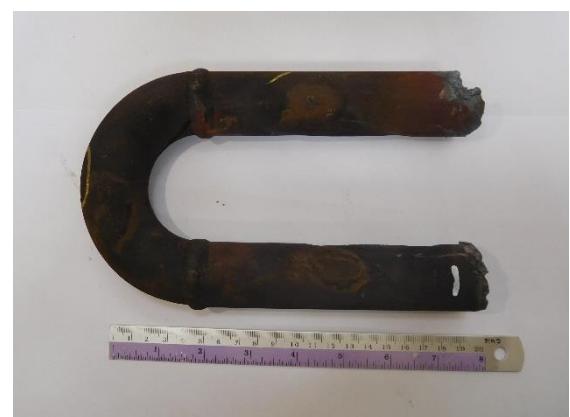
However, another leak occurred approximately 14 days after the replacement. The failed tube and its condition near the weld metal are shown in Fig. 2.

Figure 2. Photograph of the shell-and-tube heat exchanger (a) overall and (b) near the welded metal

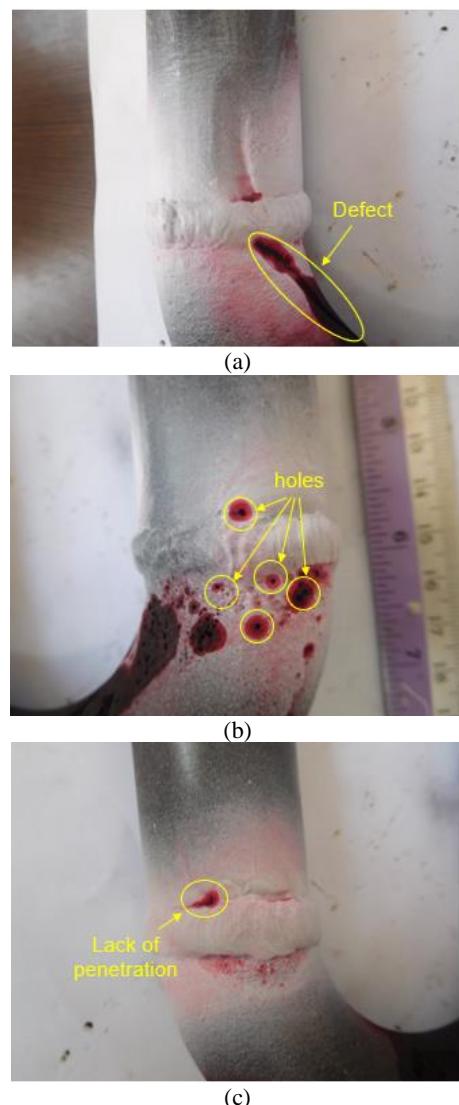
Figure 3 shows the macroscopic evaluation of the failed U-bend tube after dye penetrant testing

was conducted. The red areas in the image indicate defects revealed by the dye penetrant test. Several defects were observed in the failed U-bend tube. A continuous defect is observed around the joint area, as shown in Fig. 3(a). As seen from Figure 3(b), there are several holes in the outer surface of the failed tube, as shown by arrows. The formation of small holes in the outer surface of the failed tube is indicative of pitting corrosion. In the weld metal region, penetration is insufficient, as shown in Fig. 3(c). This indication refers to the condition in which the top part of the weld joint does not fuse with the base metal. These macroscopic defects indicate potential sites of stress concentration, which may serve as preferential locations for crack initiation under internal pressure and elevated operating temperatures.

Figure 3. Macroscopic evaluation of defect types (a) continuous defect, (b) small holes, and (c) lack of penetration in the failed tube

Fe_3O_4 . Meanwhile, erosion is identified by the continuous appearance of surface defects on the tube exterior, as shown in Fig. 3(a).

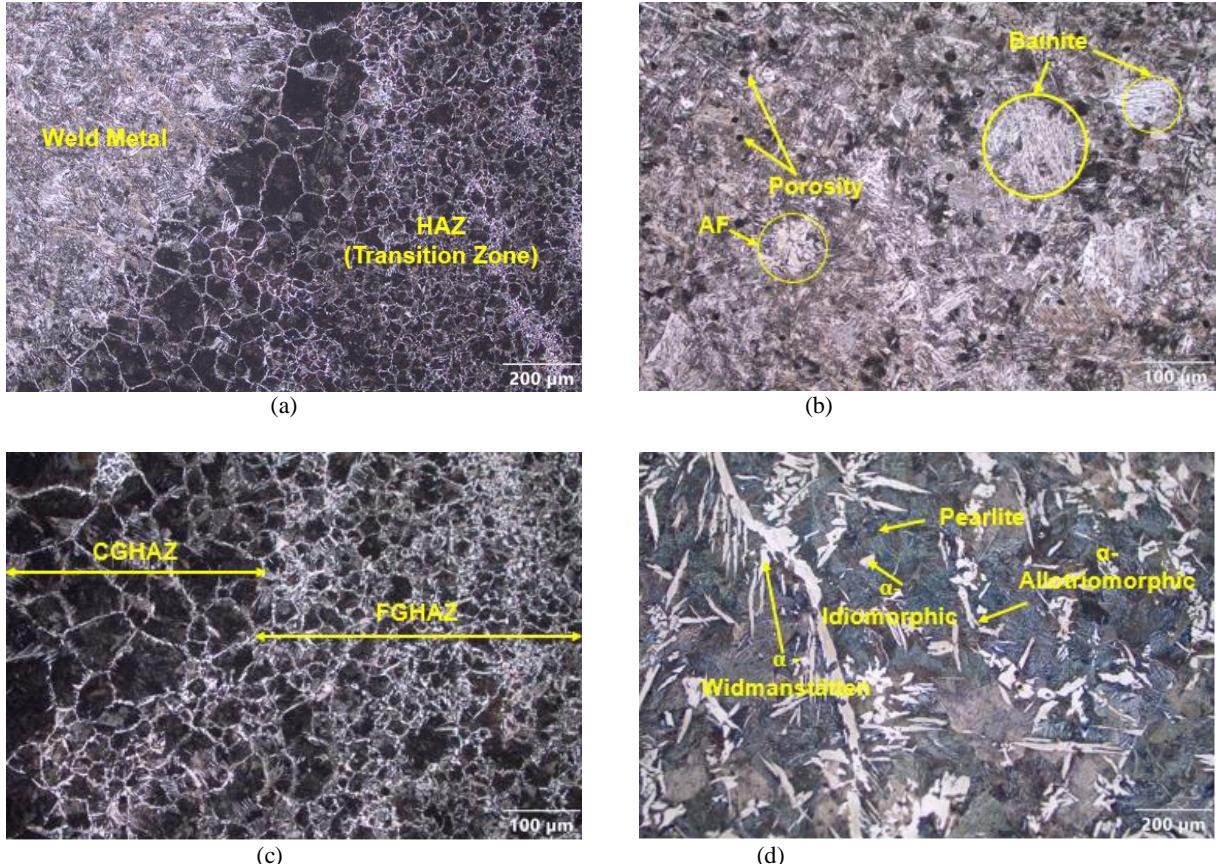
A sample was carefully cut from the welded joint of the failed U-bend tube, then ground with silicon carbide (SiC) grade 60-1500, polished with alumina paste (Al_2O_3), and etched with Nital. The morphology of the sample is divided into three distinct areas: the weld metal, the HAZ, and the base metal. Figure 4(a) shows a low-magnification overview of the weld metal and adjacent HAZ from the sample. The region adjacent to the weld metal exhibits microstructural features characteristic of the HAZ, with a gradual variation in grain size due to thermal gradients during welding.

The microstructure of the welded metal consists of evenly dispersed acicular ferrite phase and bainite throughout the welded metal, as can be seen in Fig. 4(b). The acicular ferrite can be differentiated by morphological observation because it forms a microstructure called small, non-aligned grains. The formation of the acicular ferrite microstructure may result from inclusions as a driving force for nucleation. The generation of thermal strains in the austenite phase or the formation of solute-depleted regions are the most likely mechanisms for this phenomenon [12]-[13]. A previous study also reported that the acicular ferrite microstructure on the weld metal provides an optimum combination of strength and toughness [14]. On the other hand, bainite (lath structures) is identified as a ferrite arranged in parallel positions. They can be characterized by more than two parallel lath ferrites within a single prior-austenite grain [12].

Figure 4(c) depicts the microstructure of the HAZ from the failed tube sample. Depending on the distance from the weld metal, the HAZ area can be divided into two distinct subzones: the coarse-grain HAZ (CGHAZ) and the fine-grain HAZ (FGHAZ). Several studies have reported that the peak temperature and cooling rate influence microstructural evolution in the HAZ in each subzone. Therefore, the effects of these two parameters can be correlated with the distance from the weld metal [15]-[18]. These subzones exhibit distinct mechanical and physical properties that may constitute weak points in the welded joint.

Several microstructures were observed in the base metal, as presented in Fig. 4(d). Pearlite is the dominant phase, while three distinct types of ferrite (α) can also be observed in the microstructure. The α -phase, with a plate-like or needle-like morphology, is known as α -Widmanstätten. This type of ferrite is usually undesirable because it reduces steel toughness and increases susceptibility to brittle fracture. This

structure is also classified as an unfavorable microstructure in carbon steel. The presence of Widmanstätten ferrite reduces toughness and increases susceptibility to brittle fracture, particularly under combined thermal and mechanical loading.

Figure 4. Metallurgical microstructure of the failed U-bend tube near the welded joint area, (a) low magnification overview of the welded joint, where the boundaries between the welded metal and HAZ are schematically indicated, (b) the weld metal, (c) the HAZ, and (d) the base metal

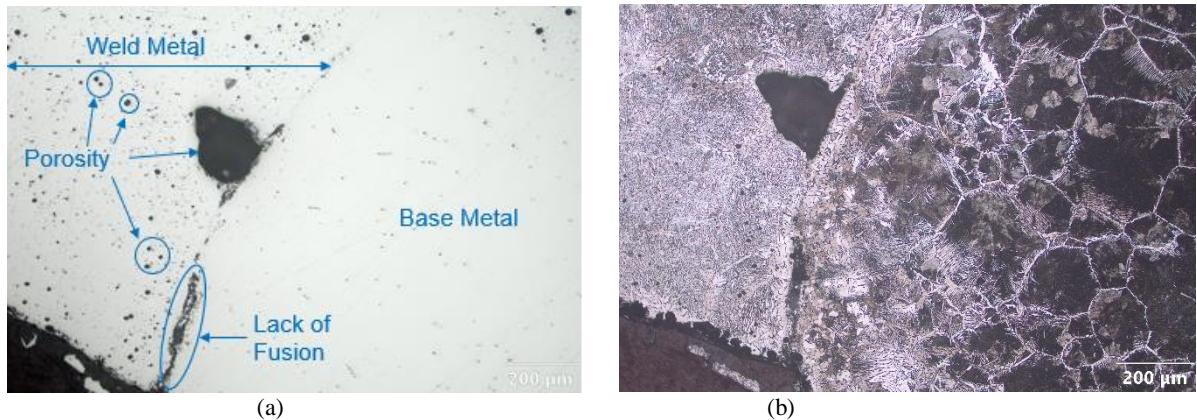
Figure 5 illustrates the metallurgical microstructure around the welded joint area of the failed tube. Numerous small porosities formed in the weld metal during welding, and a large porosity is present near the weld-base metal interface. Furthermore, the welding process appears to have been improperly performed, as evidenced by a lack of fusion between the weld metal and the base metal.

Figure 5. Metallurgical microstructure of the welded joint area (a) without etching and (b) with 3% Nital etching

Welding quality is considered a primary cause of tube failure, as evidenced by multiple welding defects. These defects act as stress concentrators within the tube material. When the tube is subjected to internal loading from pressurized fluid flow and to elevated temperatures during operation, initial defects formed during welding tend to open, expand, and eventually allow fluid to leak from the tube.

corrosion, as evidenced by iron oxide formation detected by EDS analysis. The findings highlight the necessity of strict control of material composition, improved welding procedures, and post-weld inspection. Future work should focus on quantitative life prediction models and process optimization for welded U-bend components operating under high-pressure and high-temperature conditions.

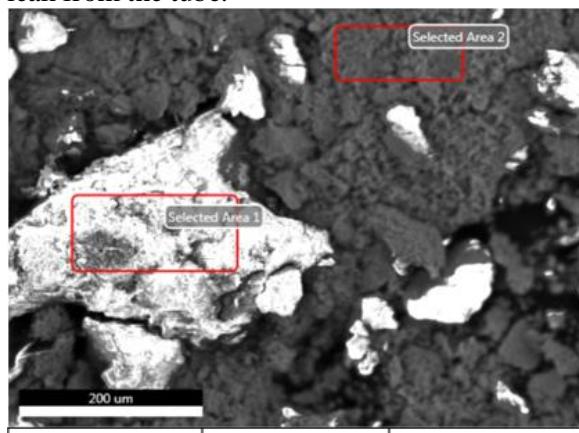
EDS analysis was conducted to investigate the potential for corrosion on the inner surface of the failed tube. As indicated by the white region in Fig. 6, the results revealed the existence of the oxygen (O) element. This element may react with Fe to form iron oxide, such as FeO , Fe_2O_3 , or Fe_3O_4 on the surface of the failed tube. The

formation of these compounds indicates that corrosion has occurred in the failed tube.

Element	wt.%	at.%
C K	48.22	63.74
O K	30.34	30.11
S K	0.28	0.14
Fe K	21.17	6.02

Figure 6. EDS results of the failed U-bend tube sample

Leakage of pressurized fluid from the tube, along with high temperatures on the shell side, promotes corrosion and erosion of the tube's outer surface. This is evidenced by the presence of oxygen on the tube surface, indicating the formation of iron oxides such as FeO , Fe_2O_3 , or
