## METALLURGICAL ASSESMENT OF A BROKEN GEARBOX INTERMEDIATE SHAFT OF A RECIPROCATING COMPRESSOR

**D. N. Adnyana**

### Abstract

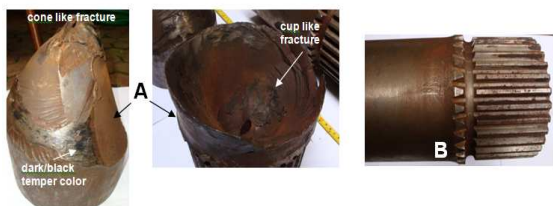
The broken quill shaft A shown in Figs. 5 and 6 consisted of two separated damage portions, one in a cup like fracture and the other in a cone like fracture. These two fracture portions of the broken quill shaft A can be reconstructed or reunited into a damage part approximately represented in Fig. 6. The cup like fracture shown in Fig. 5 is fully cracked on its external surface, in which the crack connected along one of its spline tooth root down to a bolt hole and at the same time the crack also turned into an anticlockwise direction approximately 45° to the shaft axis across the groove and the shaft body (see also Fig. 6). On the other hand, the cone like fracture it only shows the full fracture surface pattern with some dark or black temper color (see Figs. 5 and 6) indicating of some rubbing effect that may have occurred during the final fracture of the quill shaft.

Figure 5. The as received broken quill shaft A and the unbroken quill shaft B for metallurgical assessment. The broken quill shaft A consists of two separated damage portions, one in a cup like fracture and the other in a cone like fracture

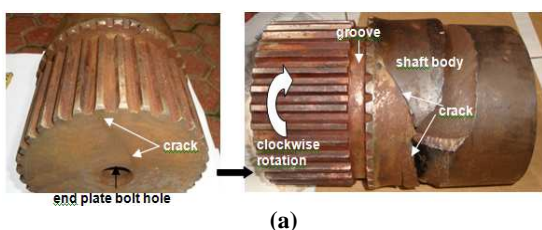
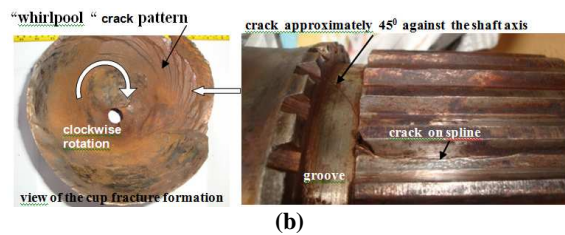
Figure 6. (a) Reconstruction of the two damaged portions of the broken quill shaft A, (b) An axial main crack formed along one of the splines root of the broken quill shaft A. This main crack subsequently propagated into the groove and the shaft body in the direction approximately 45° to the shaft axis

The crack formed along one of the spline tooth root shown in Fig. 6 is considered as the main crack which was propagated across into the groove and the shaft body in the anticlockwise direction approximately 45° to the shaft axis. This crack path ended at the shaft body circumference as shown in Fig. 6(b) and later it will continue to grow in radial direction to form a “whirlpool” crack pattern prior to the final fracture and formed a cup like fracture there<sup>[1]</sup>.

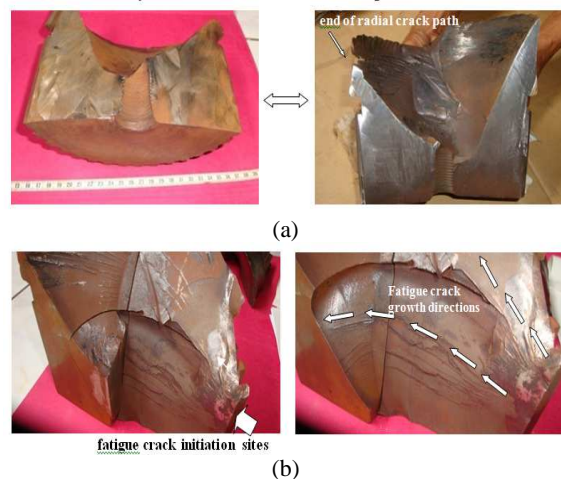
Figure 7. (a) The cup fracture sections of the broken quill shaft A after being cut-off into two pieces (continued). (b) Close up view of the surface fracture area, showing fatigue crack growth in two different directions. Under the splines area, the fatigue crack grew in a combined direction of transverse and radial, while outside the splines area the fatigue crack grew approximately 45° to the shaft axis and later turned in radial direction along the body shaft circumference to form a final typical cup fracture area

One of the sections of the broken quill shaft A after being cut-off into two pieces was further cut-off to expose the crack path in more detail, see Fig. 7. By doing such thing, it is obviously seen in Fig. 7 that the crack in broken quill shaft A grew into two different directions to form two crack paths as has been previously described. One crack path started along the tooth root of the shaft splines and

grew in transverse and radial direction away from the splines until it reached the bolt hole. The second crack path started from a stress concentrated area formed between the spline tooth root and the groove, and subsequently grew across the groove and the shaft body in radial direction to form a radial “whirlpool” crack pattern on the shaft body circumference before a final cup like fracture occurred.

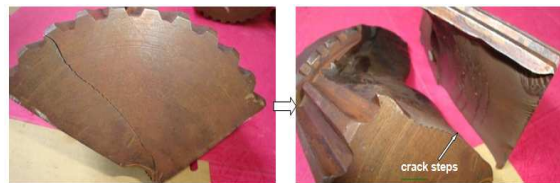
Sequence of crack path formation in the broken quill shaft A may be well understood by viewing some illustration shown in Figure 8 in which its fracture surface topography is presented in Fig. 9. A closer view on the fracture surface shown in Fig. 9 confirmed that the broken quill shaft A has been experiencing fatigue fracture that was originated from the tooth root of the splined shaft where a high stress concentration formed there, especially at both the tooth edge ends. As seen in Figs. 9 and 10 several ratchet marks are formed on both edge ends of the splines tooth indicating severe stresses were present. Formation of these ratchet marks also indicates that the crack initiated at that area was not related or caused by the presence of any defect or flaw, but this was mainly influenced by the geometric factor of the splines and/or the splines/groove connection. Further, it can also be seen from Fig. 9 that the fatigue crack growth which is indicated by beach marks formation show two different directions as has been described earlier. One fatigue crack growth formed in transverse and radial direction as soon as it left the crack initiation sites. The other fatigue crack growth which formed outside of the splines engagement area is in the radial direction approximately 45° to the shaft axis, and this is further supporting the previous description. As also seen in Figs. 9 and 10, most of the beach marks are seen smooth and fine. In addition, there are also seen some long ratchet marks extended across the fine and smooth beach marks area. Furthermore, there is seen one large curve of beach mark line to separate each fatigue crack growth area as seen in Figs. 9 and 10. This change in crack growth or beach marks pattern may have been associated with a load change imposed to the quill shaft as the compressor load change was made during its operation.

Figure 8. Cracks path direction and position located under the splines (the engagement) area and within the body shaft (outside the engagement area) observed from different views. Several crack steps were formed on the edge indicating of fatigue crack growth

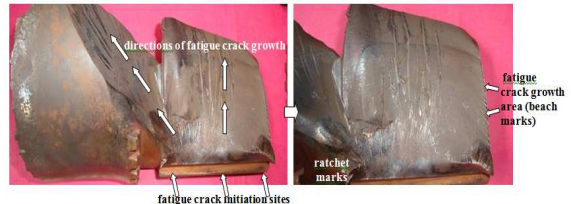
Figure 9. Close up view of the fatigue fracture surface exhibits crack initiation sites along the spline root having with some ratchet marks of a highly stressed area and the crack propagation area indicated by beach marks formation. The final fracture area is not seen in this figure as it was formed on the other side of the body shaft within the cup fracture portion

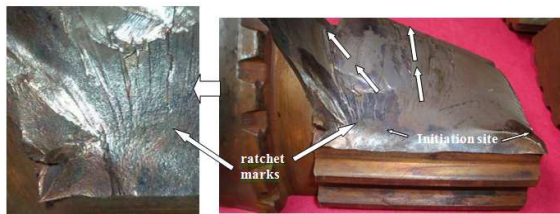
Figure 10. Close up view of the surface fracture area, showing fatigue crack growth in two different directions. Under the splines (engagement) area, the fatigue crack grew in a combined direction of transverse and radial, while outside the splines (engagement) area the fatigue crack grew approximately 45° to the shaft axis and later turned in radial direction to form a “whirlpool” crack pattern along the body shaft circumference prior to form an overload final fracture typical of cup like shape

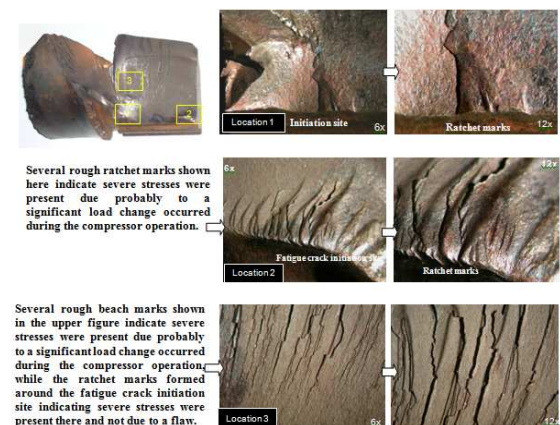
Figure 11. Close up view of fatigue fracture topography at different locations, showing the fatigue crack initiation sites having with several ratchet marks, and fatigue crack propagation area having with some smooth and rough beach marks

Close up views of fatigue fracture topography shown in Figs. 9 and 10 at different locations are given in Fig. 11, showing the fatigue crack initiation sites with several ratchet marks of severe stresses were present, and the fatigue crack propagation area having with some smooth and rough beach marks. The photographs shown in this figure (Fig. 11) is to confirm the previous photofractographs that in addition to ratchet marks which are usually formed at the fatigue crack initiation sites, there were also other rough ratchet marks that may have formed within the beach marks area indicating of severe stresses were present due probably to a significant load change occurred on the quill shaft as required by compressor operation for production purpose.

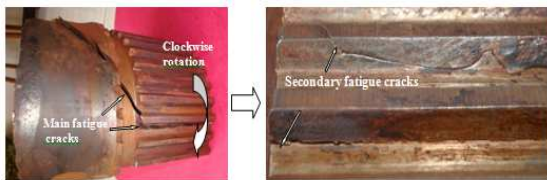
Figure 12. In addition to the main fatigue crack, a number of secondary fatigue cracks were also formed on the other splines teeth. However, some of these secondary fatigue cracks did not always form along the spline tooth root, indicating there was some engagement problem occurred between the shaft splines and the mating coupling hub due probably to some misalignment and/or geometrical clearance problem

In addition to the main fatigue crack as described earlier, a number of secondary fatigue cracks were also formed on the other spline teeth of the broken quill shaft A as presented in Fig. 12. However, as it is obviously seen in Fig. 12 some of these secondary fatigue cracks did not form along the spline tooth root of the quill shaft. This

indicates that there may have been some contact engagement problem occurred between the shaft splines and the splines of the mating coupling hub due probably to some misalignment and/or geometric clearance problem.

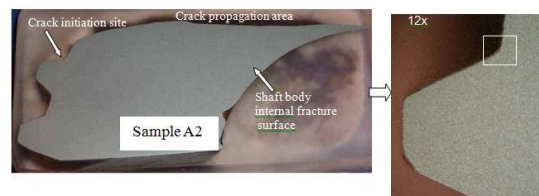
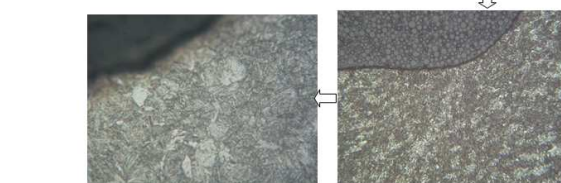
Figure 25. Microstructures obtained from sample A2 at location around fatigue crack initiation site indicated by rectangular grid

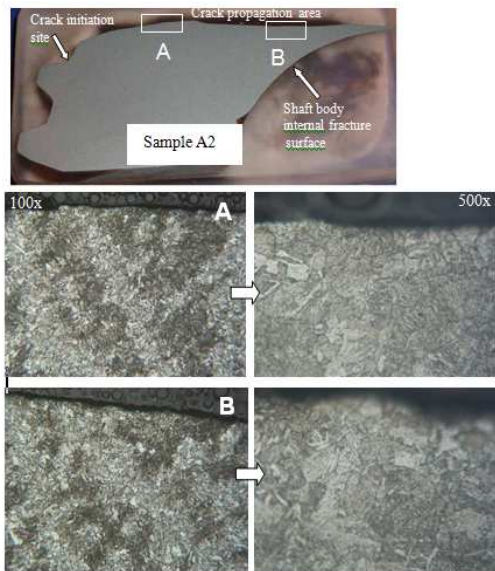
Figure 26. Microstructures obtained from sample A2 at location around the fatigue crack propagation area indicated by rectangular grid

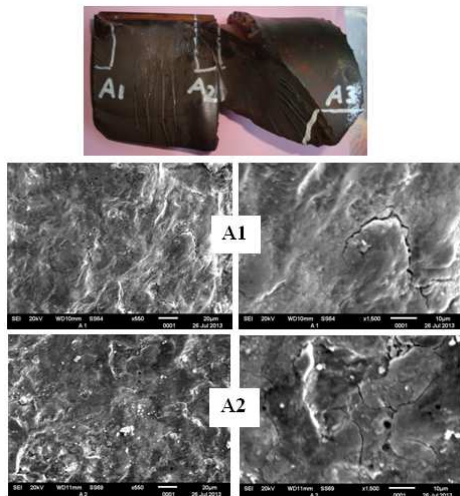
the crack initiation site near to the edge end of the spline tooth, and its SEM micrographs obtained are presented in Fig. 34, showing the fatigue crack direction from lower left to the upper right. Fatigue striations were not resolvable at any location, and the entire fatigue fracture surface displayed similar crystallographic features. Not all metals form distinct striation in fatigue, and those that do may not form striations under all stress ranges depending on material and loading conditions (as well as condition of the fracture surface)<sup>[4]</sup>. However, the absence of striations may not mean that fatigue did not occur. Further evidence of the occurrence of fatigue fracture was also indicated by the fact that no any plastic deformation in the form of dimple fracture was observed on most of the SEM microfractographs shown in Fig. 34.

Figure 34. SEM microfractographs obtained from fracture surface of the broken quill shaft A around the fatigue crack initiation sites A1 and A2, respectively

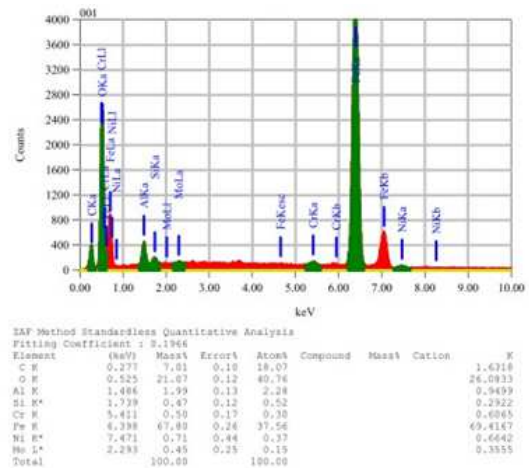
The corresponding EDS spectrum obtained from fatigue crack propagation area/crack initiation site are presented in Figs. 35 and 36. The EDS spectrum show some major elements of the low-alloy steel from which the broken quill shaft A was made such as: Fe, C, Ni, Cr, Mo, Si and Al. In addition, other significant elements were also present on most of the EDS spectrum such as C and O. The high C content found was not to represent the real carbon content of the fracture surface deposit, but this was very much influenced by the sample preparation or the specimen holder, whereas the high O content observed may be related to the oxide scales that may have formed on the fracture surface. It is also clearly seen from Figs. 35 and 36 that no any corroding element was present on most of the fracture surface deposit of the broken quill shaft A around its initial fatigue crack/fatigue propagation area.

Figure 35. EDS spectrum of elements representing the corresponding composition of fracture surface at the broken quill shaft A at location around the fatigue crack initiation site A1

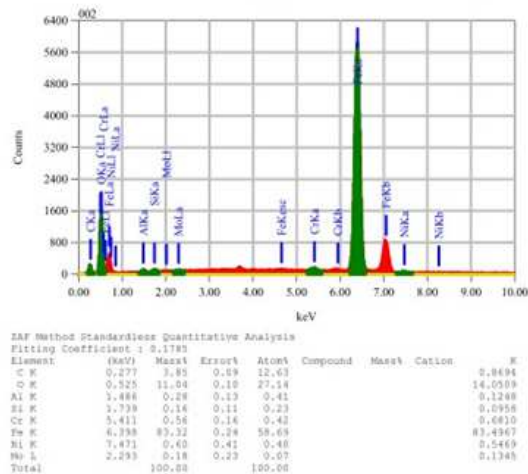
Figure 36. EDS spectrum of elements representing the corresponding composition of fracture surface at the broken quill shaft A at location around the fatigue crack initiation site A2
