METALLURGICAL EXAMINATION AND LIFE TIME ASSESMENT OF HIGH PRESSURE STEAM PIPES OF A PALM OIL PROCESSING PLANT

Dewa Nyoman Adnyana

Steel pipes are commonly used for transporting high pressure steam from a steam generating unit or boiler to a steam turbine or other processing unit. This paper presents a metallurgical examination performed on HP steam pipes of a newly constructed plant for transporting high pressure steam from a boiler to a palm oil processing plant. The aim was to assure that the material integrity of the steam pipes meet the intended specification and reliability. In addition, the aim was also to determine the estimated service life of the steam pipes. The metallurgical examination was conducted by preparing a number of specimens from the as-received three pieces of HP steam pipes. Various laboratory exam-inations were performed including chemical analysis, metallographic examination, hardness testing and tensile testing at 300 °C. In addition, a life-time analysis was also made using an equation based on the ASME Boiler and Pressure Vessel Code (BPVC) and data obtained from the API Standard 530. Results of the metallurgical examination obtained showed that the HP

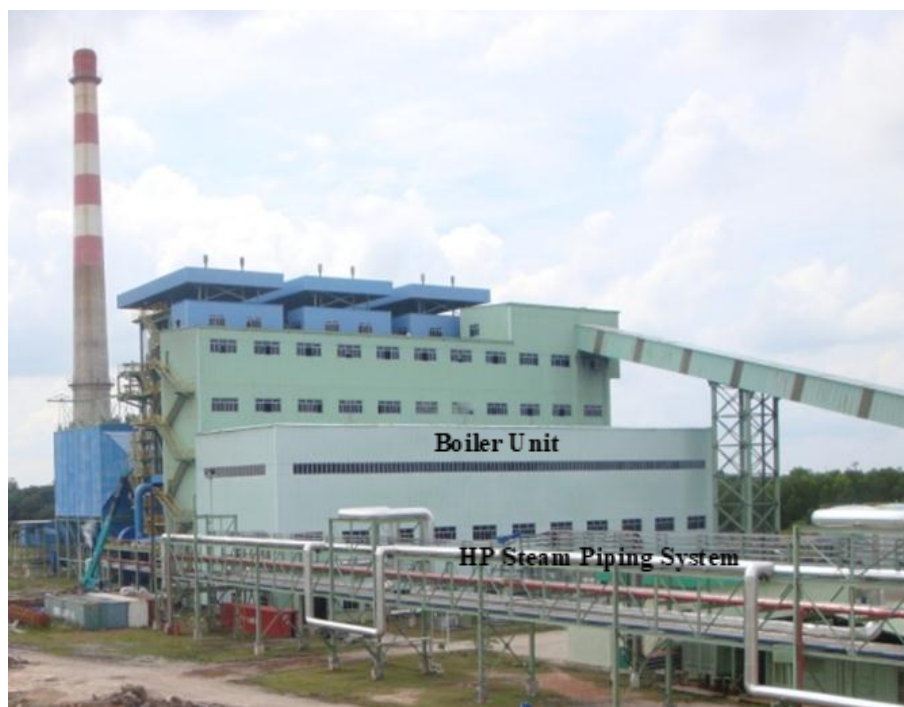
Figure 1. A newly built boiler construction and its corresponding HP steam piping system, connected to a palm oil processing unit at location approximately on the right hand side (not seen)

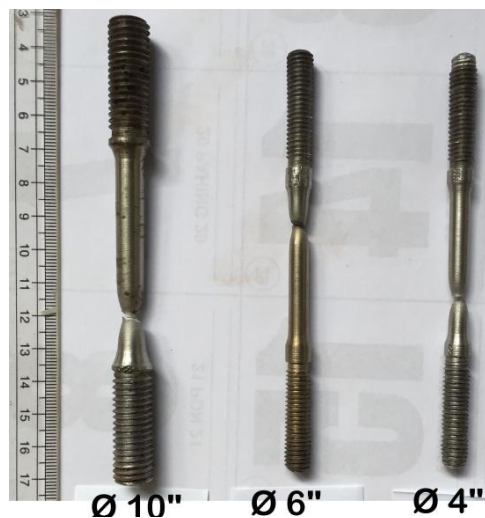
Figure 3. The three broken tensile test specimens after being tested at 300 °C

The broken tensile test specimens after they have been tested at 300 °C are seen in Figure 3, and the tensile test data obtained are summarized in Table 4. It can be seen that the TS values of the three pipes of diameter 10," 6" and 4" are well above the minimum TS value according to the material specification of ASTM A-106 Gr. B, either based on the ASME Boiler and Pressure
