FATIGUE FAILURE OF WHEEL STUDS AND NUTS OF LIGHT VEHICLES USED IN COAL MINE OPERATION

D.N. Adnyana

*Light vehicle is a potentially useful and efficient mode of transportation to be utilized in supporting the coal mine operation. However, due to the harsh road condition at the mine site, many light vehicles presently used are frequently experiencing a number of incidents caused by loose wheel. The occurrence of this loose wheel is very much related with some broken or damaged wheel studs and/or nuts of the vehicle. Type of failure and factors that may have caused the damage of the wheel studs and/or nuts of the vehicles are discussed in this paper. The metallurgical assessment was conducted by preparing a number of specimens from the damaged and undamaged wheel studs and nuts of the vehicles. Various laboratory examinations were performed including macroscopic examination, chemical composition analysis, metallographic examination, hardness test and SEM (*scanning electron microscopy*) examination equipped with EDS (*energy dispersive spectroscopy*) analysis. In addition, torsion test was also conducted on several new studs and nuts to measure the relationship between the torque an

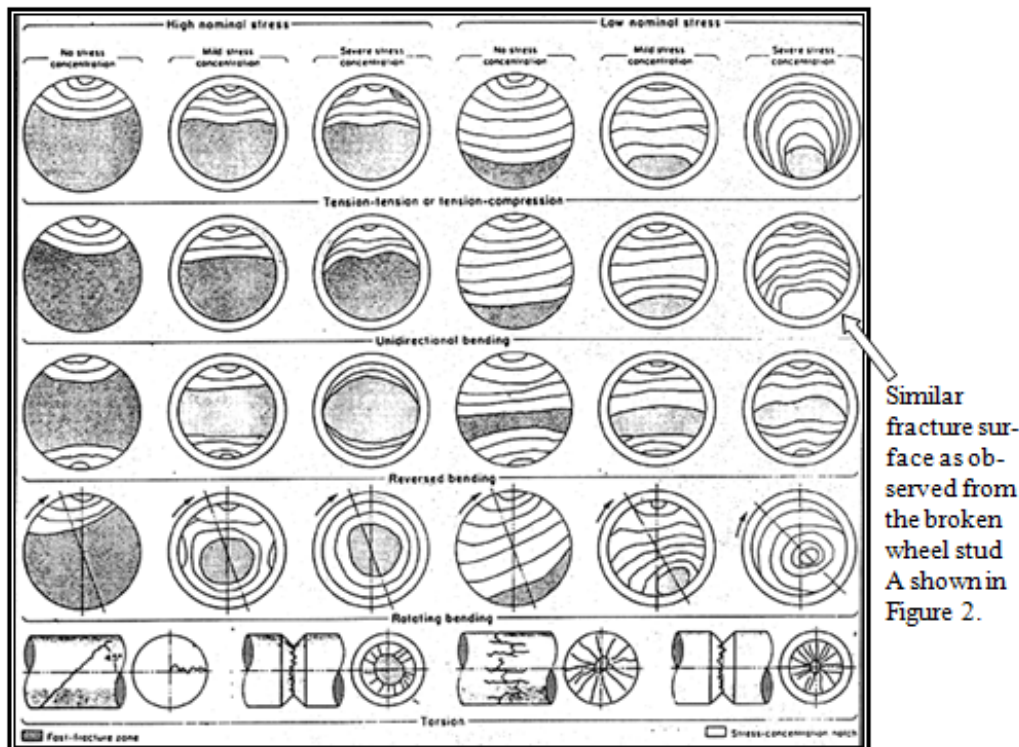
Figure 3. Schematic of marks on surfaces of fatigue fractures produced in smooth and notched components with round cross section under various loading conditions at high and low nominal stress^[5]

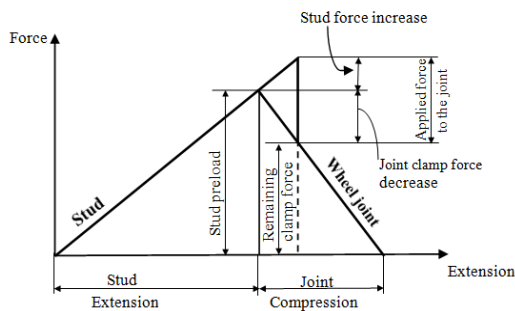
This means that the vehicle has not been operated properly in such harsh road condition at the mine site so that the stud-wheel joint of the vehicle is subjected to an excessive or severe working load. As schematically illustrated in Figure 13, this severe working load when exceeded the stud preload, it could start to reduce the clamping force between the stud and the wheel joint and hence could establish a highly dynamic cyclic load condition. With the high fluctuating load due to road condition, this situation could cycle the wheel stud progressively, with continued loss of preload and thus resulted in a loose joint, and eventually followed by a possible rapid fatigue failure.

Figure 13. Diagram force versus extension of stud-wheel joint under an applied external force (ii). Improper material of the stud

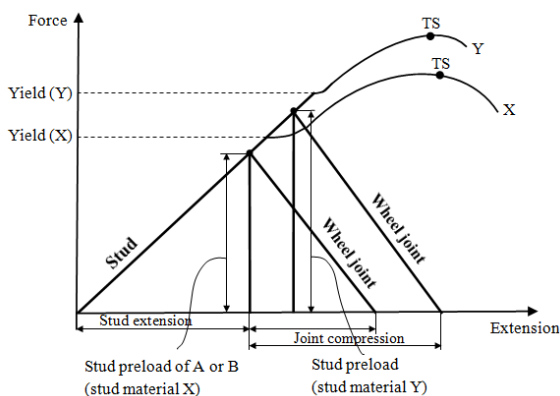
The yield and tensile strength of the studs A or B (see Figure 14 for the stud material X) may not be sufficient to withstand for the severe working load occurred on the harsh road condition at mine site. As a result, the studs A or B which is made from the material X was likely not able to accommodate a high (initial) preload during its installation if compared to a stud that made of material Y (see Figure 14). It can be seen from Figure 14 that material Y has higher yield and tensile strength than this material X. In practice, a high initial preload is actually required to obtain a high clamping force that make more rigid joint and thus increase stud fatigue life. Due to this limitation, the preload that could be applied to the stud A or B became relative low, and therefore the clamping force of joint tended to decrease easily when subjected to a severe load condition and thus resulted in a loose joint and eventually followed by a rapid fatigue crack or fracture.

Figure 14. Diagram of stud-wheel joint having two different preloads due to the difference in stud material used

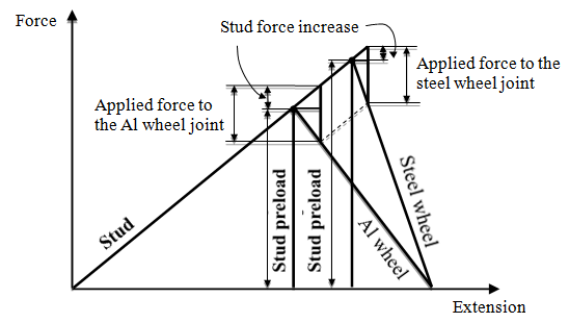
The wheel material of light vehicle presently used is generally made using some aluminum alloy. The application of this aluminum wheel could result a “soft” joint (a high stiffness stud with a low stiffness joint), because the stiffness slope of the wheel stud is greater than that of the wheel joint and could result in a low preload (see Figure 15)^[10]. As seen in Figure 15, when using a steel wheel it could result in a “hard” joint (a low stiffness stud with a high stiffness joint) and provides a higher initial preload compared to the aluminum wheel. The steel wheel joint could be subjected to a high working load compared to the aluminum wheel joint and therefore the clamping force of steel wheel joint could maintain its stability/rigidity. As seen in Figure 15, for the same applied force to the wheel joint, the stud would sustain the majority of the applied force when the wheel material is made of aluminum compared if the wheel material is made of steel. Consequently, under a severe load condition the clamping force of Al wheel joint could decrease rapidly and establish a highly dynamic cyclic loading condition, leading to a rapid fatigue on the stud.

Figure 15. Diagram of stud-wheel joint having two different wheel materials, one is made of aluminum alloy and the other is made of steel

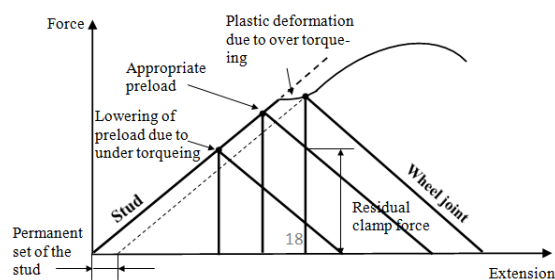
other hand, when the studs were over torqued, the stretch occurred on the studs could exceed the elastic limit, and the stud experienced some plastic deformation, taking a permanent set (see Figure 16). This typical damage due to some plastic deformation may have occurred on the studs B. This could result a loss in stud preload, and the clamping force acting on the wheel and hub joint would continue to decrease. Under high fluctuating loads during operation due to a severe road condition, this situation could cycle the stud progressively with continued loss of preload and possibly rapid fatigue failure. In addition, over torquing would also cause the nut-thread stripping that may have also contributed to rapid stud failure.

Figure 16. Diagram of stud-wheel joint under different preloads due to the difference in torques applied
