## STRESS CORROSION CRACKING OF CAGE SUPERHEATER TUBES OF A NEWLY BUILT BOILER

**Dewa Nyoman Adnyana**

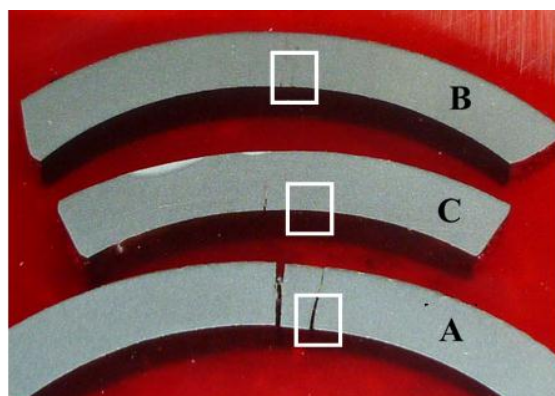
Figure 7. Three specimens A, B and C at different locations were prepared from the leaked tube at its fire side position for metallographic examination

Three different specimens in transverse cross section (A, B and C) were cut away from the leaked tube piece at the fire side position (see Figure 7), and the microstructures obtained are presented in Figures 8, 9 and 10. All the microstructures of samples A, B and C obtained

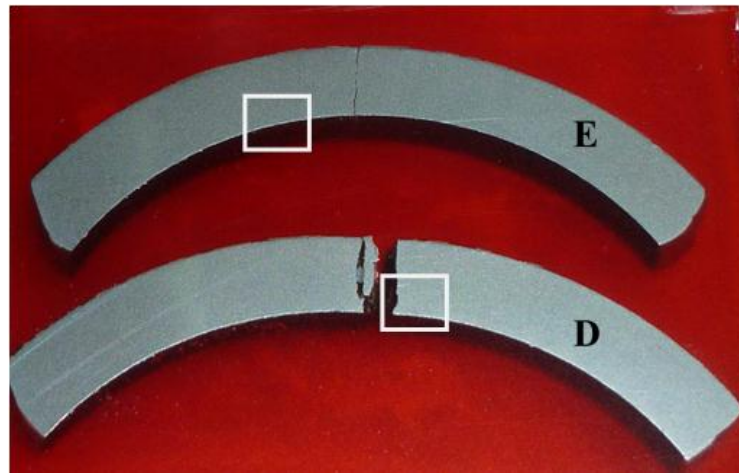
Two other specimens in transverse cross section (D and E) were also cut away from the leaked tube piece at its wall side position (see Figure 11), and the microstructures obtained are presented in Figures 12 and 13. All the microstructures of samples D and E obtained from the wall side position of the leaked tube piece also exhibited similar microstructures as obtained from samples A, B and C at the fireside position of the leaked tube piece. The tube material microstructures consisted of matrix ferrite phase with pearlite second phase. Similarly, all the cracks formed in samples D and E were also typical of stress-corrosion cracking (SCC), originated from the corrosion pits that were present at the tube internal wall and propagated toward the external surface of the tube by cracking through the pearlite phase and/or ferrite grain boundaries.

Figure 11. Two tube specimens D and E at different locations were prepared from the leaked tube at the wall side position for metallographic examination
