## CAVITATION-EROSION STUDY IN ELBOW TUBES OF A LOW-PRESSURE EVAPORATOR OUTLET HEADER

**Dewa Nyoman Adnyana**

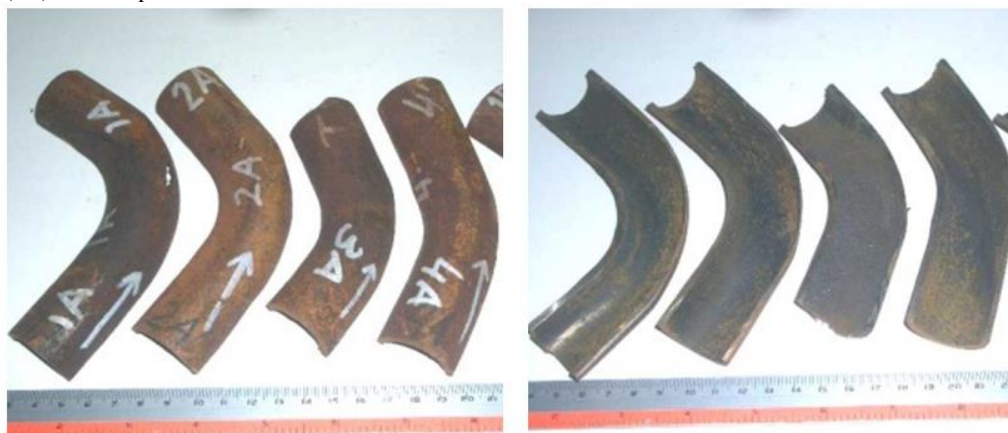
tube shown in Figure 2 was sectioned into two halves (see Figure 3) and subsequently cut into several specimens for laboratory examination. The macroscopic test on the damaged surface of the elbow tubes was performed using a stereomicroscope. Chemical analysis of the prepared sample was carried out using an optical spark emission spectrometer. The purpose of this chemical analysis was to determine whether the material used for the damaged elbow tubes met the specification. Besides, metallographic examinations were also performed on the prepared samples using an optical microscope at various magnifications. The metallographic samples were mounted

Figure 3. The four elbow tubes (1A to 4A) divided into two parts for the preparation of laboratory test samples
