## DAMAGE INVESTIGATION ON WELD ALUMINUM COMPONENT OF A COMPRESSOR AFTER-COOLER

**Dewa Nyoman Adnyana**

*This study was carried out on a compressor heat exchanger (after-cooler) which leaked in the welded joint of a component made of non-heat-treatable aluminum alloys. The purpose of this study is to determine the type, cause, and mechanism of failure/damage in relation to the metallurgical structure that occurs. In this study, several tests were carried out including visual and macroscopic examinations, metallographic and hardness testing, and SEM (scanning electron microscope) analysis equipped with EDS (energy dispersive spectroscopy). The results show that the type of failure that occurs in the compressor after-cooler is intergranular corrosion due to the sensitization that occurred in the microstructure. In addition, the damage that occurs may also be influenced by the weld defect in the form of gas porosity.*

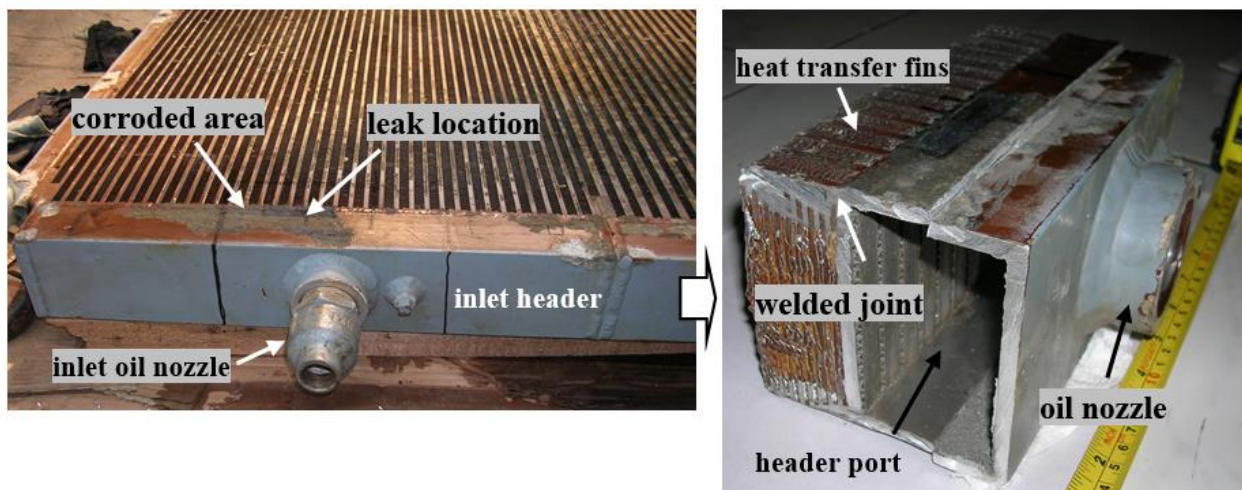
Figure 2. Cutting-off some parts of the compressor after-cooler around the leak location for samples preparation

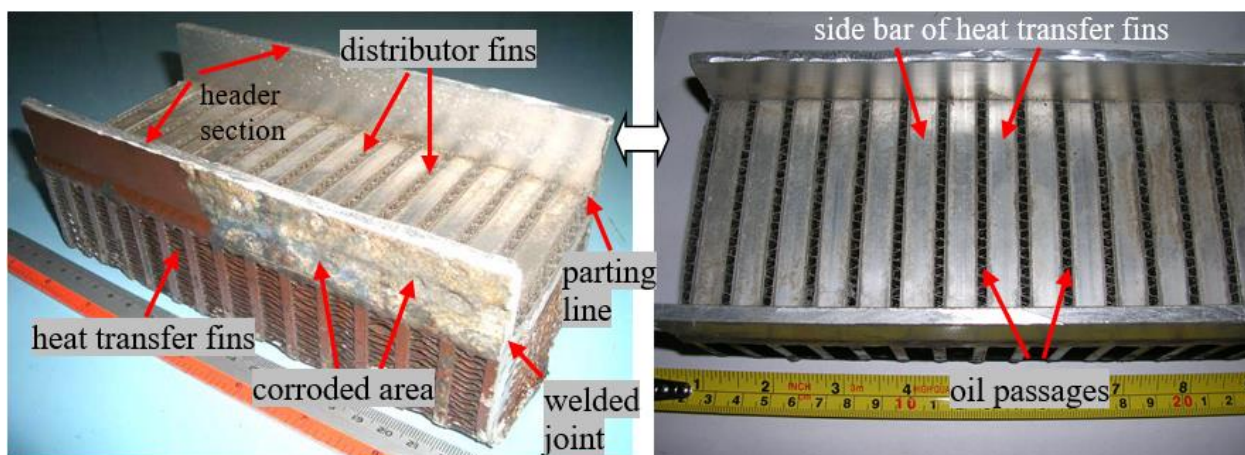
Figure 3. Close up view of the inside header port, showing several oil passages containing distributor fins and parting line of the weld joint between the header and sidebars/parting sheets

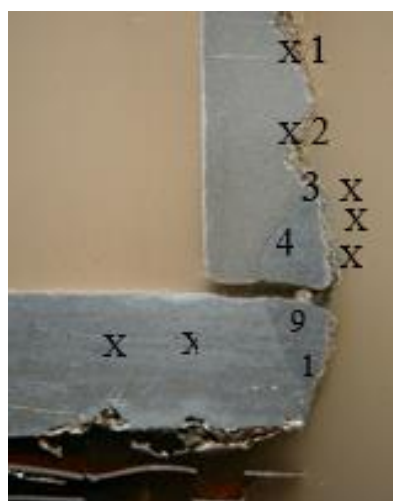
Table 1. Hardness survey (HV) obtained from various test locations of the metallographic sample shown in Figure 11

Test Location	Hardness (HV)
1	87.4
2	102.0
3	94.6
4	105.0
5	64.4
6	84.1
7	23.2
8	34.1
9	24.4
10	59.3

Figure 11. Various test locations for hardness survey

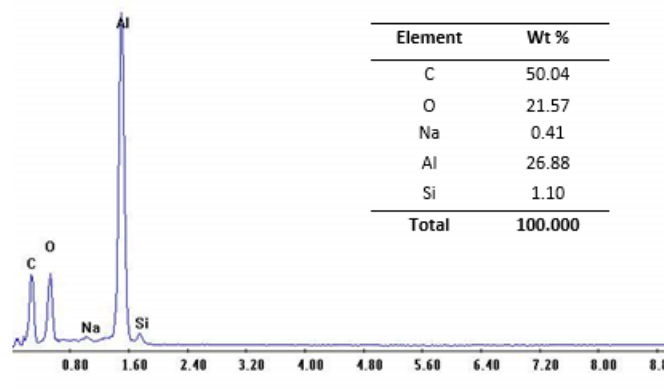
The EDS spectrum of elements obtained from the header fracture surface shown in Fig. 12 that experienced corrosion damage shows some major elements such as aluminum (Al), carbon (C), and oxygen (O) (see Fig. 13). The oxygen content obtained is much likely affected by the oxide formation due to corrosion (as corrosion product). Whereas the high carbon content found in the EDS spectrum may be influenced by some leakage of compressor hot lubricating oil that entered into the oil cooler. In addition to those elements, there are also other elements observed in the EDS spectrum such as magnesium (Mg), silicon (Si), sodium (Na), chloride (Cl) and calcium (Ca). Both elements of Mg and Si are the alloying elements of the aluminum alloy AA5xxx. The source of Na and Cl was most likely coming from the seawater and/or its moisture or maybe present from other aqueous environments. Figure 14 also shows the EDS spectrum of elements representing the corresponding composition of inclusion that formed inside a large porosity shown in Fig. 12. The inclusion is a typical aluminum oxide that likely formed from the filler metal used during welding.

Figure 14. EDS spectrum of elements obtained from the inclusion formed in the weld defect (porosity) shown in Fig. 12
