## FATIGUE FAILURE IN A LONGITUDINAL WELDED ELBOW OF A PROCESSING VESSEL

**Dewa Nyoman Adnyana**

*Longitudinally welded elbow made of austenitic stainless steel type 316 and used as a drain line on a processing vessel had suffered damage (leakage) after it had only been in operation for a few years. Process fluid that was drained out of the vessel consists of fatty acid-containing hydrogen gas at a temperature of 150 °C and a pressure of 60 bar(g). Initially, the draining process was carried out only once a year, but recently due to frequent changes in the types of product being made, the frequency of the draining process has increased to several times a month. This study aims to determine the type and factors that have caused leakage in the elbow. The metallurgical assessment was carried out by preparing many specimens from the leaking elbow. A number of laboratory examinations were performed, including visual and macroscopic tests, chemical composition analysis, metallographic examination, hardness tests, and SEM (scanning electron microscope) equipped with EDS (energy-dispersive spectroscope) analysis. The results obtained indicate that the leaking elbow has experienced fatigu

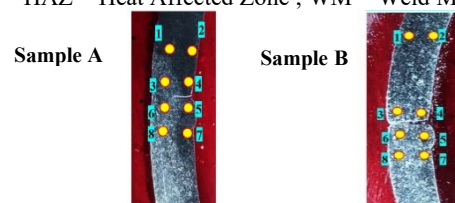
Results of hardness test obtained from specimens A and B of the damaged elbow material are presented in Table 2. It can be seen that the hardness values in the base metal (BM) and HAZ of the damaged elbow material were found ranging from 145.1 to 165.4 HV. These hardness levels are approximately within the range to the hardness levels obtained from the AISI type 316 stainless steel of 227 HV (max). From Table 2, it is also found that in the weld metal (WM) area, the range of hardness levels was relatively higher compared to that obtained from the BM and HAZ, namely 167.8-185.5 HV. These high hardness levels occurred at the WM of the elbow may be resulted from the smaller grain size that formed in the WM microstructure compared to the microstructure obtained from the BM and HAZ. The hardness value on HAZ looks the lowest because it has a coarse grain size so it is prone to cracking.

Table 2. Results of hardness test obtained from specimens A and B of the damaged elbow material using Vickers hardness method (HV) at different test locations
