## METALLURGICAL ASSESMENT OF A BROKEN GEARBOX INTERMEDIATE SHAFT OF A RECIPROCATING COMPRESSOR

**D. N. Adnyana**

### Abstract

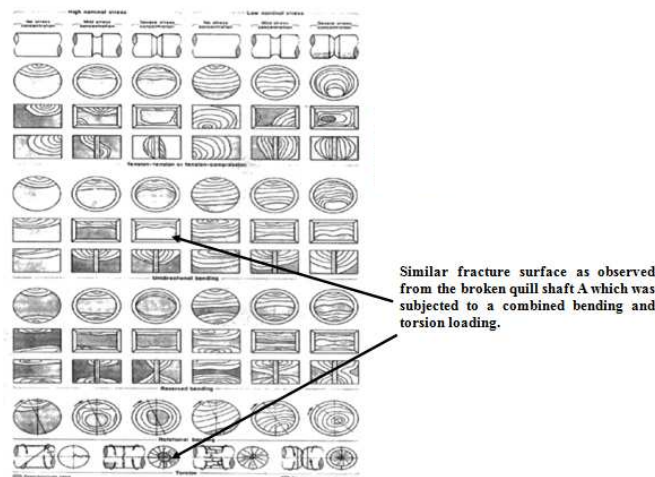
Figure 13. Schematic of marks on surfaces of fatigue fractures produced in smooth and notched components with round, square, and rectangular cross sections and in thick plates under various loading conditions at high and low nominal stress

From the results of macroscopic examination obtained on the surface fracture of the broken quill shaft A as presented above, and by using Fig. 13 to interpret the results obtained, it can be concluded that the broken quill shaft A had been experiencing fatigue fracture under complex stresses condition of a combination of shear stress, bending stress and torsion stress. From the fatigue crack path observed, under the engagement area where the shaft splines were in contact with the splines of the coupling hub, the level of bending stress and shear stress was quite high compared to the torsion stress and therefore the fatigue crack grew in transverse and radial direction, and later the crack stopped at the bolt hole. For the splined shaft located outside the engagement area, the shear stress was no longer present, while the bending stress decreased and therefore the majority of stresses present there was the torsion stress. Consequently, the fatigue crack grew in radial direction to form a radial “whirlpool” fracture pattern prior to a cup like final fracture. According to Fig. 13, formation of this final fracture area is relatively larger in comparison with the cross sectional area of the splined shaft body, and therefore the broken quill shaft A is considered to have been experiencing fatigue fracture due to a high nominal stress with a severe stress concentration<sup>[2]</sup>.
